PROPOSED W.D.A DEVELOPMENT
AT
CLYDACH VALE
RHONDDA

OVE ARUP & PARTNERS
GEOTECHNICAL DESK STUDY
SYNOPSIS

CLYDACH VALE 1.5 HECTARE PLATEAU

GEOTECHNICAL DESK STUDY

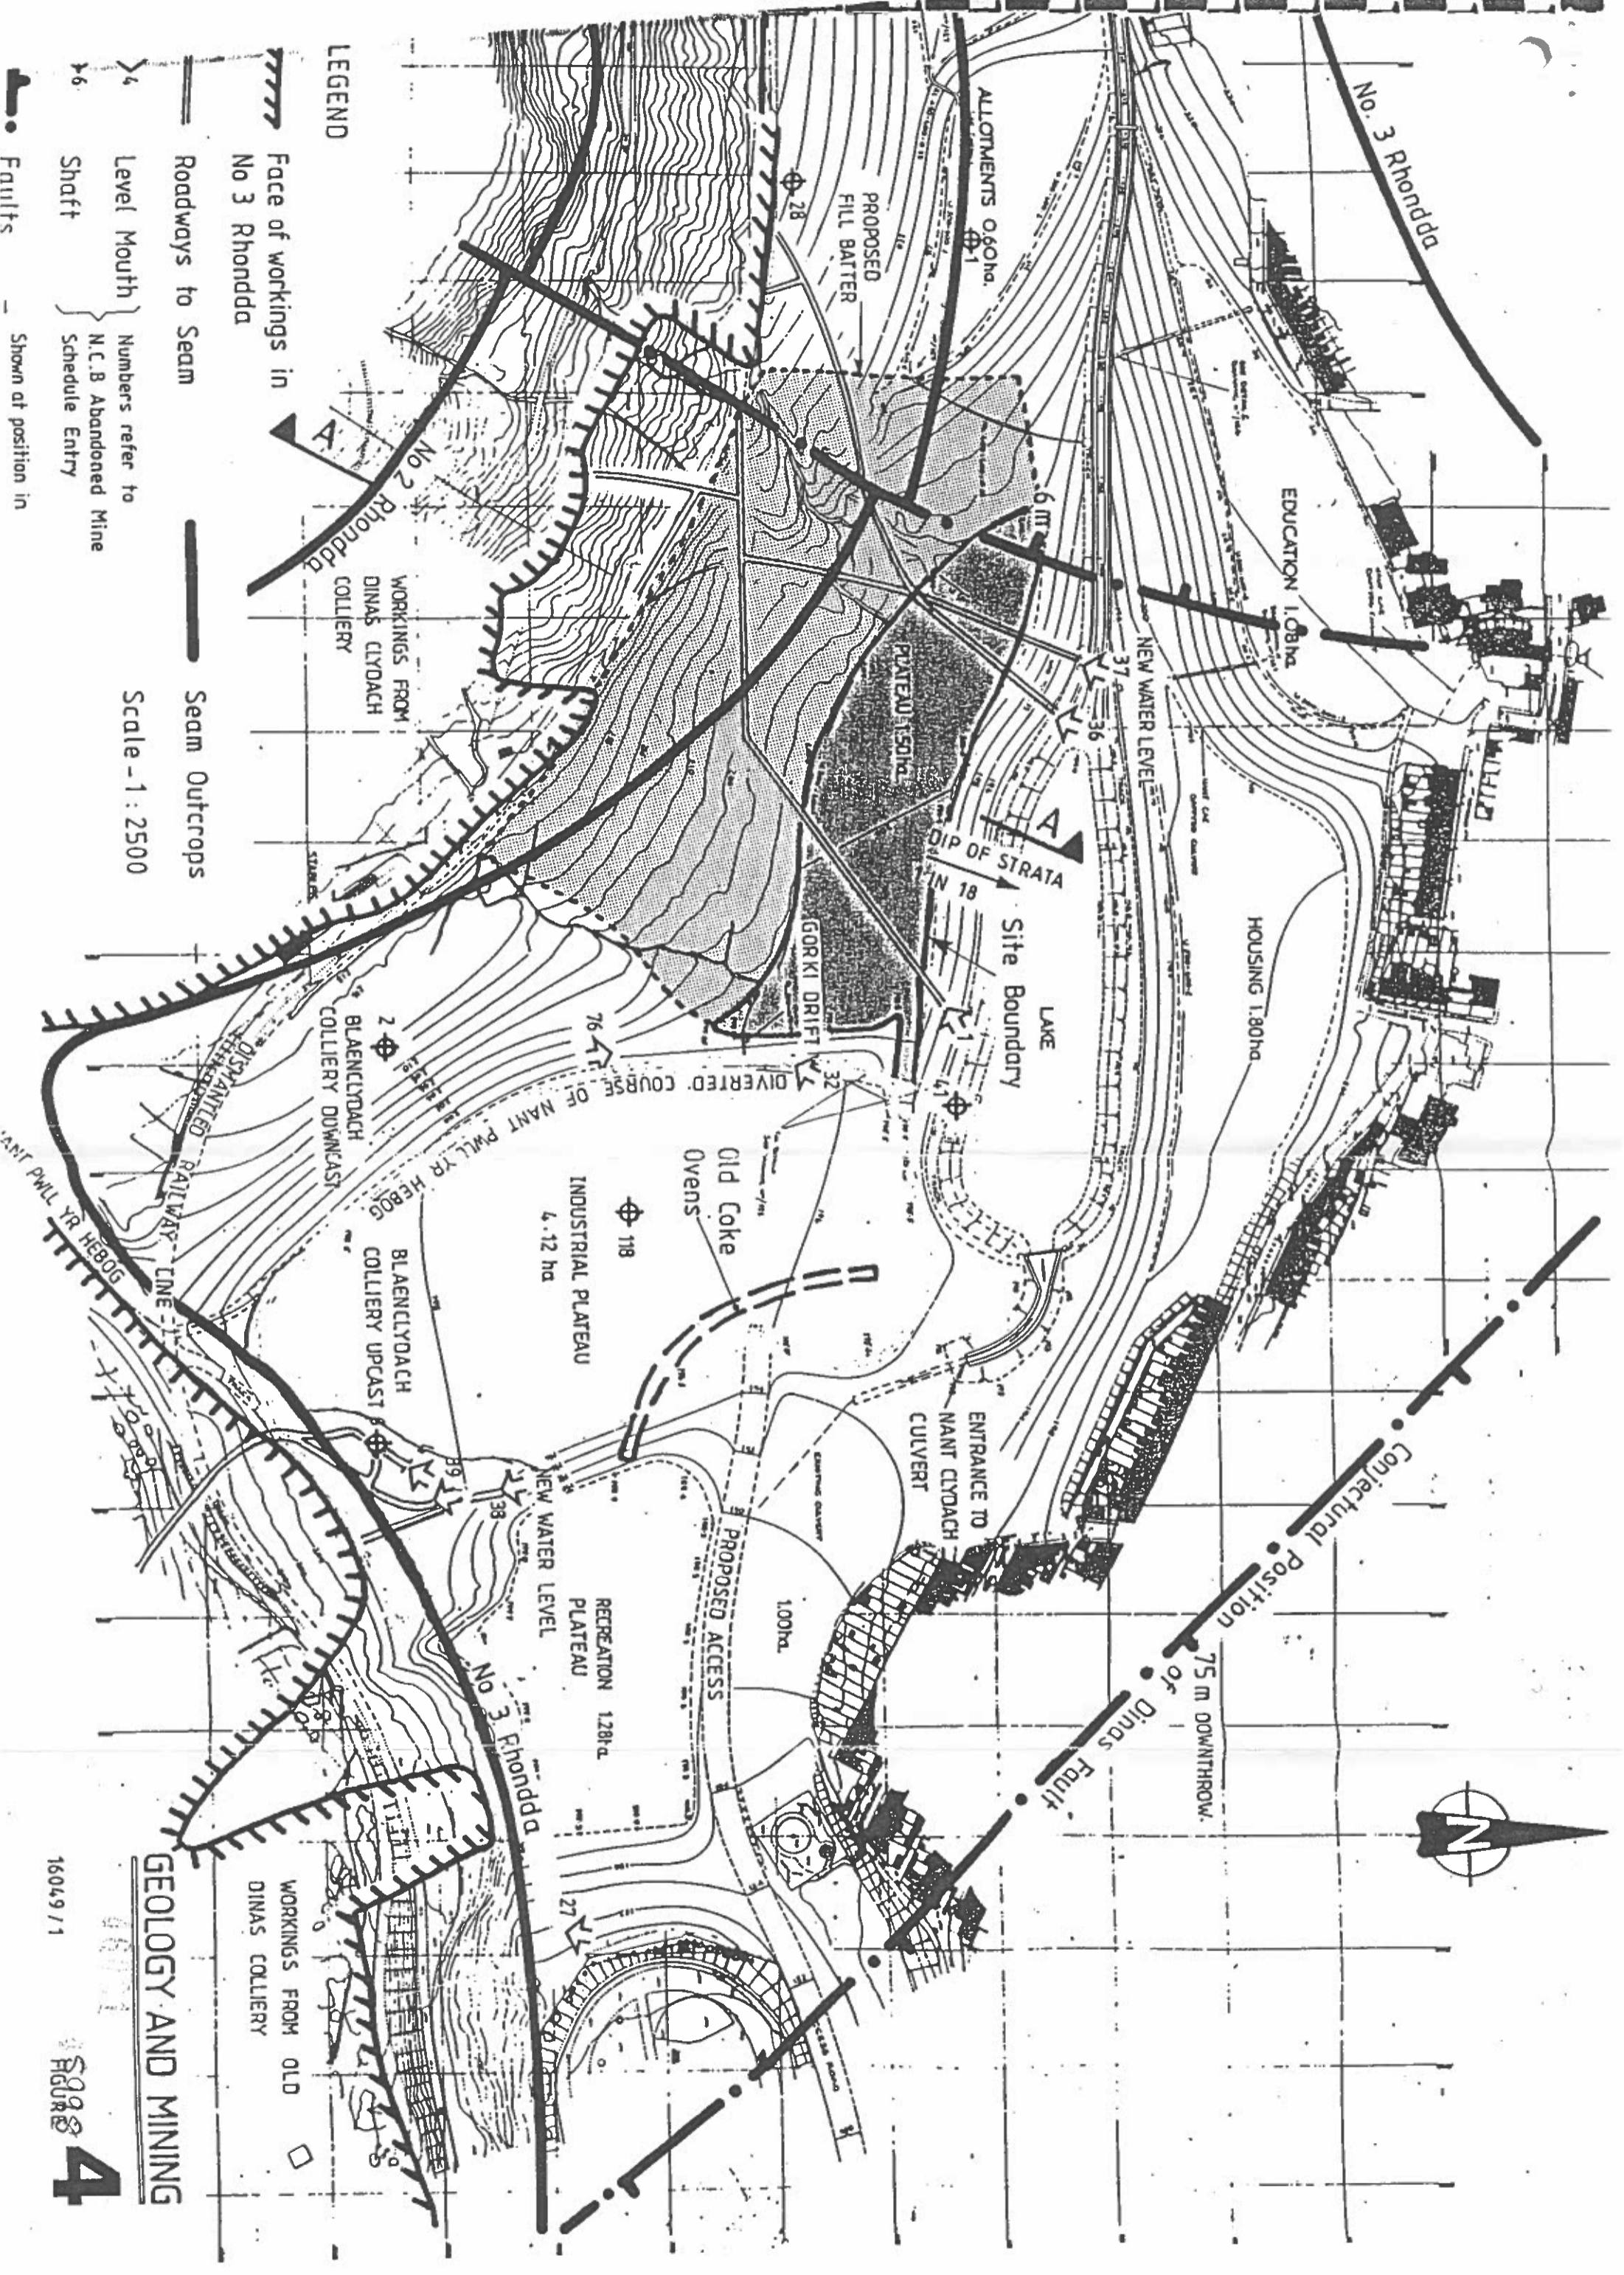
GEOLOGY AND MINING

A minor fault is shown on mine plans crossing the western end of the site, in the No.3 Rhondda Seam, see Figure 4. It trends north-north-east and the downthrow is some 6m to the west-north-west.

The No.3 Rhondda Seam, which outcrops beneath the proposed filled batter, see Figure 4, was extensively worked from Dinas Clydach Colliery between 1863 and 1897. It was worked almost to outcrop at the eastern end of the batter; however, a pillar of coal was left beneath the western end.

Relevant mine entries are shown on Figure 4.

Levels 1, 36 and 37 pass beneath the plateau and the filled batter. They are associated with No.3 Rhondda workings of Dinas Clydach Colliery.

Levels 2, 36 and 37, see Figure 4, have been treated by excavation to invert level and backfilling with compacted fill. This treatment extended from the level mouths across the plateau to the toe of the proposed fill batter. Prior to backfilling, rubble drains were laid in the inverts of these excavations to provide drainage from the old workings.

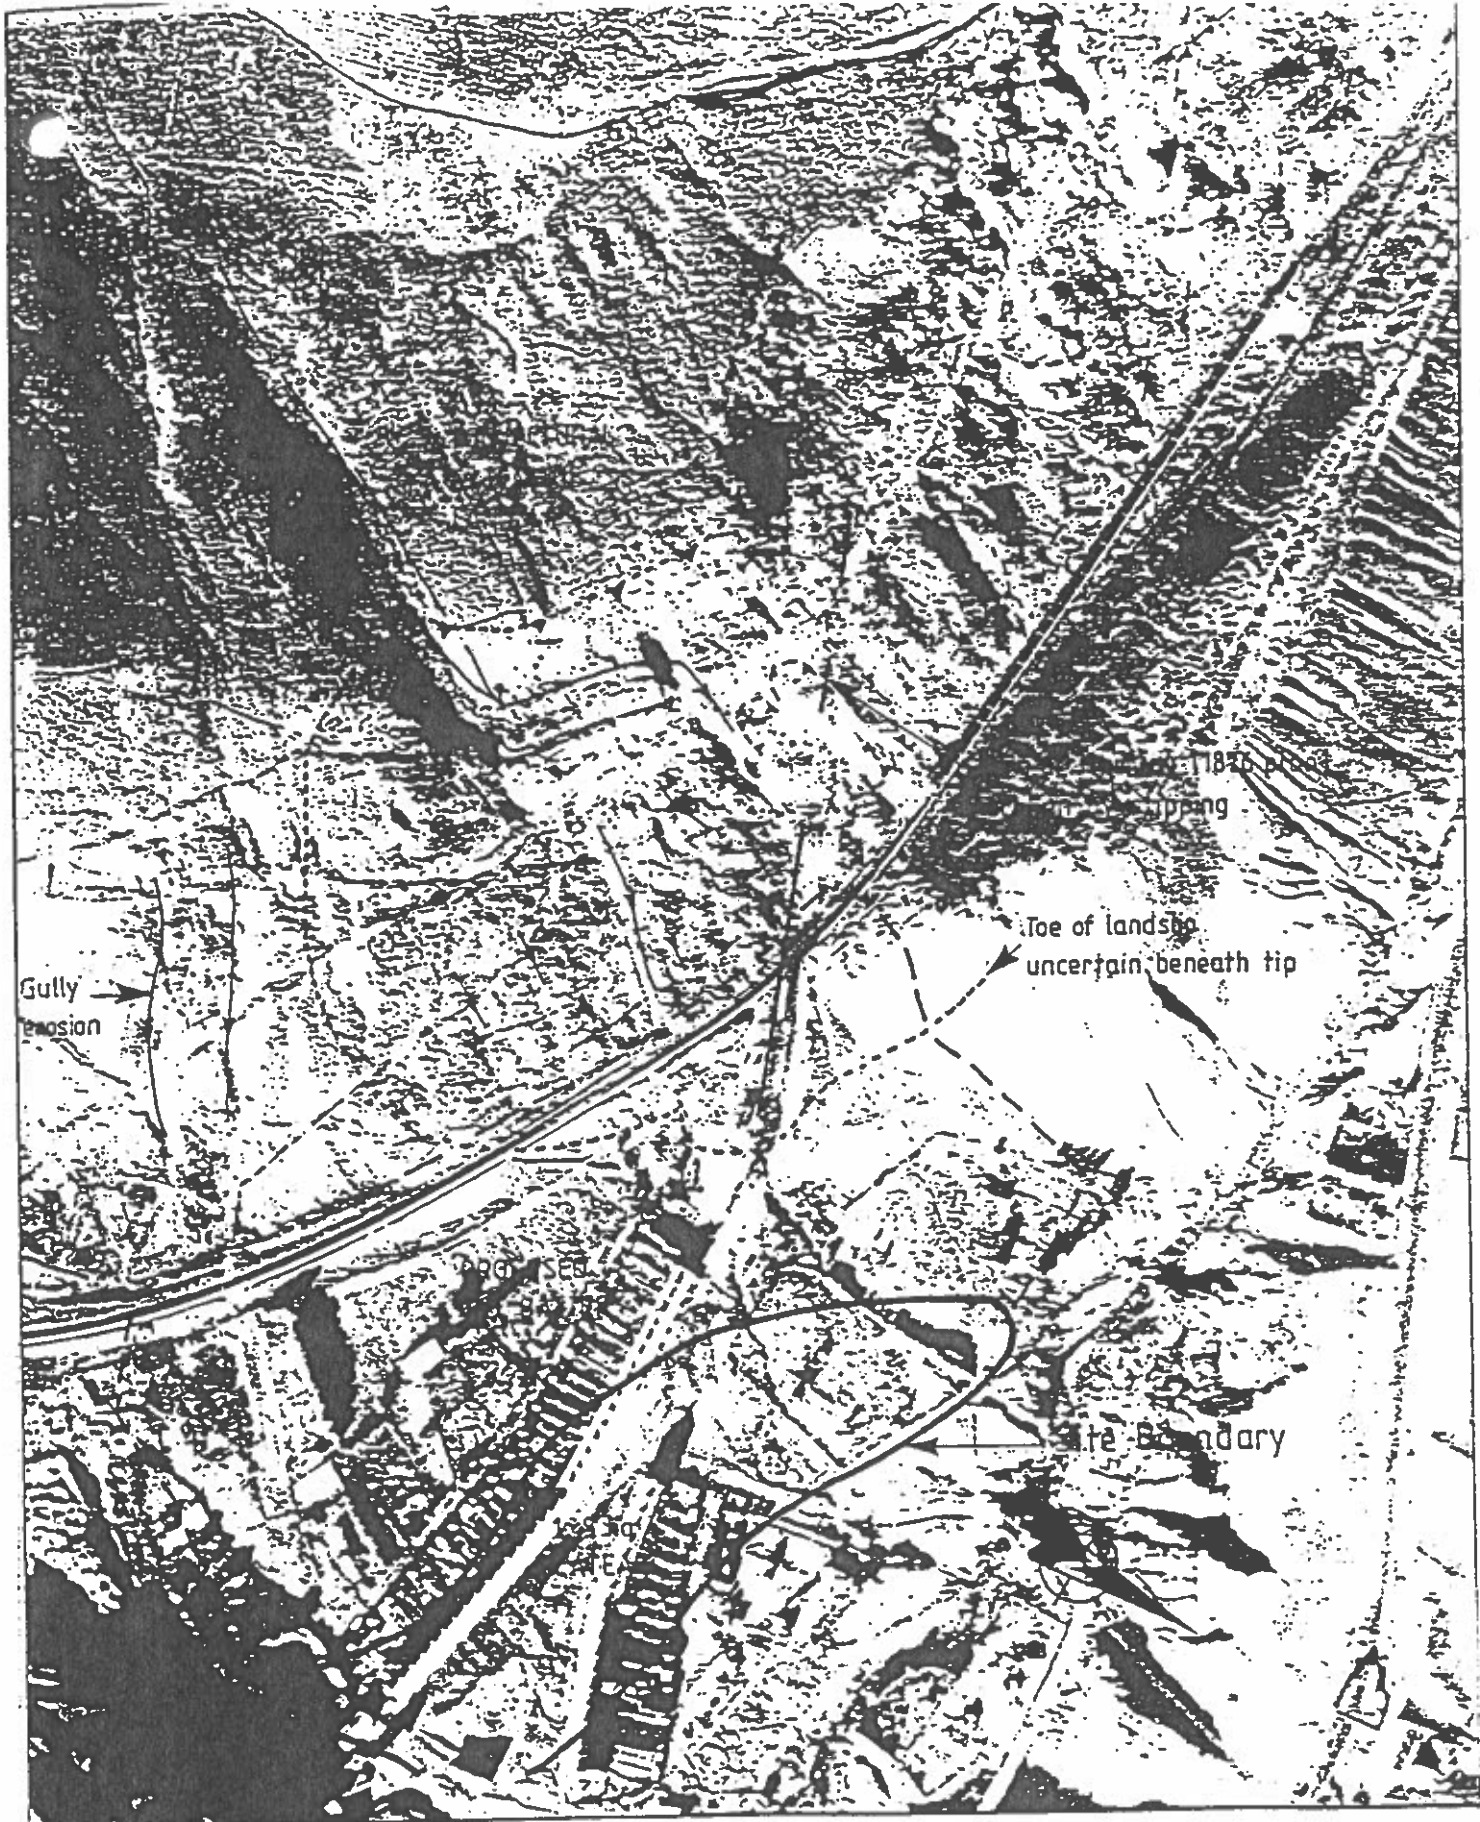
AERIAL PHOTOGRAPH

Aerial photograph overlays, see Figures 6 and 7, show the conjectured extent of the landslipping together with the main scars, lobes and drainage lines. The eastern end of the landslip lies uphill of part of the 1.5 ha plateau and encroaches into the south-west corner of the proposed fill batter.

The landslip morphology changed relatively little between 1954 and 1985. At the eastern end, there have been shallow movements associated with drainage lines, including erosion in gullies and backsapping at issues. These shallow movements are on-going and account for several bare scars which are presently visible. The movements in 1976, referred to by IGS, are likely to have been of a similar nature.
