# HAWKESWOOD ECOLOGY

Our Ref: HE/18/2025

### **Ecological Constraints Assessment Relating to Uplift Road Resurfacing.**

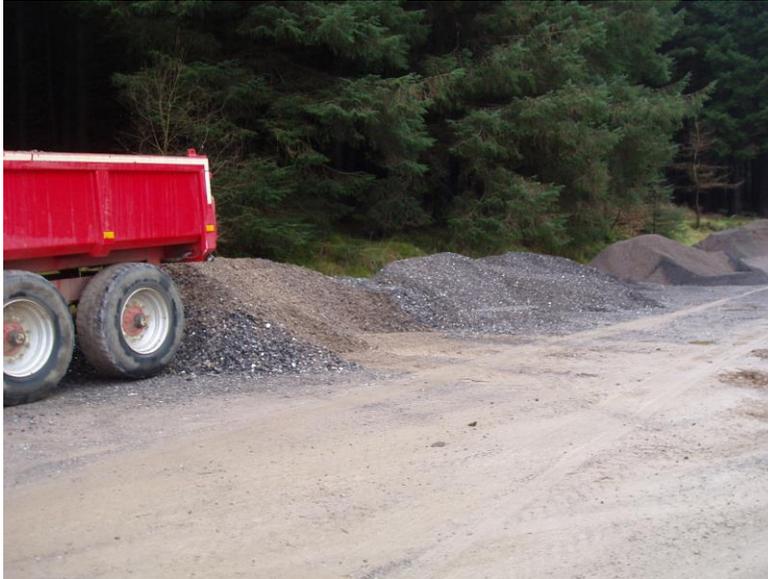
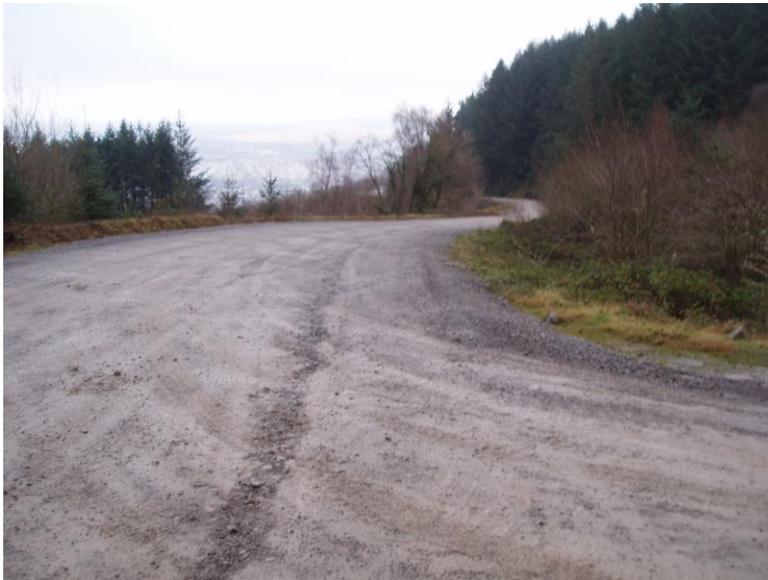
**The Storage area and roadway near to it showing wear.**
