2433 Bridgend Clusters

Report on a Preliminary Roost Assessment

Fulcrum Group
2433
September 2023

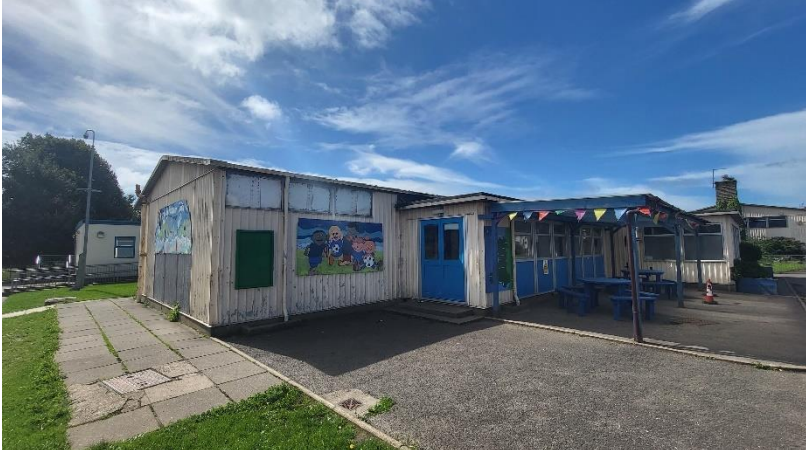
<p style="text-align: center;">Image 1</p>
B1 (a)	Rear of Building B1 (SE side) Section a. Roof and walls appeared well-sealed with no gaps under the roof overhang or any other access points or PRF's identified.

- 3.2.7 **Section 1(a)** is at the eastern end of the unit (image 1) and was noted to be generally well sealed with a lack of access points along the roof edge, to either front (more northerly facing, where there was a section of flat roof) or rear, or elsewhere along the roof, or around windows (Image 2). The north-east gable end had an attached wooden board with a painted mural, with a similar board on the north-west facing front wall. Both had gaps behind due to the corrugated panels preventing the boards lying flush with the walls. These gaps offer some roosting potential although this is sub-optimal and not significant (Images 3 and 4).

Building	Description	Photographs
B1 (a)	North-east corner of Building B1. Shallow pitched roof, separate flat roof. Flat roof appeared well sealed with no potential access points suitable for bats.

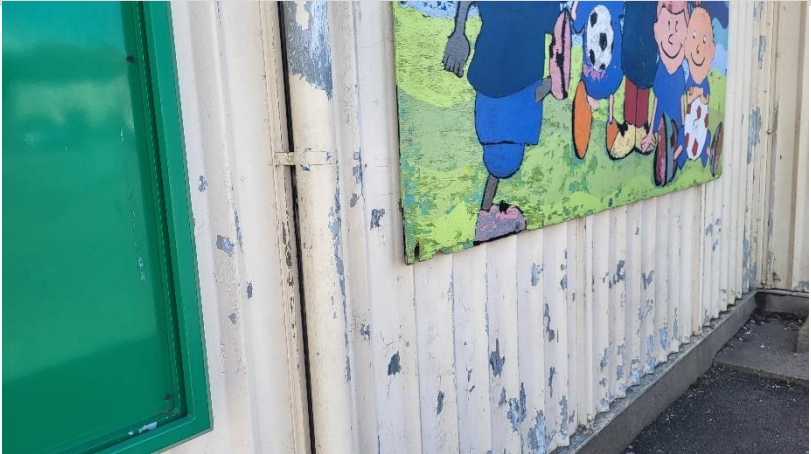
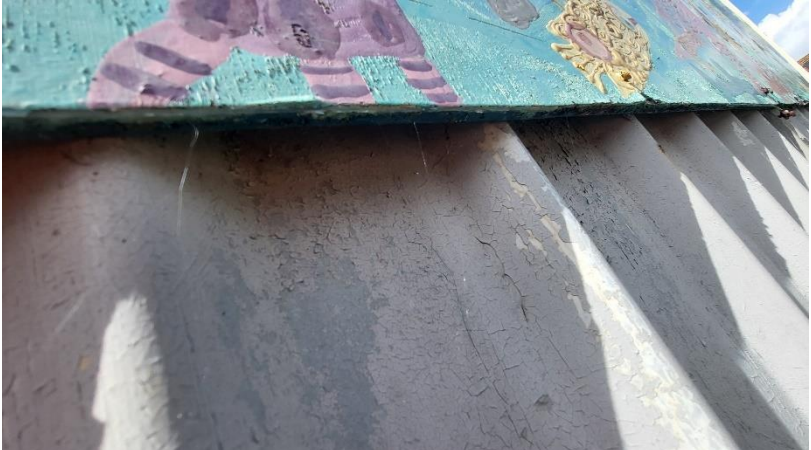
Building	Description	Photographs
B1 (a)	<p>Gaps between painted boards and corrugated wall panelling (NW and NE walls) offer roost potential for occasional ad-hoc use (sub optimal). Cobwebs behind and no evidence of use by bats at time of assessment</p>

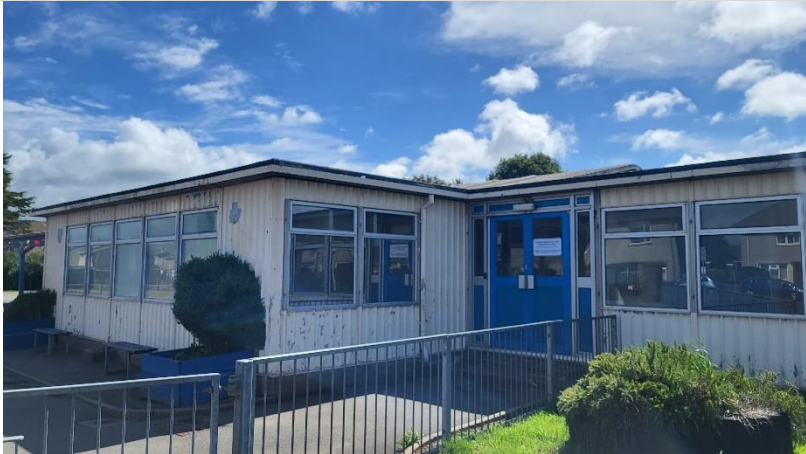
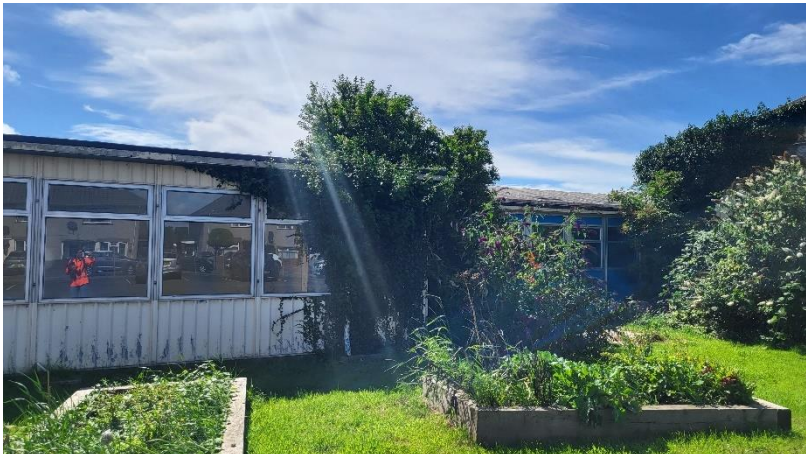
3.2.8 **Section 1(b)** (Images 5 and 6) is of a similar structure to Section 1(a) with corrugated panel walls and both pitched and flat roofs. Small vegetable beds and a selection of shrubs were present on the north side. No obvious potential roost features were noted in this section.

Building	Description	Photographs
B1 (b)	Section B1 (b) – no obvious potential roost features noted.

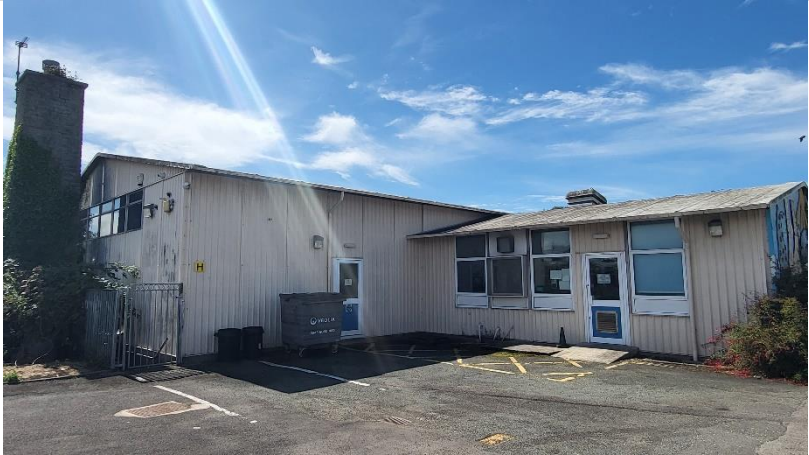
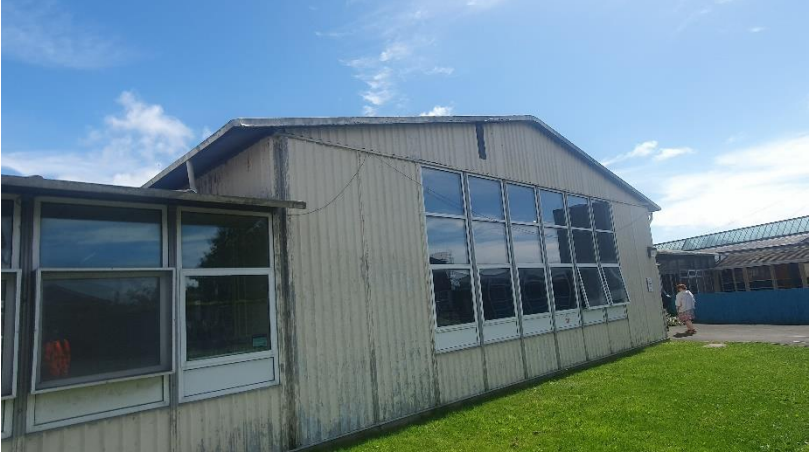
Building	Description	Image
<p>B1 (c)</p>	<p>Three units making up Section (c) with free standing chimney present at NE end.</p>	<div style="text-align: center;">

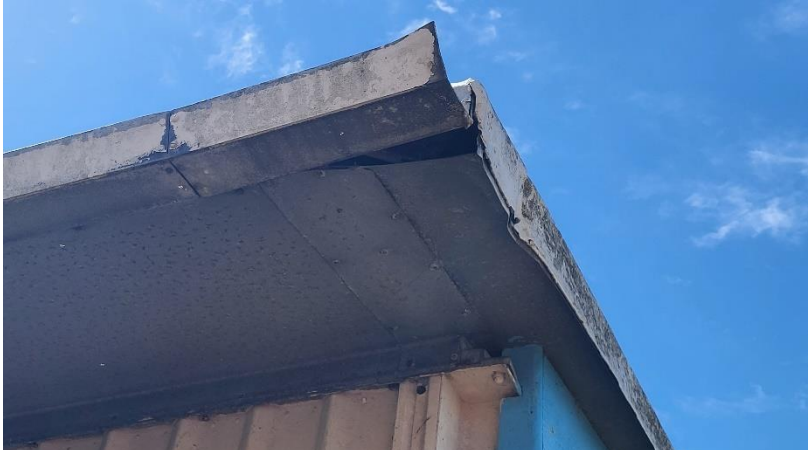
- 3.2.12 A mural covered the north-west facing gable wall and a variety of shrubs were planted along the base in this area with ivy growth partially obscuring the mural (Image 9). The roof edging had been pulled away at the northern corner of this wall creating an obvious access point under the roof overhang (Image 10).

Building	Description	Image
<p>B1 (c)</p>	<p>North-west gable with gap at roof corner.</p>	  <p style="text-align: center;">Image 9</p>

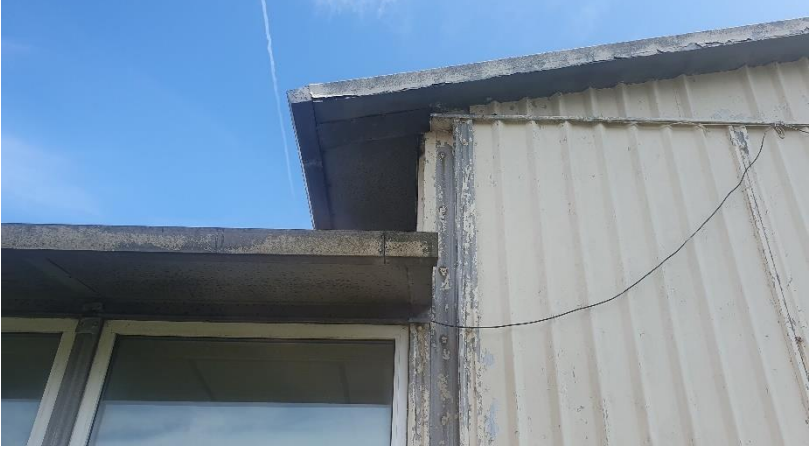
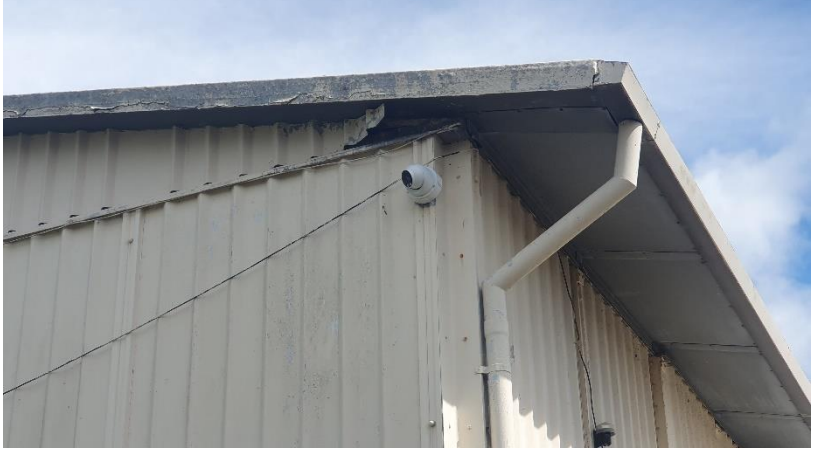
<p style="text-align: center;">Image 11</p>

- 3.2.13 Material along the roof edge/fascia of the south-western gable was noted to be peeling (Images 11 and 12). This offered minor gaps behind, although roosting potential is considered low.
- 3.2.14 The cellar/boiler room had open vents in the doors and a hole in the wall allowing access into the interior (Images 13 and 14). Access could allow for roosting to occur within the boiler room although cobwebs and detritus in this area indicated a lack of recent movement. Hibernation is unlikely if the boiler room is in active use as temperatures won't be at the low, constant levels required for torpor.
- 3.2.15 The chimney stack (Images 15-17) was of stone/brick construction with concrete edging. Some partial ivy covering was present on the northern side and gaps in the brickwork were noted at height on both the northern and southern side, offering minor roost potential.

<p style="text-align: center;">Image 10</p>
<p>B1 (c)</p>	<p>Examples of peeling material at roof edges.</p>

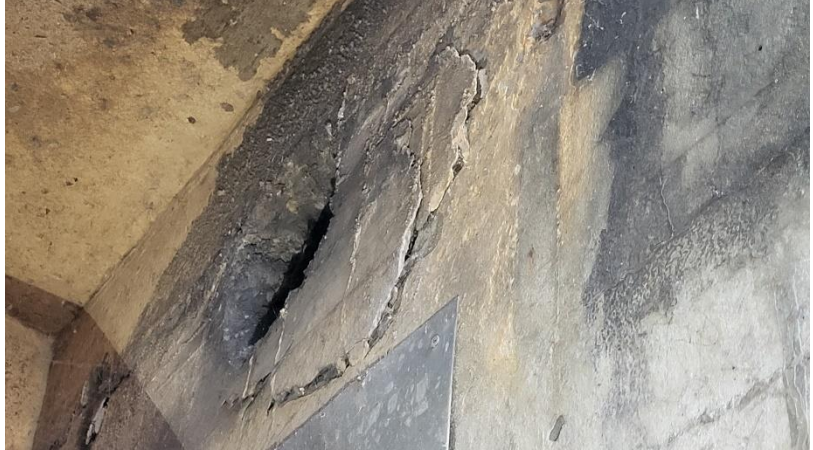
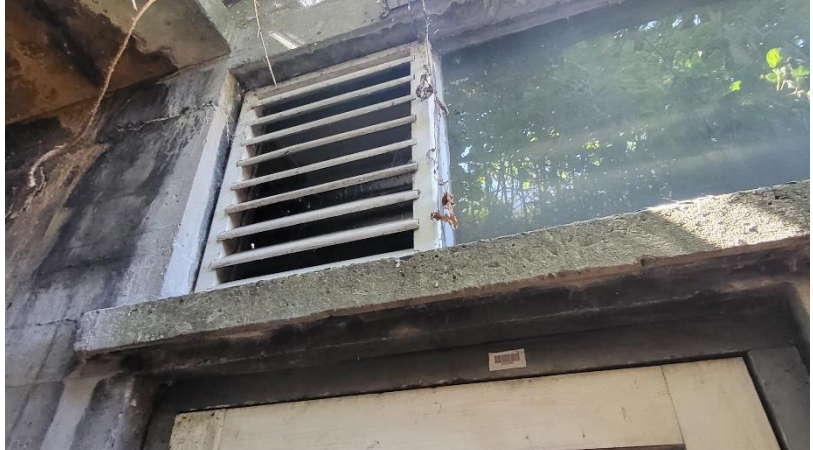
<p data-bbox="1018 1232 1150 1263">Image 13</p>

<p data-bbox="1018 725 1150 757">Image 12</p>
<p data-bbox="102 1263 181 1294">B1 (c)</p>	<p data-bbox="339 1234 647 1328">Potential access points into boiler room (cellar) – hole in wall and vent.</p>

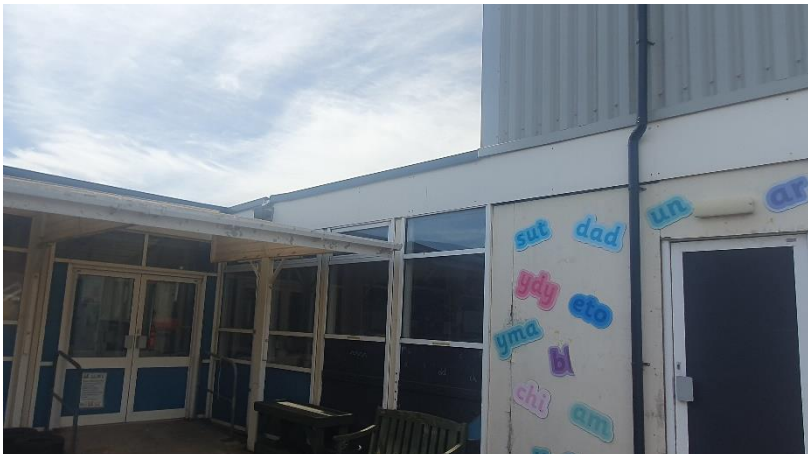
<p style="text-align: center;">Image 19</p>

roof on this side has some gaps at the top due to the shaping of the panels but this was considered to offer negligible likelihood of roosting (Images 19-21).

<p style="text-align: center;">Image 18</p>
B1 (d)	Corrugated metal tower and minor gaps behind plastic panelling along the roof edging offered limited potential for roosting

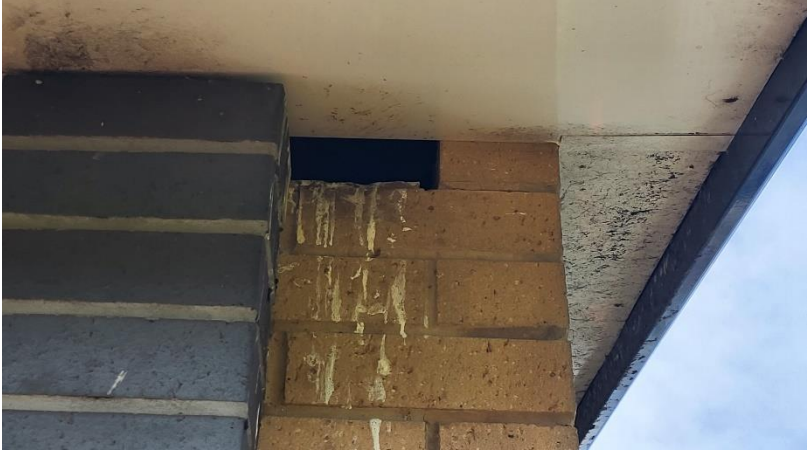
<p data-bbox="1023 1232 1145 1263">Image 31</p>
B2 (d)	Very minor gaps between soffit and wall. Low bat roost potential.

- 3.2.23 **Section B2(d)** is a small section at the eastern end of the building (Image 30). Double doors were present in the south-facing wall and a single door present in the eastern gable. A brick was noted to be missing under the roof edge in the south-east corner and staining by bird droppings underneath indicated nesting had likely been occurring (Image 31). It is considered to have moderate bat roost potential in the absence of habitat considerations, dependent on the extent of bird use. A narrow gap was also present between the soffit and wall across the eastern gable end (low roost potential) and a further small hole was present due to a broken brick in the north wall underneath the soffit (Images 32-33).

<p data-bbox="1023 725 1145 757">Image 30</p>
B2 (d)	Missing brick at top of wall under soffit with evidence of bird use.

- 4.2.2 **Building B2** had a number of potential roost features, the majority of which likely offer only occasional roosting opportunities and thus have low roost potential. Conversely, the missing brick with evidence of bird presence likely allows access into the soffit and/or wall and may offer greater opportunities depending on the extent of bird use. However, when considering the immediate habitat available for foraging and commuting, the lack of connectivity across the site and the likely impacts of lighting across the adjacent residential streets beyond the school site, the suitability of that specific gap can be considered to be low.

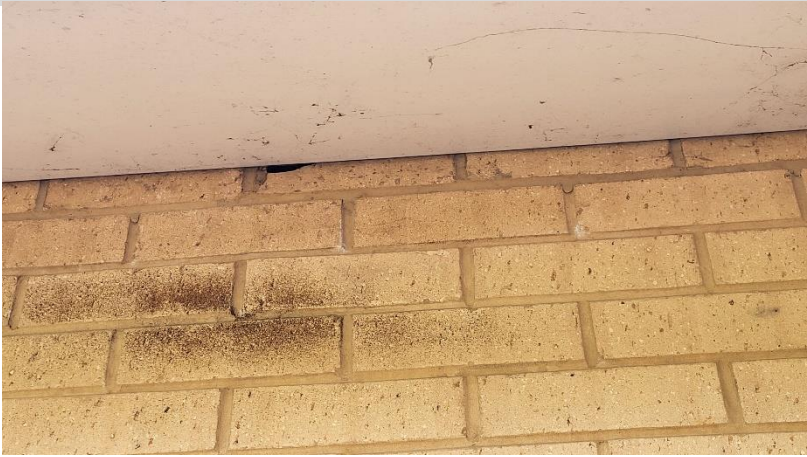
<p data-bbox="1023 725 1145 757">Image 33</p>

Building	Description	Image
B2 (d)	Small gap under soffit on N wall due to broken brick. Low roost potential.

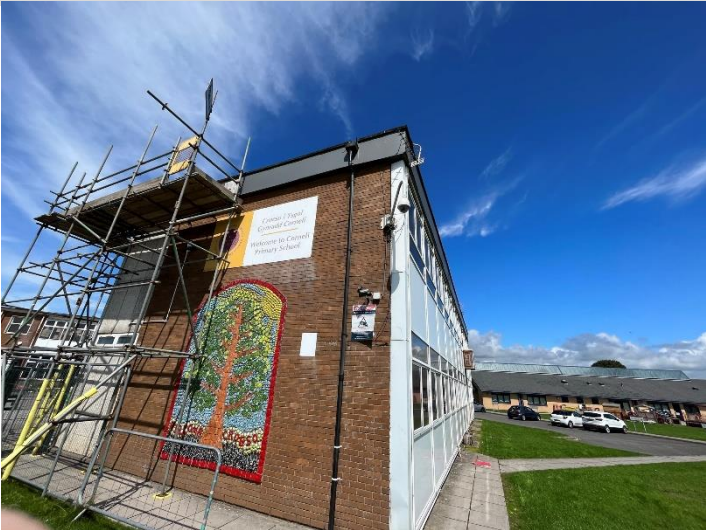
<p>Image 36</p>

Building Section	Description	Image
<p>B3 (a)</p>	<p>Southern aspect with hole behind drainpipe</p>

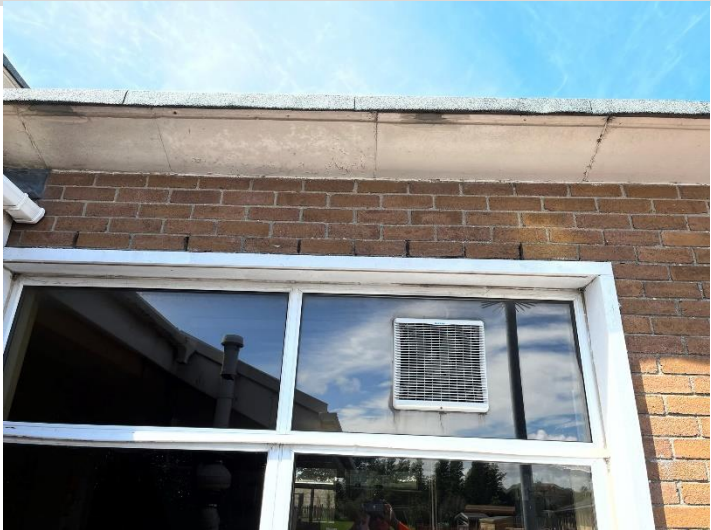
<p>Image 39</p>
<p>B3 (b)</p>	<p>Gap above window</p>

- 3.2.26 **Section B3(b)** is a brick-built section at the north-east corner with multiple levels and flat roofs (Images 38-42). It was noted that the roof material was peeling in the south-western corner and a gap was present above the windows on the south eastern aspect. A broken section plastic soffit above a drainpipe on was also present on the south aspect, and the gap appeared to go into a void. Roof lining/felt was visible and its appearance suggested it may have been eaten/chewed (e.g. by rodents)

Building Section	Description	Image
<p>B3 (b)</p>	<p>Example of peeling roof material in corner</p>

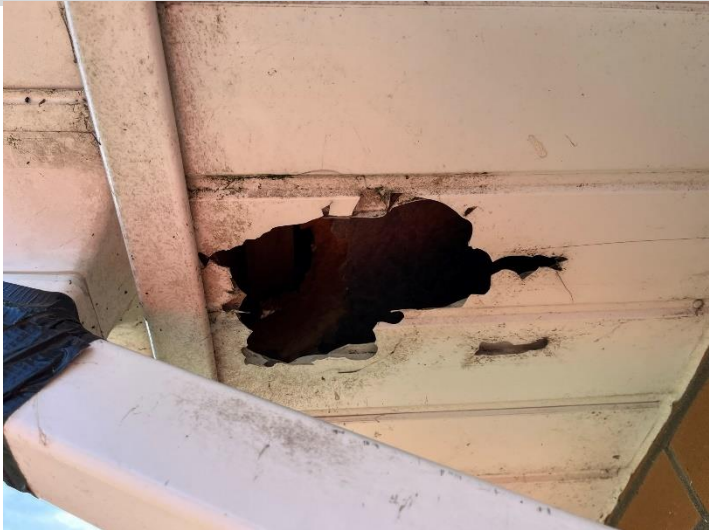
<p style="text-align: center;">Image 41</p>

Building Section	Description	Image
<p>B3 (b)</p>	<p>Broken section of plastic soffit above drainpipe on southern aspect with lining visible, having a chewed appearance.</p>

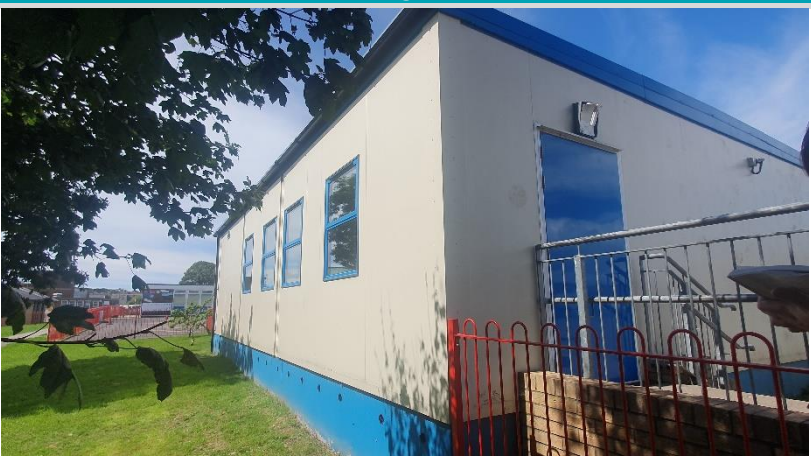
<p data-bbox="1018 1594 1145 1630">Image 45</p>

3.2.28 **Building B4** (Table 10, Images 45-46) was a small pre-fabricated unit with plastic clad windows on the north and south side. Careful assessment noted that it appeared well sealed with no gaps behind the fascia and no obvious features suitable for roosting bats.

Building/Section	Notes	Photographs
B4	Small, pre-fabricated unit, No gaps around windows, behind fascia, or elsewhere, that could provide suitable roosting opportunities for bats.

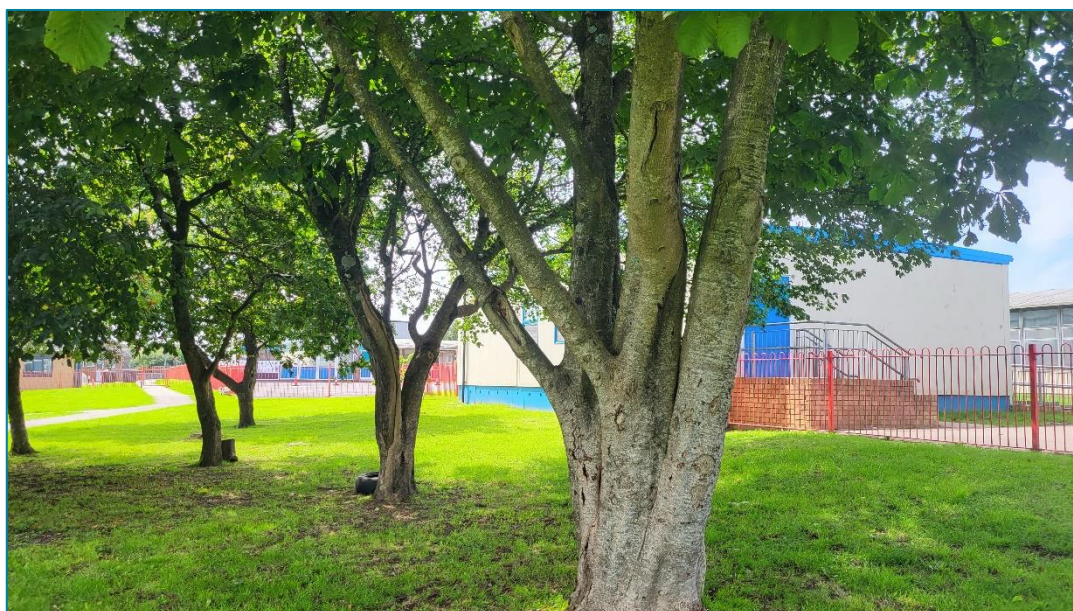
Figure 1: Small cluster of trees present near building B4.

3.2.29 A small cluster of trees were present adjacent to Building 4 (Figure 1, Grid reference: SS 81963 81717). This consisted of one field maple (*Acer campestre*), one horse chestnut (*Aesculus hippocastanum*), one rowan (*Sorbus acuparia*), two small oaks (*Quercus* sp.) and a lime tree (*Tilia* sp.) The horse chestnut was noted to have a small area of split/peeling bark approximately 2m up on one stem which offered negligible bat roost potential. No roost potential roost features were noted in the other trees. .
