Ysgol Gyfun Gymraeg Glantaf-Otter Report

Cardiff Council

Project number: 60687936

October 2022

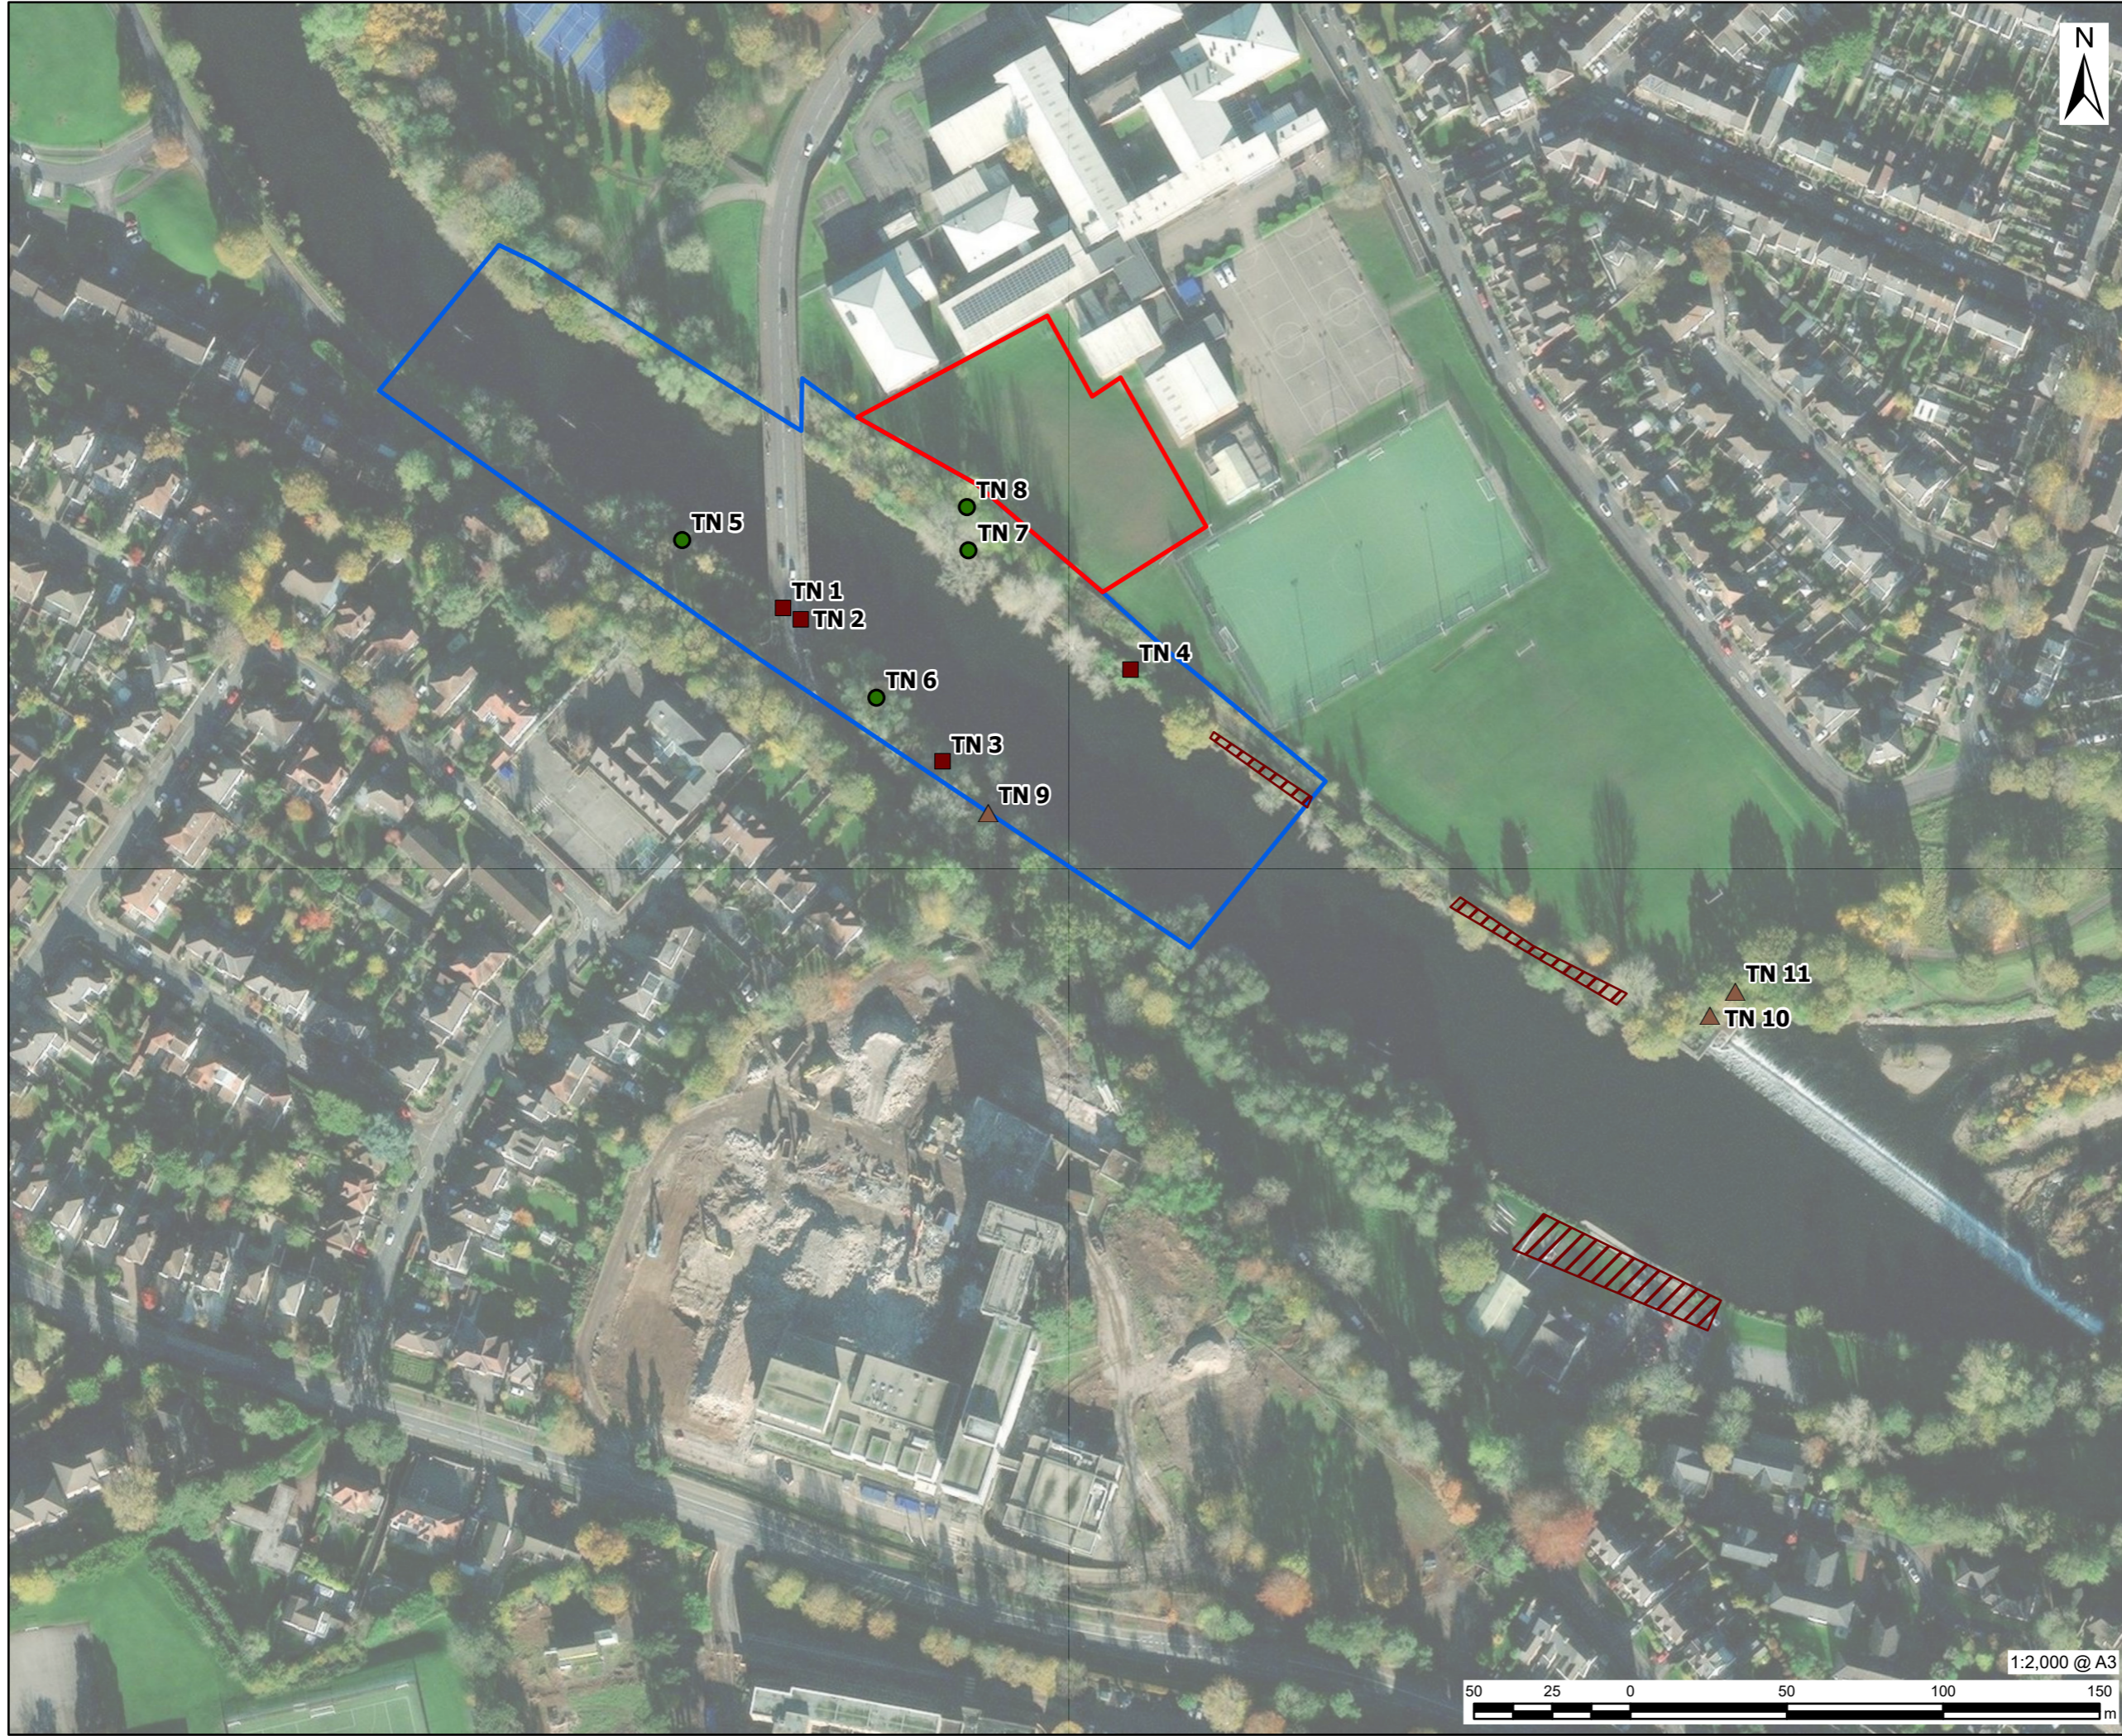
Figure 1 – Survey area and results

- 1.5 The survey recorded evidence of otter on the southwest and northeast banks of the River Taff, confirming its use by otter. The evidence comprised four sightings: two under the southwest abutment of Llandaff bridge (NGRs: ST1487578602; ST1488578597; Figure 1: Target Notes (TN) 1 and 2); one on a rock on the southwest bank (NGR: ST1494278544; Figure 1: TN 3); and one on a log on the northeast bank (NGR: ST1499678573; Figure 1: TN 4).

- 4.1 Evidence of foraging and commuting otter was found during the field survey. The evidence is outlined in Table 1 and shown on Figure 1.

Target Note (Figure 1; Appendix A)	Location (National Grid Reference (NGR))	Description	Photographs (Appendix B)
1	ST1487578602	Otter spraint. Approximately 5 cm by 8 cm. Quite fresh. Found on the west side of the ledge below southwest abutment of Llandaff Bridge.	1
2	ST1488578597	Otter spraint. Approximately 2 cm by 5 cm. Fairly dry, so not recent. Found on the east side of the ledge below southwest abutment of Llandaff Bridge.	2
3	ST1494278544	Otter spraint. Approximately 5 cm by 5 cm. Full of fish scales. Very crumbly. Found on southwest riverbank on a rock. Adjacent to woodland with scrub understorey.	3
4	ST1499678573	Likely an otter spraint. Approximately 7 cm by 6 cm. Very old and discoloured so uncertain of species. Found on northwest riverbank on log partially submerged within the river. Adjacent to scrub.	4

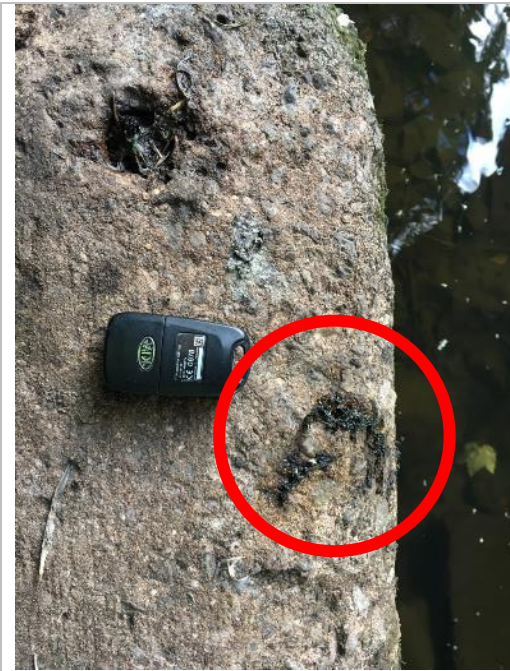
Photograph 1: Otter spraint found on west side of ledge under southwest abutment of Llandaff bridge. (Figure 1 and Appendix A: TN 1).

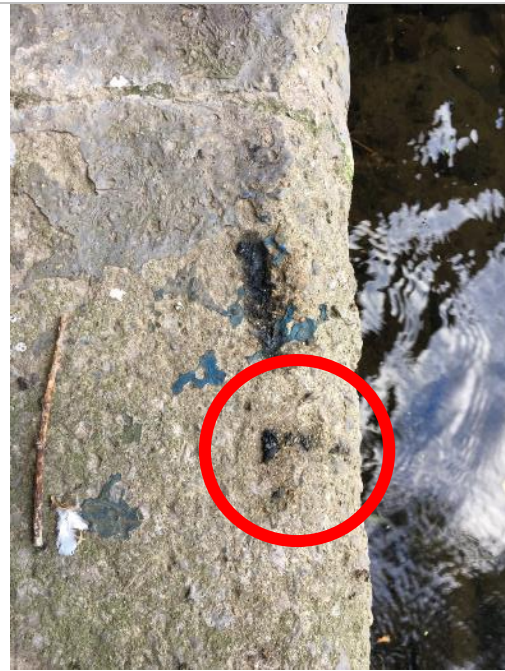
Photograph 2: Otter spraint found on east side of ledge under southwest abutment of Llandaff bridge. (Figure 1 and Appendix A: TN 2).

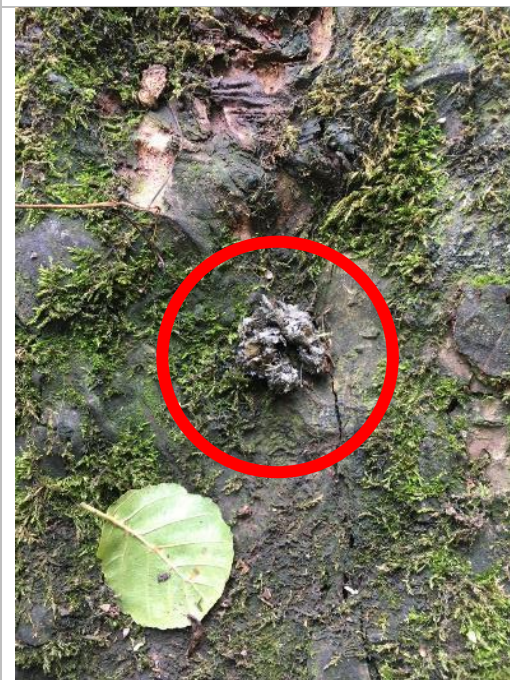
Photograph 3: Otter spraint found on rock on southwest riverbank (Figure 1 and Appendix A: TN 3).

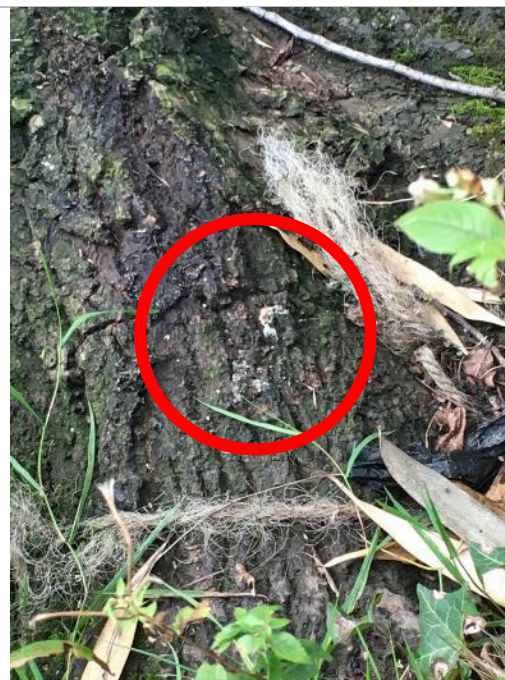
Photograph 4: Otter spraint found on northeast riverbank on partially submerged log (Figure 1 and Appendix A: TN 4).

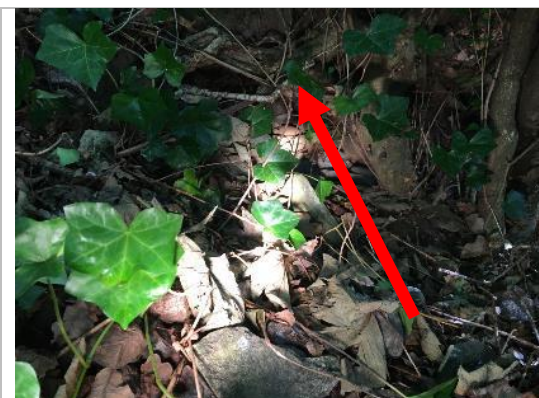
- 4.2 A potential hover (sheltered resting place) was found on the northeast riverbank, approximately 20 m southeast of the Site (Figure 1 and Appendix A: TN 11; Appendix B: photograph 5; NGR: ST1520078482). The resting place was a hollow beneath a tree root, approximately 1 m deep and 50 cm wide (widest point), that was partially walled with stone and compacted soil. It is approximately 10 m from the waterline so is at low risk of flooding. Immature trees and scrub surround the hollow to give it further protection; however, it showed no signs of recent use (for example, fallen leaves undisturbed) and no otter field signs were in proximity to the hollow. A mink spraint was identified within 5 m of the potential hover (see Mink section).

Photograph 5: Resting place for semi-aquatic mammals near northeast riverbank near Llandaff Weir (Figure 1 and Appendix A: TN 11).

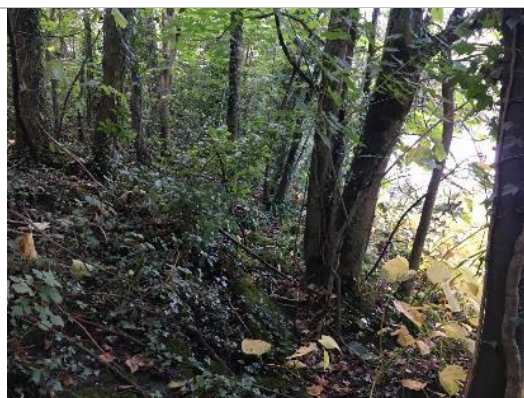
Photograph 6: Southwest riverbank, south of Llandaff Bridge with some habitat suitable for otter holts (Figure 1 and Appendix A: TN 6).

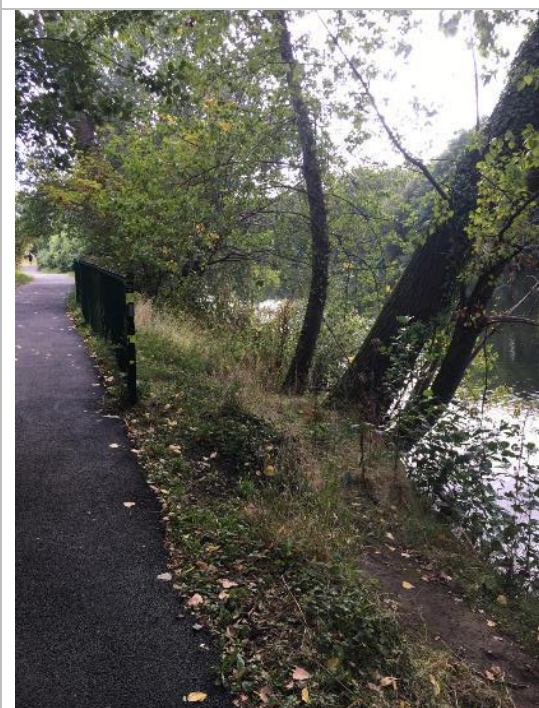
Photograph 7: Northeast riverbank, south of Llandaff Bridge with some habitat suitable for otter holts (Figure 1 and Appendix A: TN 7).

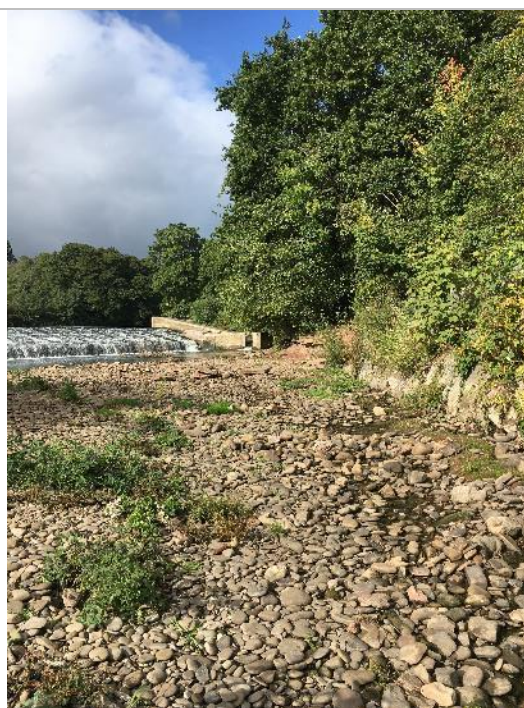
Photograph 8: Southwest riverbank. Downstream section of Survey Area with Llandaff Weir.

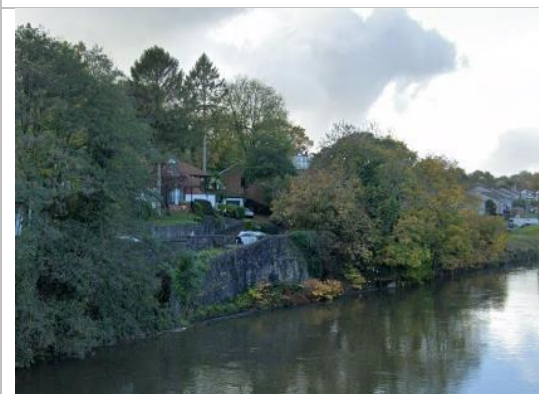
Photograph 9: Southeast bank in upstream section of the Survey Area. Bank is made of concrete and boulders (Figure 1 and Appendix A: TN 5).

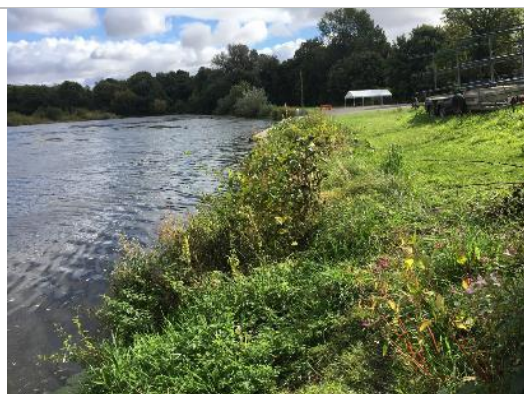
Photograph 10: Llandaff Rowing Club with unsuitable habitat for otter holts.

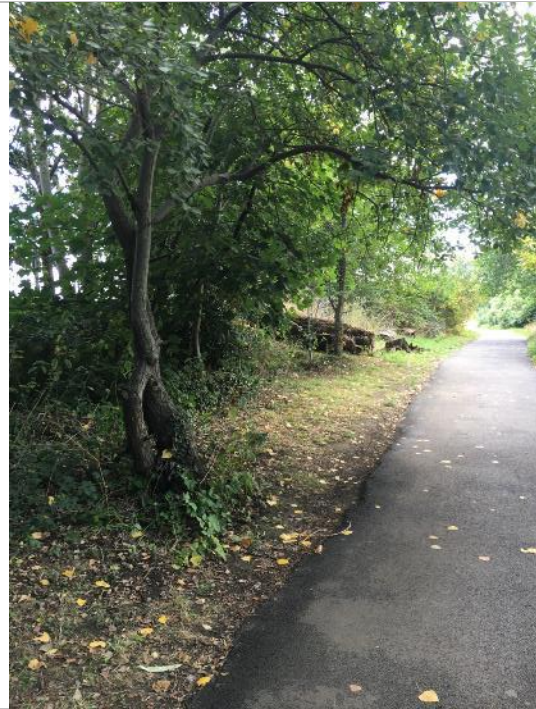
Photograph 11: Vegetation between public footpath and the Site, with habitat unsuitable for otter holts (Figure 1 and Appendix A: TN 8).

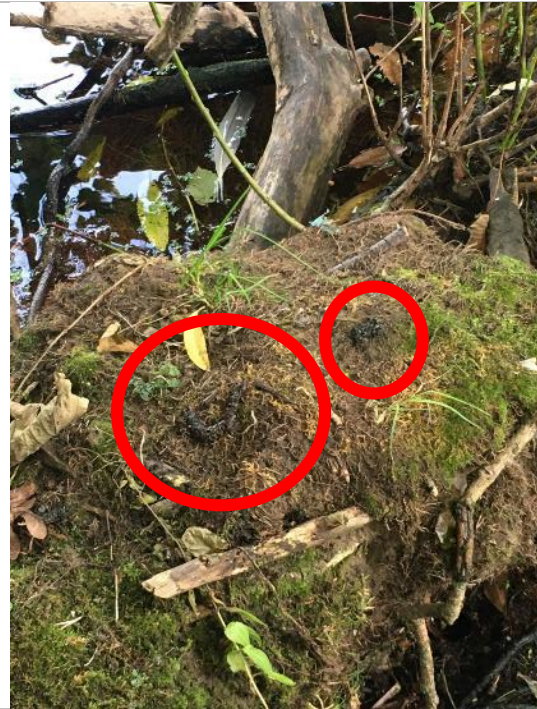
Photograph 12: Mink spraint on log on southwest riverbank (Figure 1 and Appendix A: TN 9).

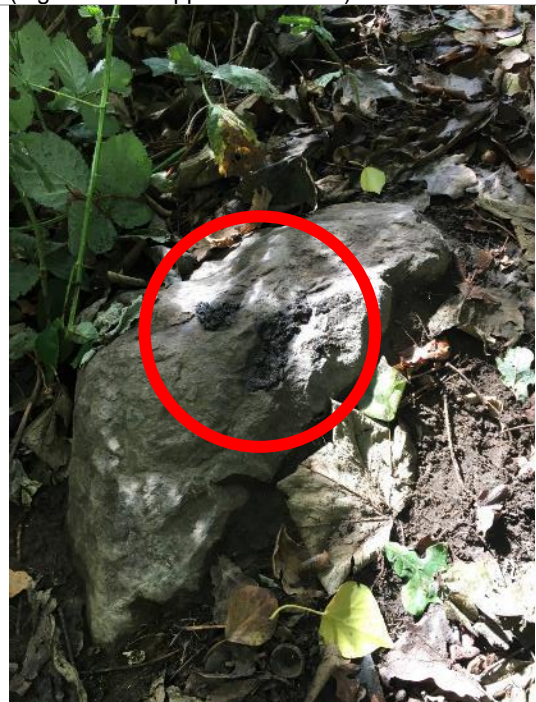
Photograph 13: Mink spraint on log on northeast riverbank near potential resting place (Figure 1 and Appendix A: TN 10).
