# Ysgol Iolo

## Phase 1 Ground Conditions Desk Study

Doc ref: 31793-HYD-XX-XX-RP-GE-1000

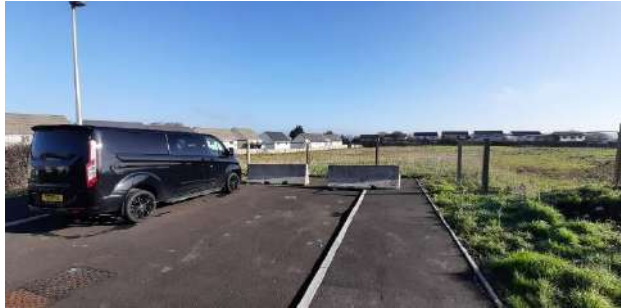
*Figure 2.3: Access to site from Dunraven Close.*

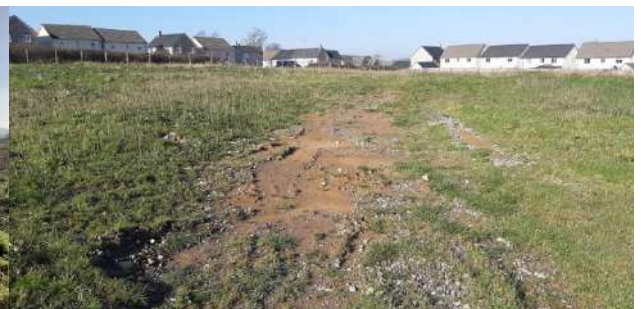
*Figure 2.6: Remains of former track in central site.*

Geotechnology highlight that the south-west of the site has been used for access, parking and storage of materials (bricks etc.) whilst the adjacent housing estate has undergone construction. Through the site was an access road orientated northwest to southeast, which was stripped of topsoil, and replaced with a sub-base of slag aggregate imported from Tarmac and Port Talbot. Geotechnology state that this has largely been removed from site.

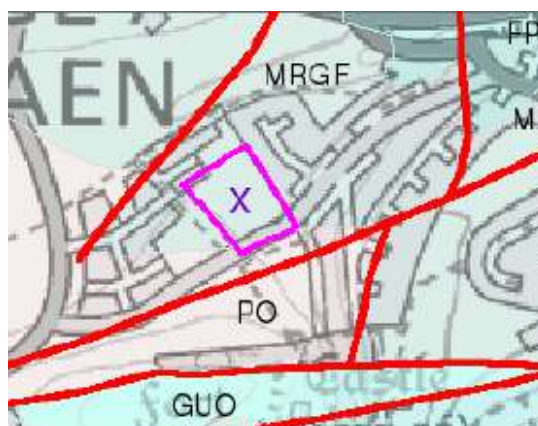
Ref. for Figures	Location	Stratigraphic Name	Description
Superficial Deposits (Figure 2.7)			
Not present at this site.			
Solid Geology ( <b>Error! Reference source not found.</b> )			
MRGF-SHLST	On site.	Blue Lias Formation (Marginal Facies)	Interbedded bioclastic (shelly) limestone, calcareous mudstone and siltstones.
PO-LSMD	On site.	Porthkerry Member	Interbedded mudstone and limestone.

Figure 2.7: Solid geology.

It should be noted that the Blue Lias Formation (Marginal Facies) and the Porthkerry Member were both deposited simultaneously, with the Marginal Facies forming part of the Porthkerry Member. Facies are described due to changes in depositional environment. Therefore, the boundary between the two is likely to be gradual, with the units likely to be difficult to differentiate.

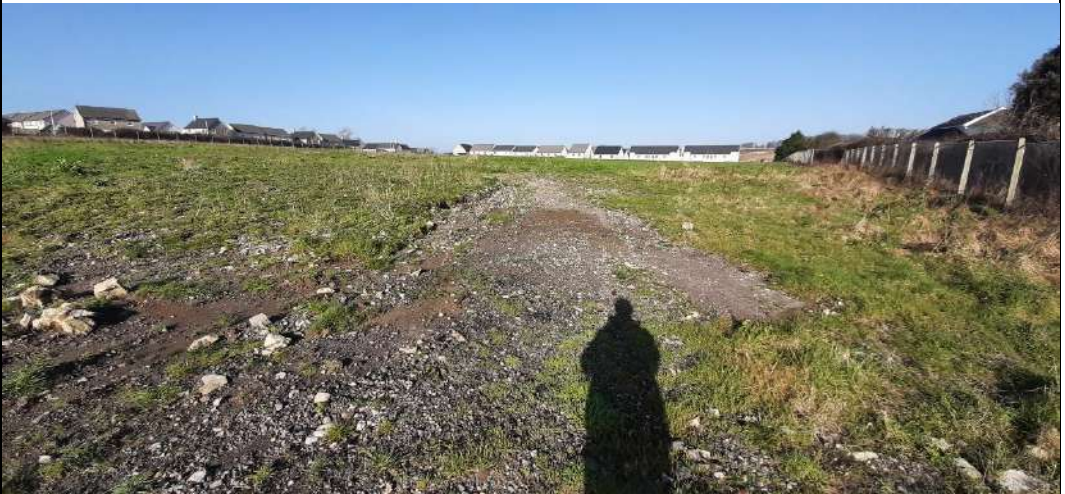
<b>Direction Photograph Taken:</b> North-west.	
<b>Description:</b> Rubble near to the site entrance.

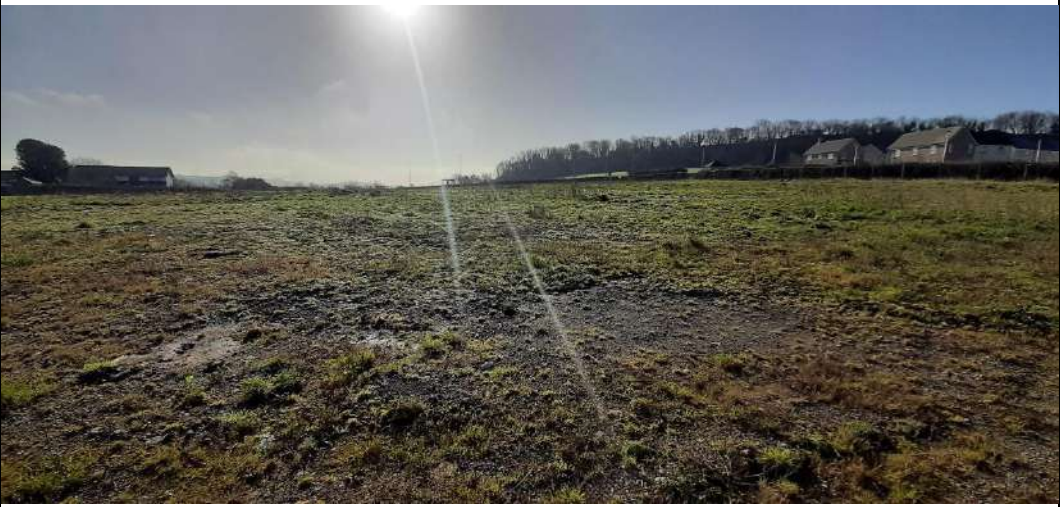
<b>Date:</b> 06/03/24	
<b>Direction Photograph Taken:</b> South.	
<b>Description:</b> Gravel and rubble in the north of the site.

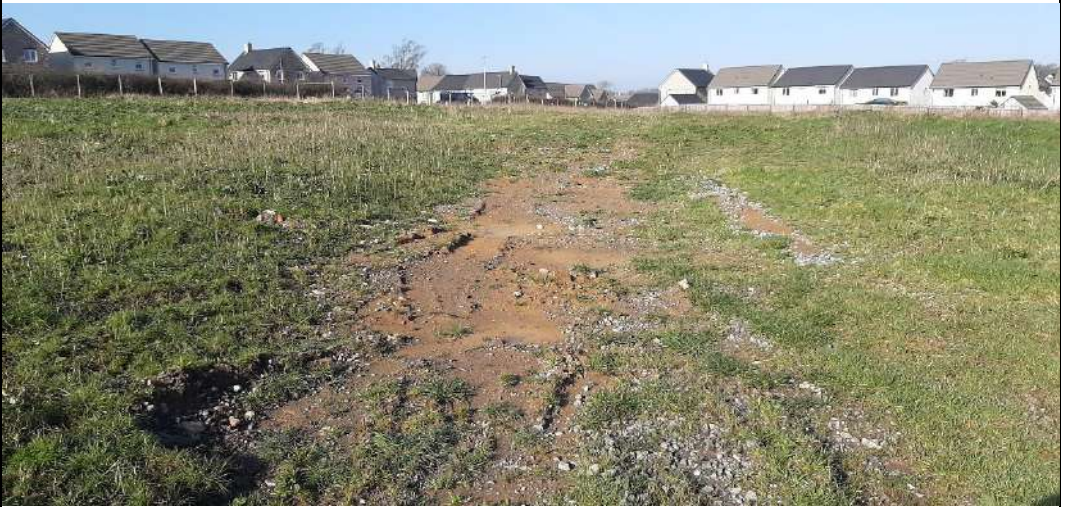
<b>Date:</b> 06/03/24	
<b>Direction Photograph Taken:</b> North-west.	
<b>Description:</b> Former track through the centre of the site assumed to be associated with previous construction activities.

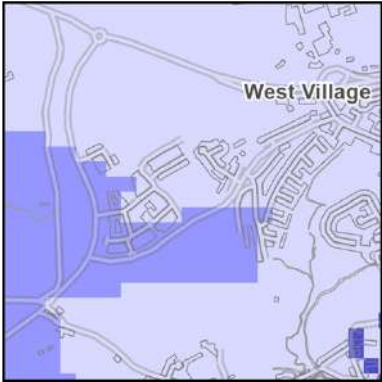
<b>Bedrock permeability</b>

<p>Contains OS data © Crown Copyright and database right 2024</p>	<div><div></div> Bedrock deposits are likely to be <b>free-draining</b>.</div>	
	<div><div></div> The bedrock permeability is <b>spatially variable</b>, but likely to permit moderate infiltration.</div>	
	<div><div></div> Bedrock deposits are likely to be <b>poorly draining</b>.</div>	
<p>These maps show the permeability range that is summarised above.</p> <p><b>Key</b></p> <div><div></div> Very Low</div> <div><div></div> Low</div> <div><div></div> Moderate</div> <div><div></div> High</div> <div><div></div> Very High</div>	<b>Minimum</b>	<b>Maximum</b>

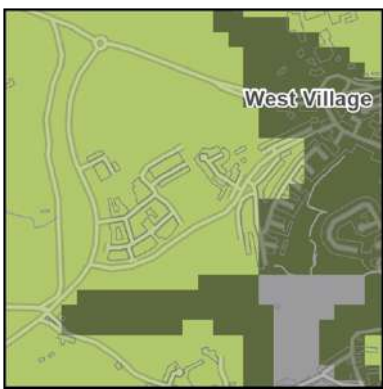
Soluble rocks

<p>Contains OS data © Crown Copyright and database right 2024</p>	<div><div></div> Increased infiltration is unlikely to result in subsidence.</div>
	<div><div></div> Increased infiltration is unlikely to cause localised subsidence, but potential impacts should be considered.</div>
	<div><div></div> Increased infiltration may result in localised subsidence. The potential for or the consequences of subsidence associated with soluble rocks should be considered.</div>
	<div><div></div> Very significant possibility of localised subsidence that could be initiated or made worse by infiltration.</div>
