## GF05 Brookland Road Council Services Site

### *DRAINAGE STRATEGY REPORT*

Document ref no. 21575-R-601-DRAINAGE STRATEGY-B

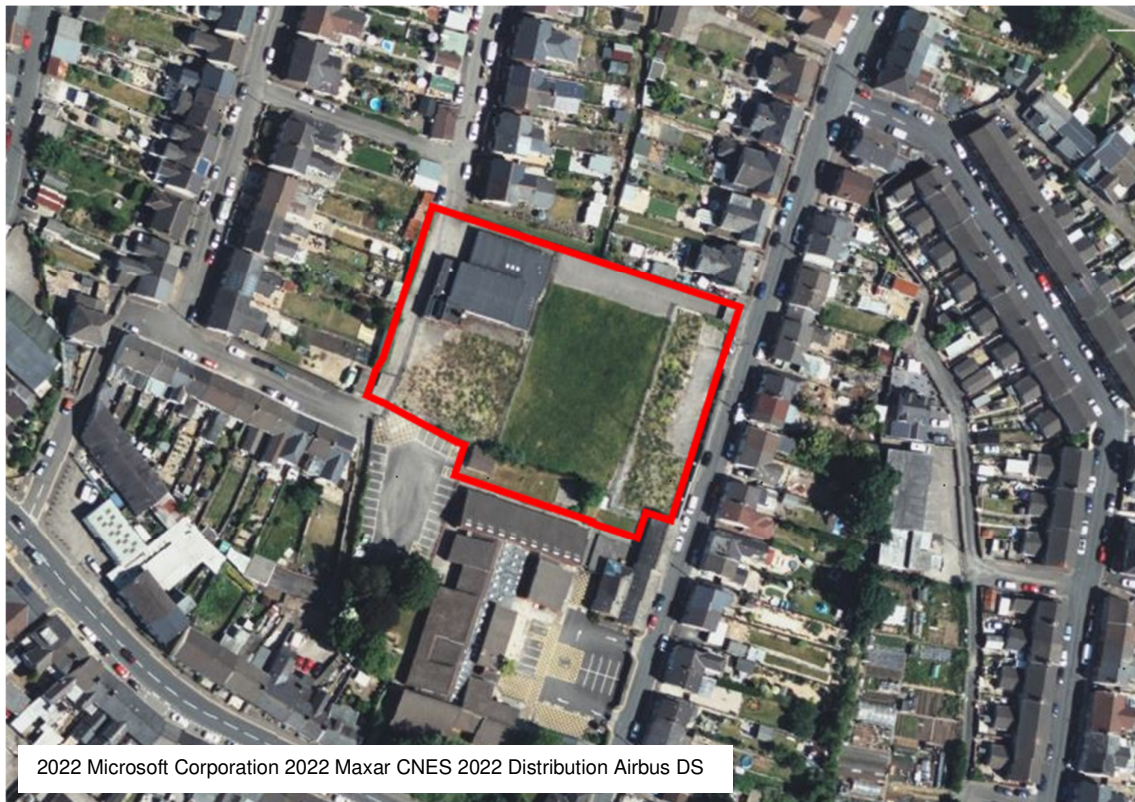
*Figure 1 - Site location*

- 2.1 The site is located off Brookland Road in Risca. The nearest post code is NP11 6BH, site coordinates 324188,190191.
- 2.2 The existing site topography (Appendix 1) is very flat with a minor fall in a southeastern direction. Levels range from 46.00m to 45.25m AOD which has been confirmed by means of a topographical survey undertaken by Corner Point Surveys.
- 2.3 The site is located within an urban area. Approximately one-third of the site is open space playing fields with another third of the site covered in asphalt. The remaining third is occupied by the former youth and community centre. The site is bounded by residential properties to the north, Brookland road to the east, Caerphilly CBC buildings to the south and the rear gardens of residential properties to the west.
- 2.4 The wider site boundary is 0.52ha with the development boundary being 0.52ha also.

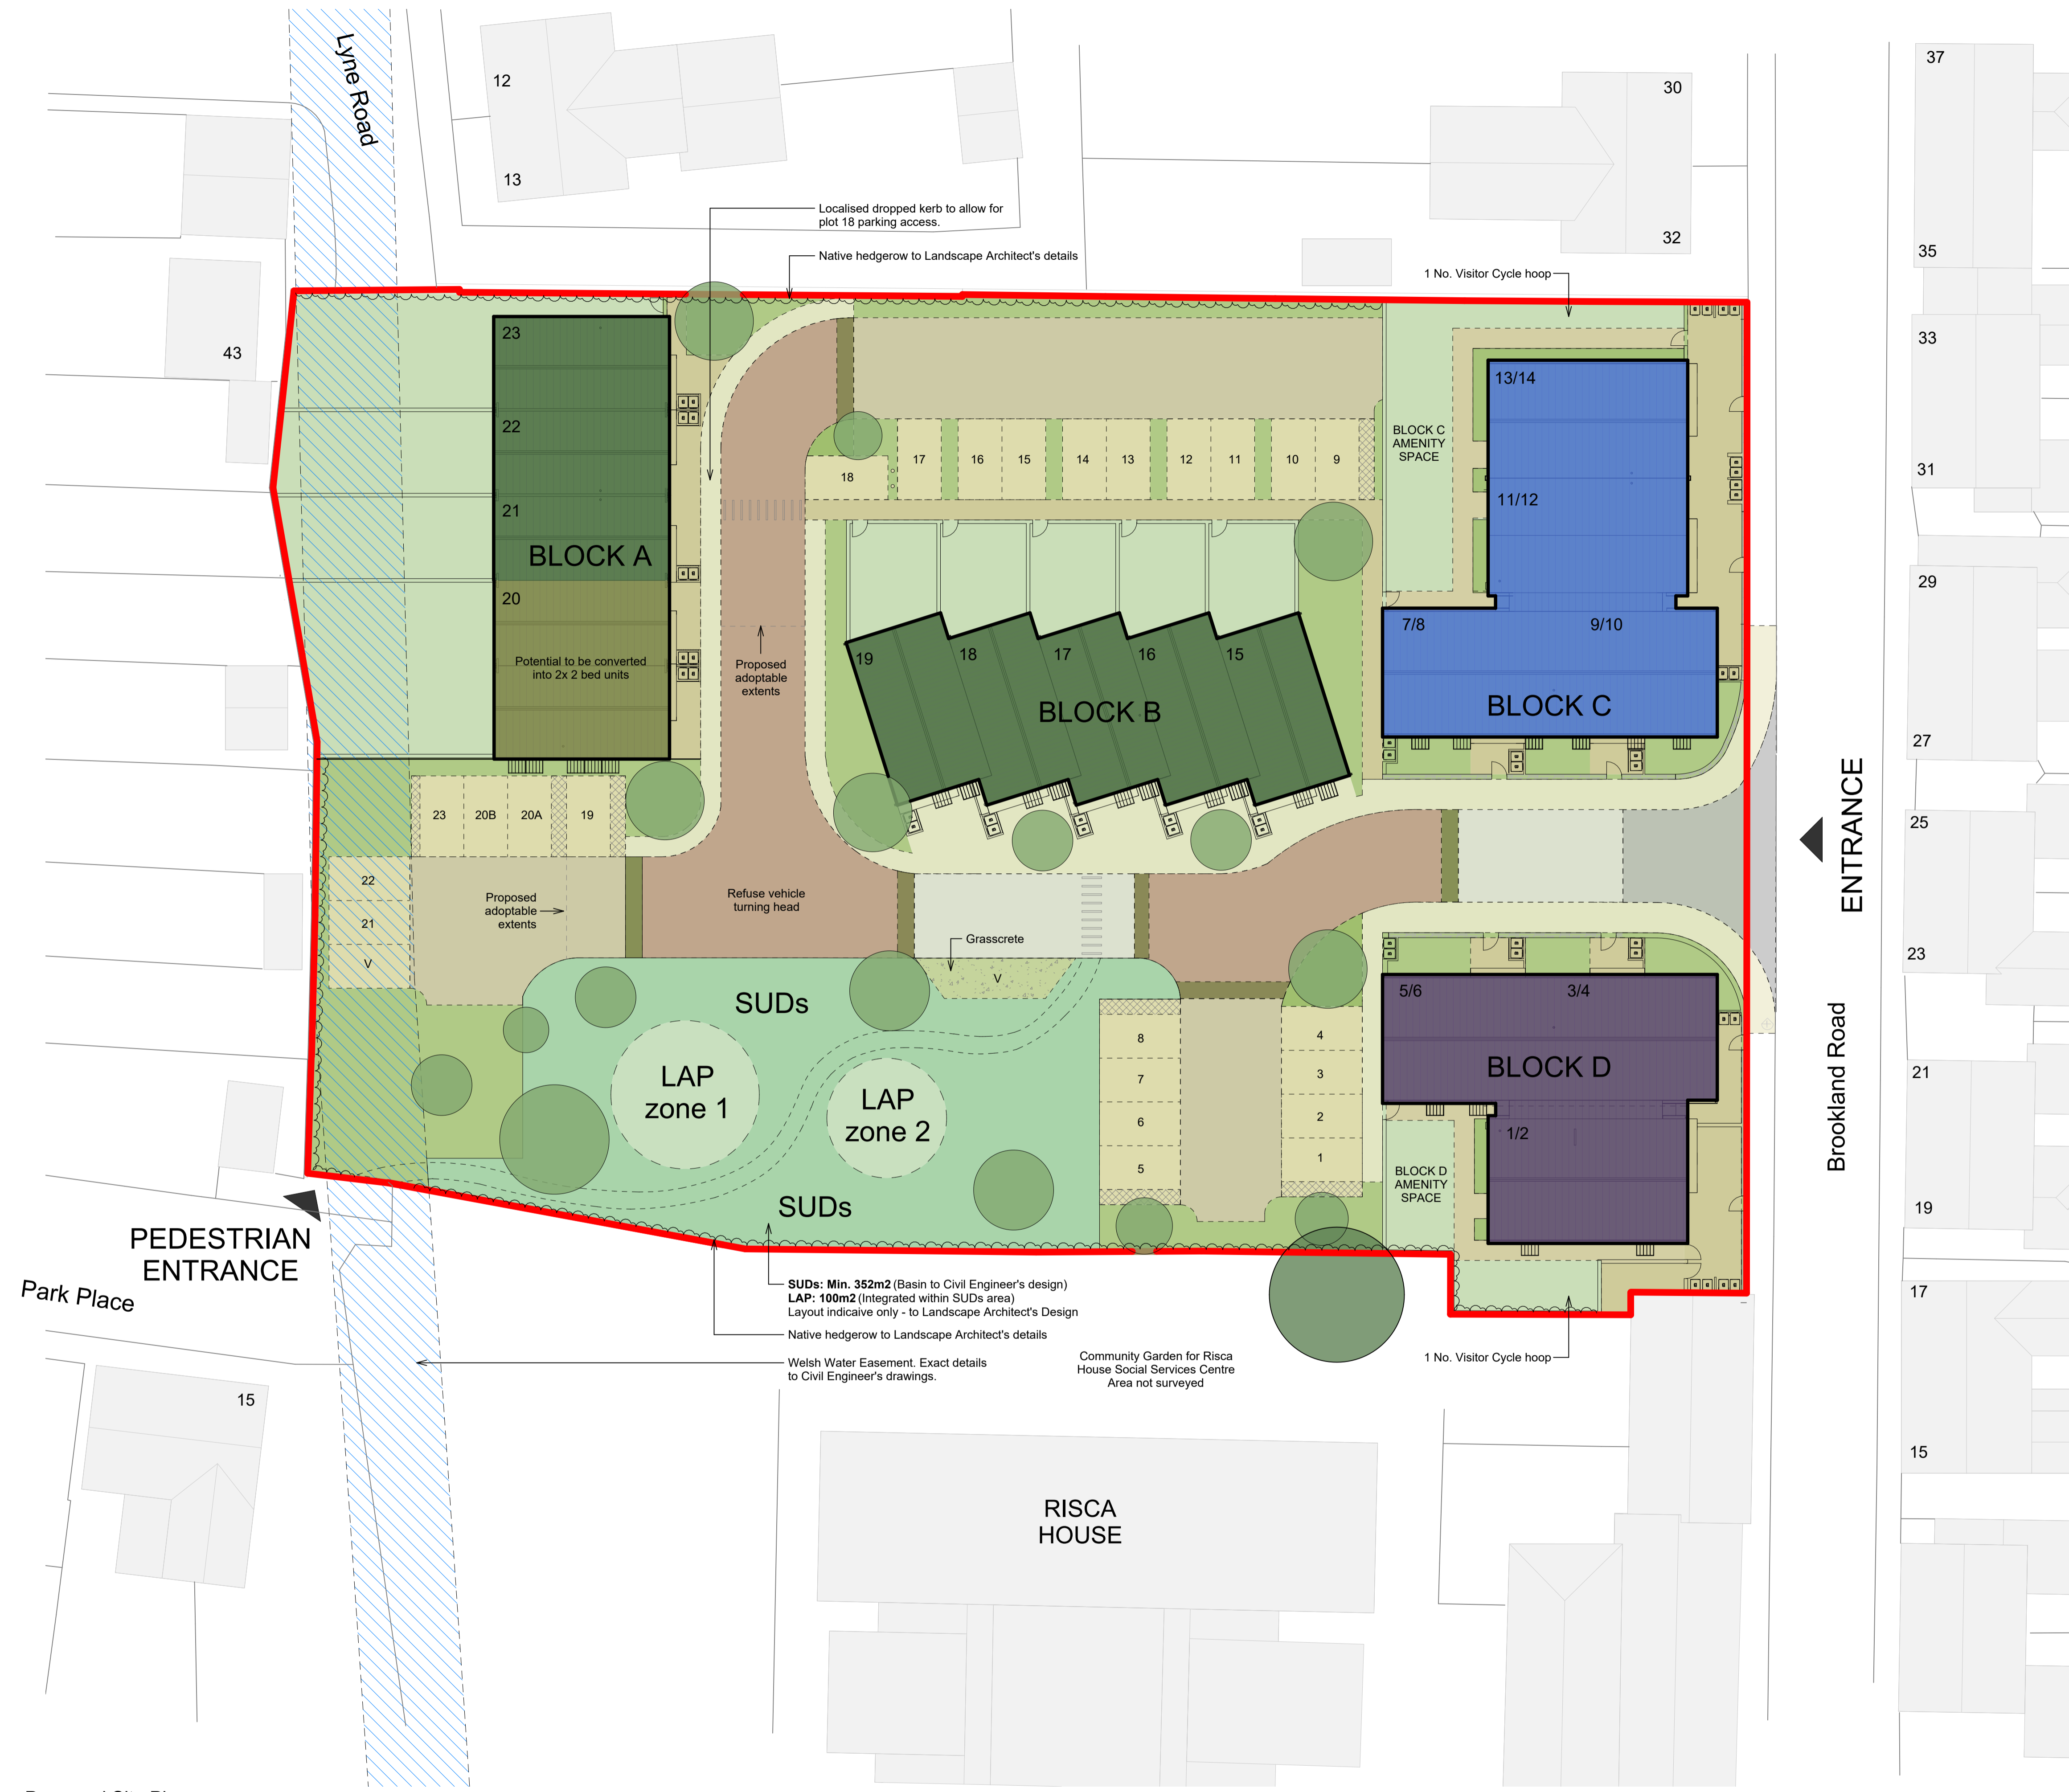
**APPENDIX 4 – PROPOSED SITE LAYOUT**

SW Connection to be provided into existing infrastructure to facilitate emergency overflow from Cellular Infiltration Structure - Limiting discharge to agreed rate of 9.66l/s

It is proposed that the surface water generated by the development shall be treated and conveyed through a series of suds systems and discharged via infiltration within a cellular storage structure located under the POS area to the south of the development. There are areas of permeable pavements within driveways and shared surfaces which shall benefit from infiltration, with high level overflows. With infiltration testing confirming the ground is adequate to support a strategic infiltration strategy.

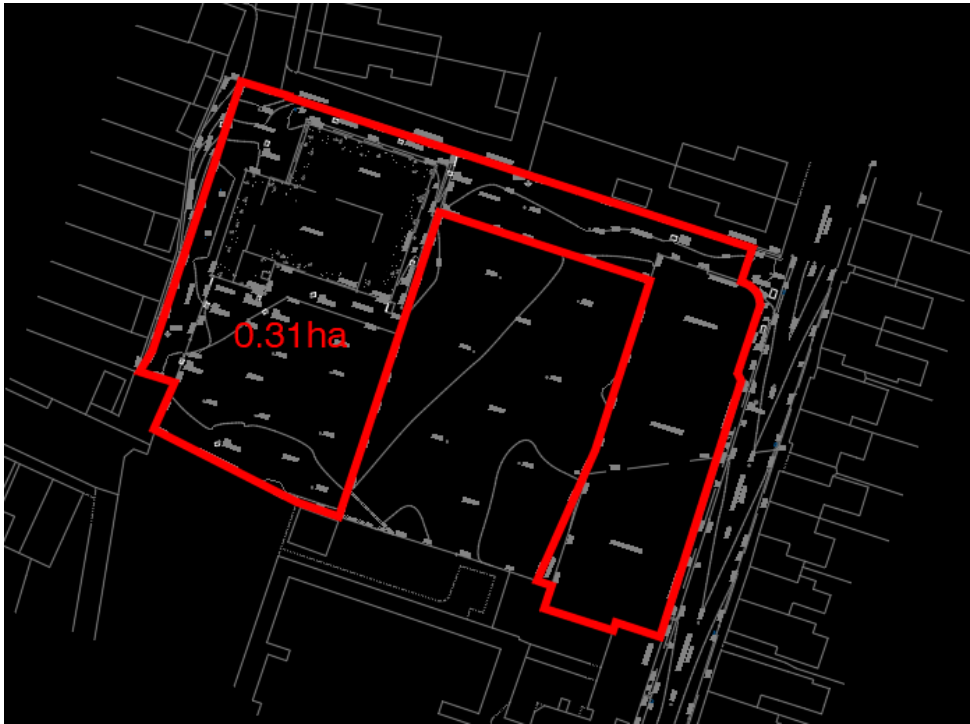
Previous Site Impermeable Area

$$Q = 2.78 \times 1.0 \times 35 \times 0.331 = \mathbf{32.20 \text{ l/s}}$$

Using guidance as set out in the “Recommended non-statutory standards for sustainable drainage (SuDS) in Wales” a 30% betterment has been added to the existing runoff rate, we therefore propose to discharge the development at **22.54 l/s**

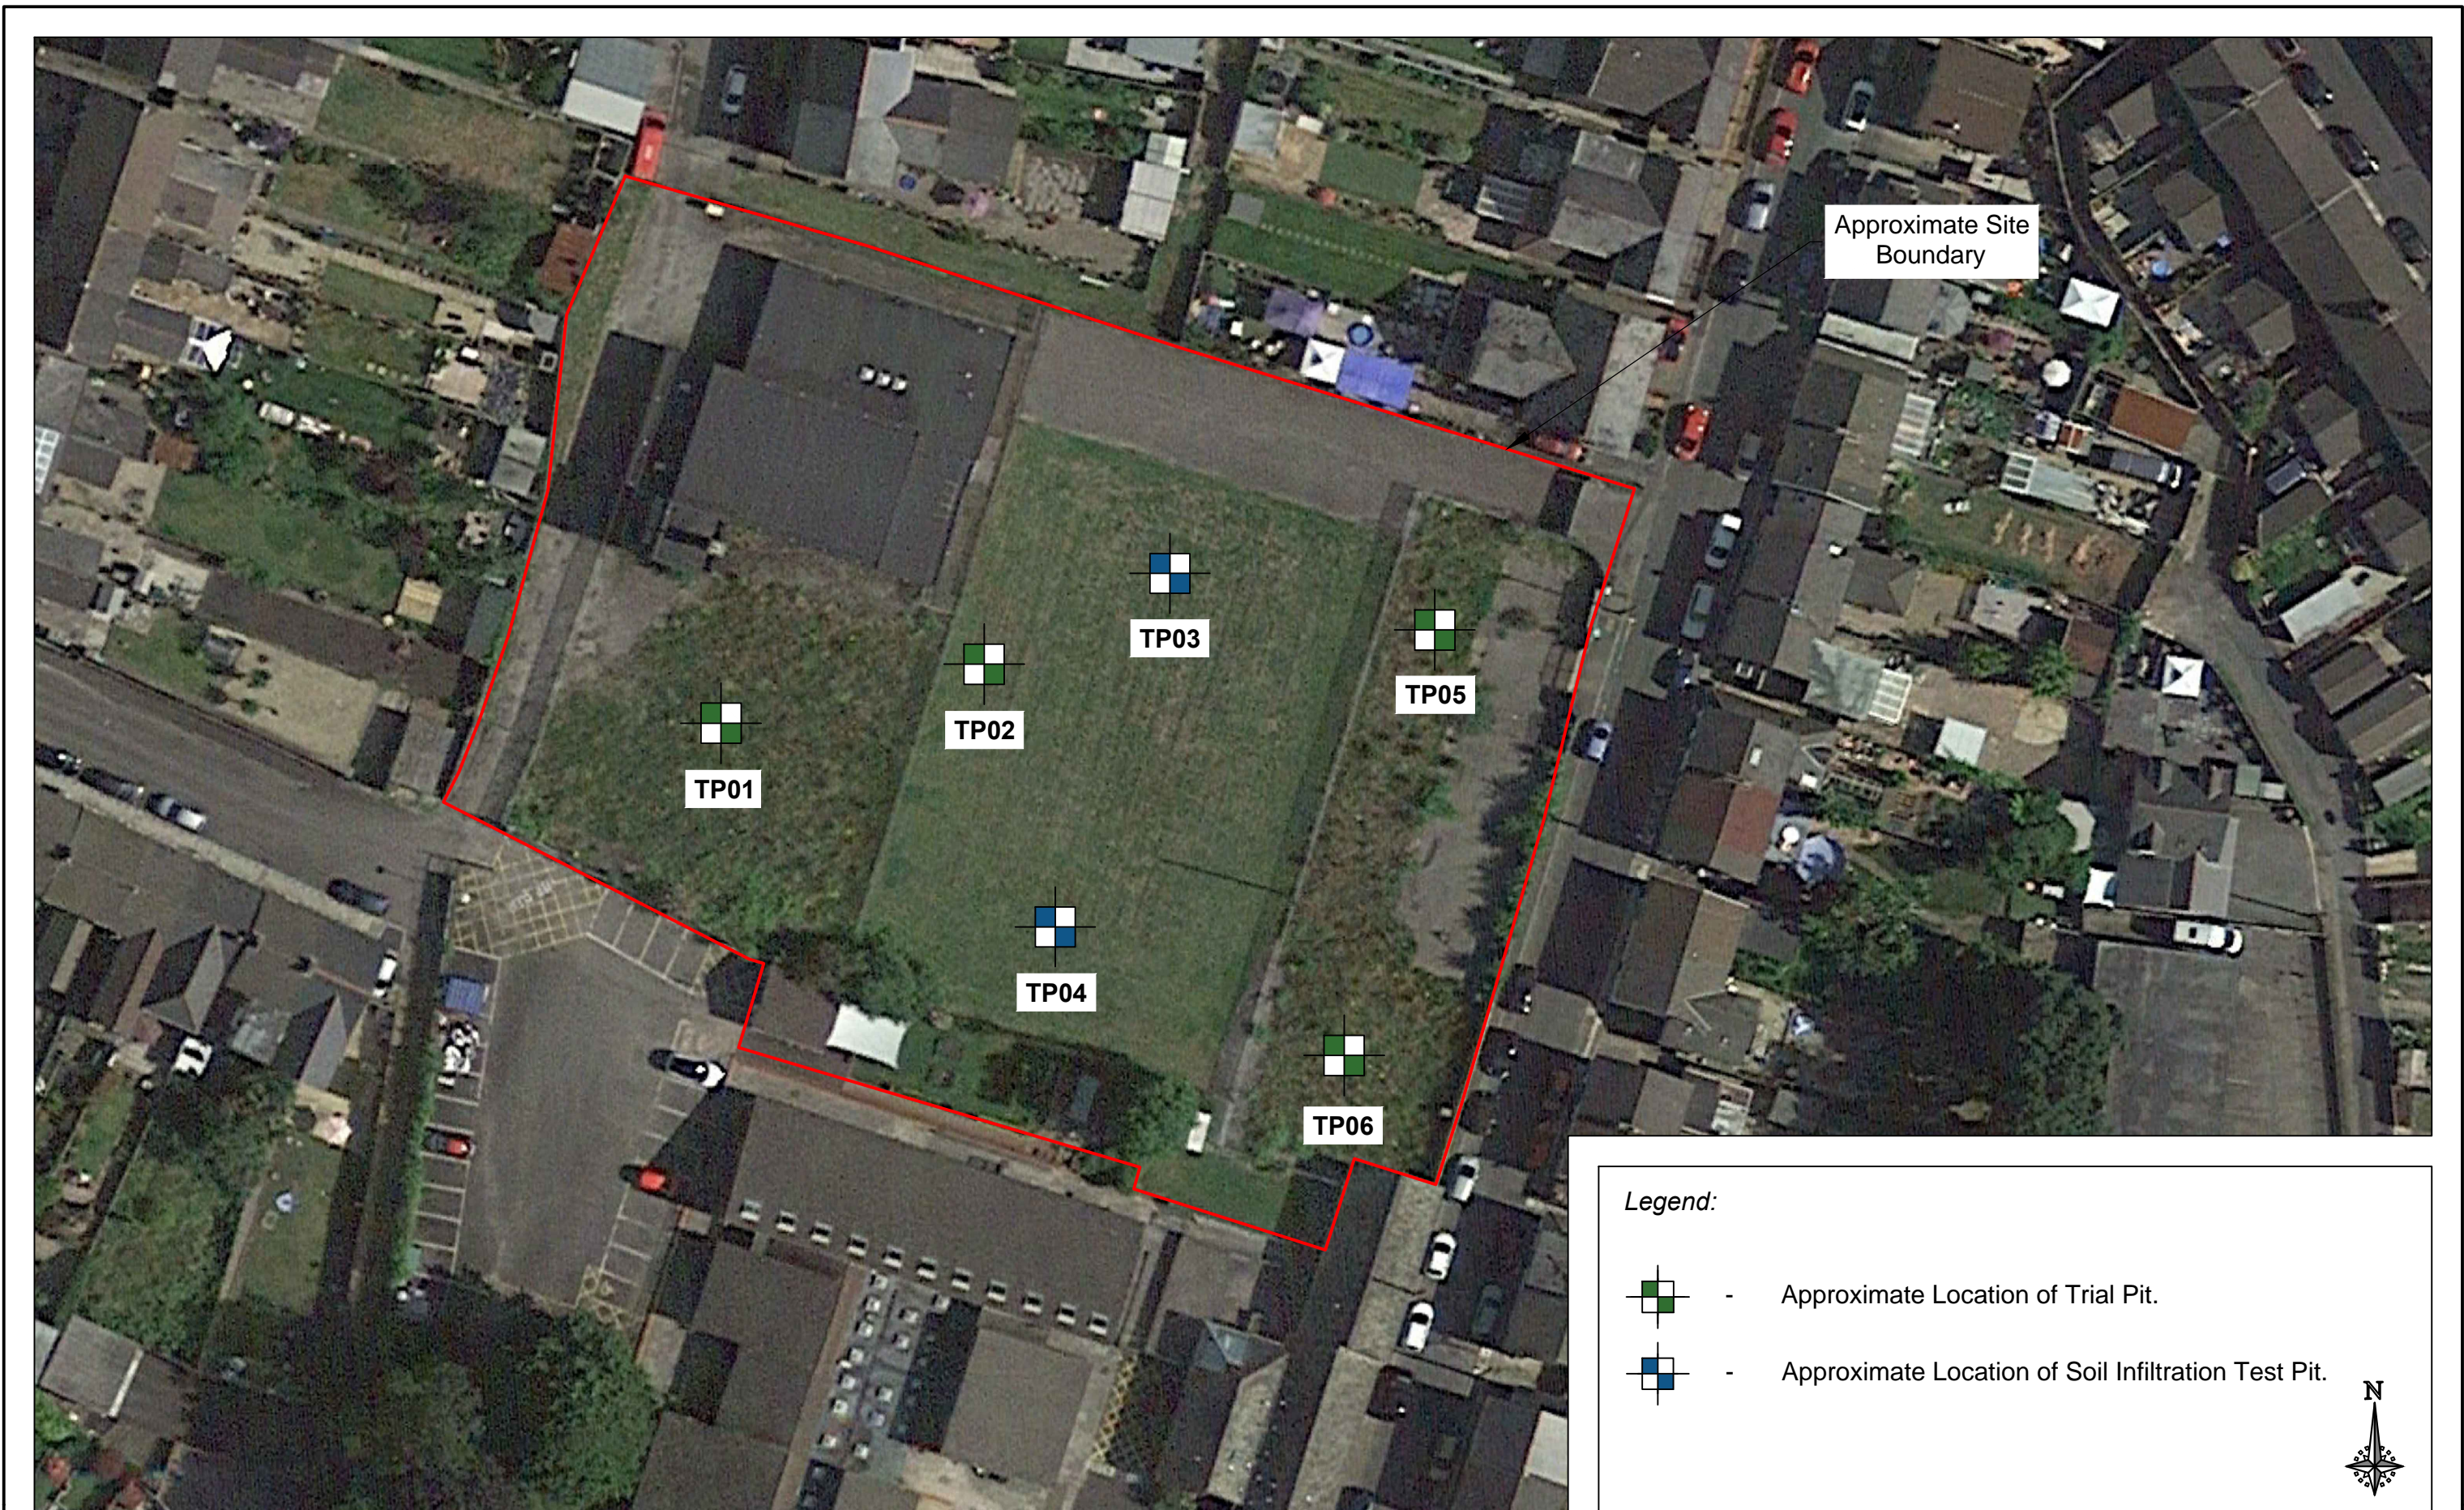
Figure 2: Site Plan

The approximate locations of the trial pits and soil infiltration test pits are shown on Figure 2, while their associated logs are presented in Appendix A.

The trial pits (referenced TP01 to TP06) were positioned across the site following the findings of the Desk Study Report and in areas where access for the excavator was readily available to obtain representative information. The trial pits were excavated to a maximum depth of 3.10m below existing ground level (bgl). The purpose of the trial pits was to prove the shallow ground conditions and allow an assessment of the most appropriate foundation type for the proposed development. Soil infiltration testing was undertaken at 2 No. trial pit localities (TP03 and TP04) to assess/monitor the likely permeability of the natural ground.

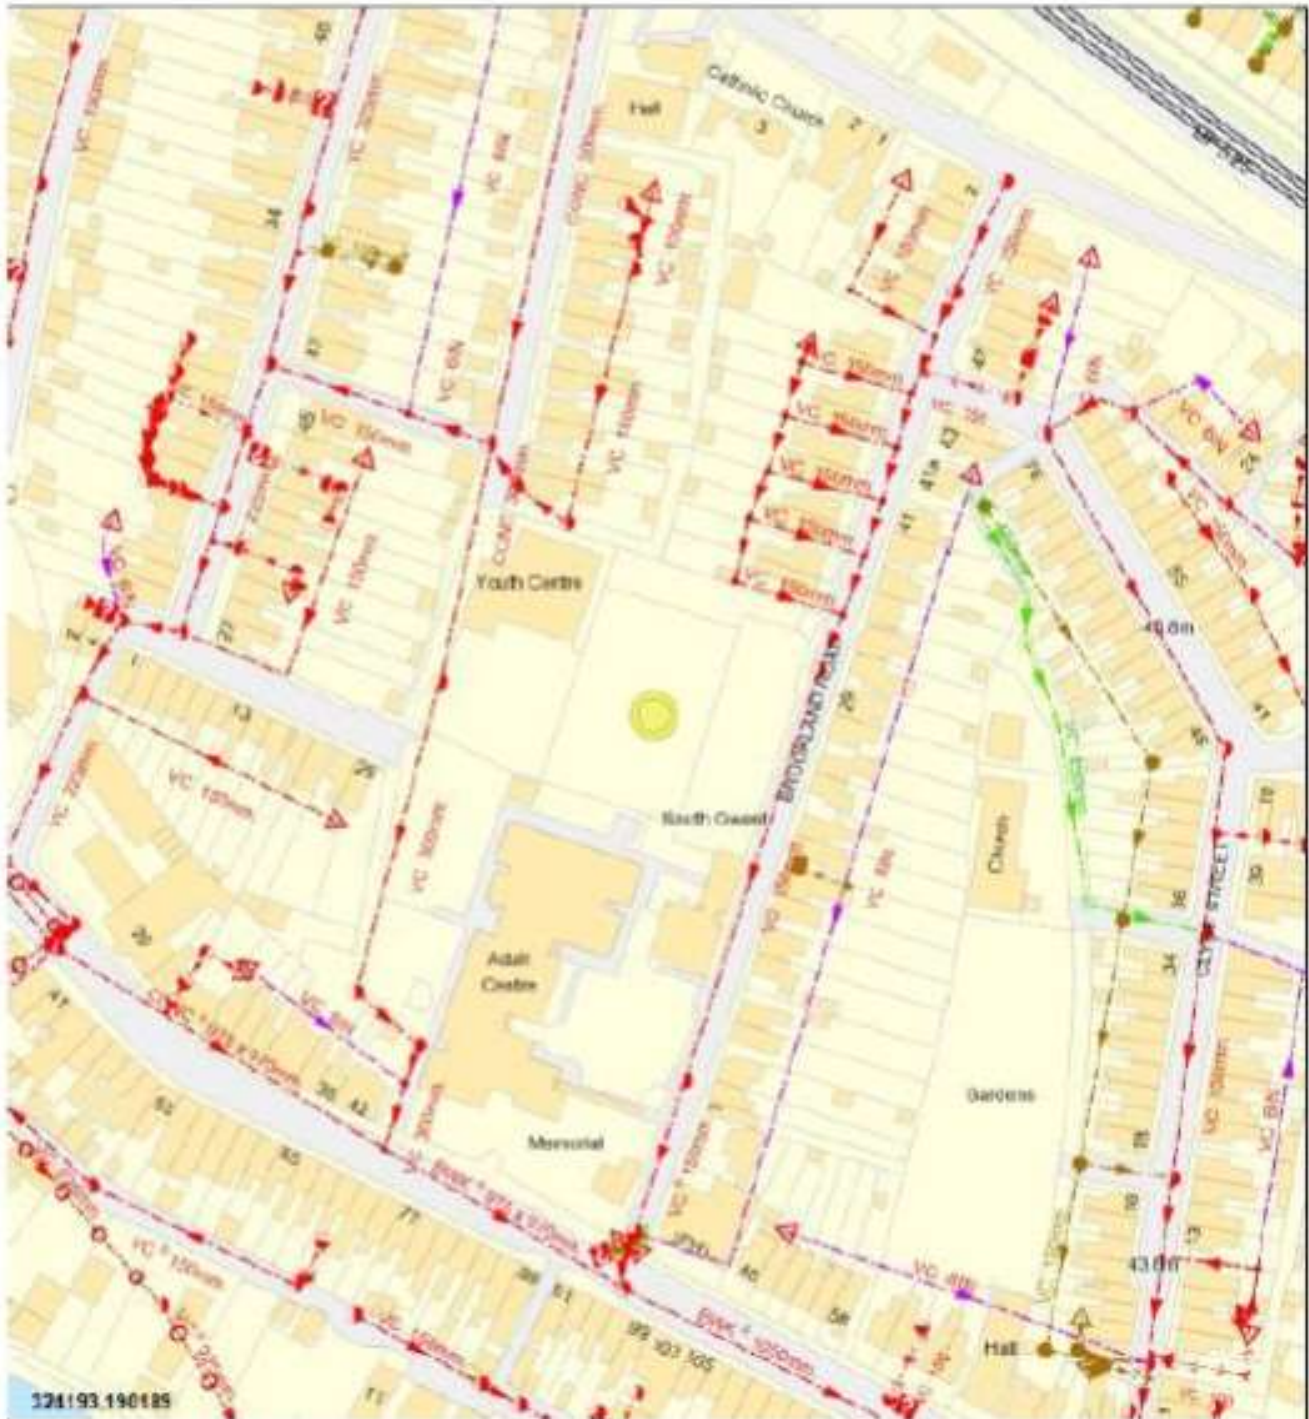
**APPENDIX 9 – WELSH WATER ASSET MAPS**

**OF65 Brookland Rd (sewer)**

Welsh Water Asset plans show an existing 300mm combined sewer crossing the development parcel running in north to south direction along the western boundary of the site. It is also noted a 150mm DCWW Combined Sewer within Brooklands road to the east of the site, this also runs from north to south.(Refer to Appendix 9).

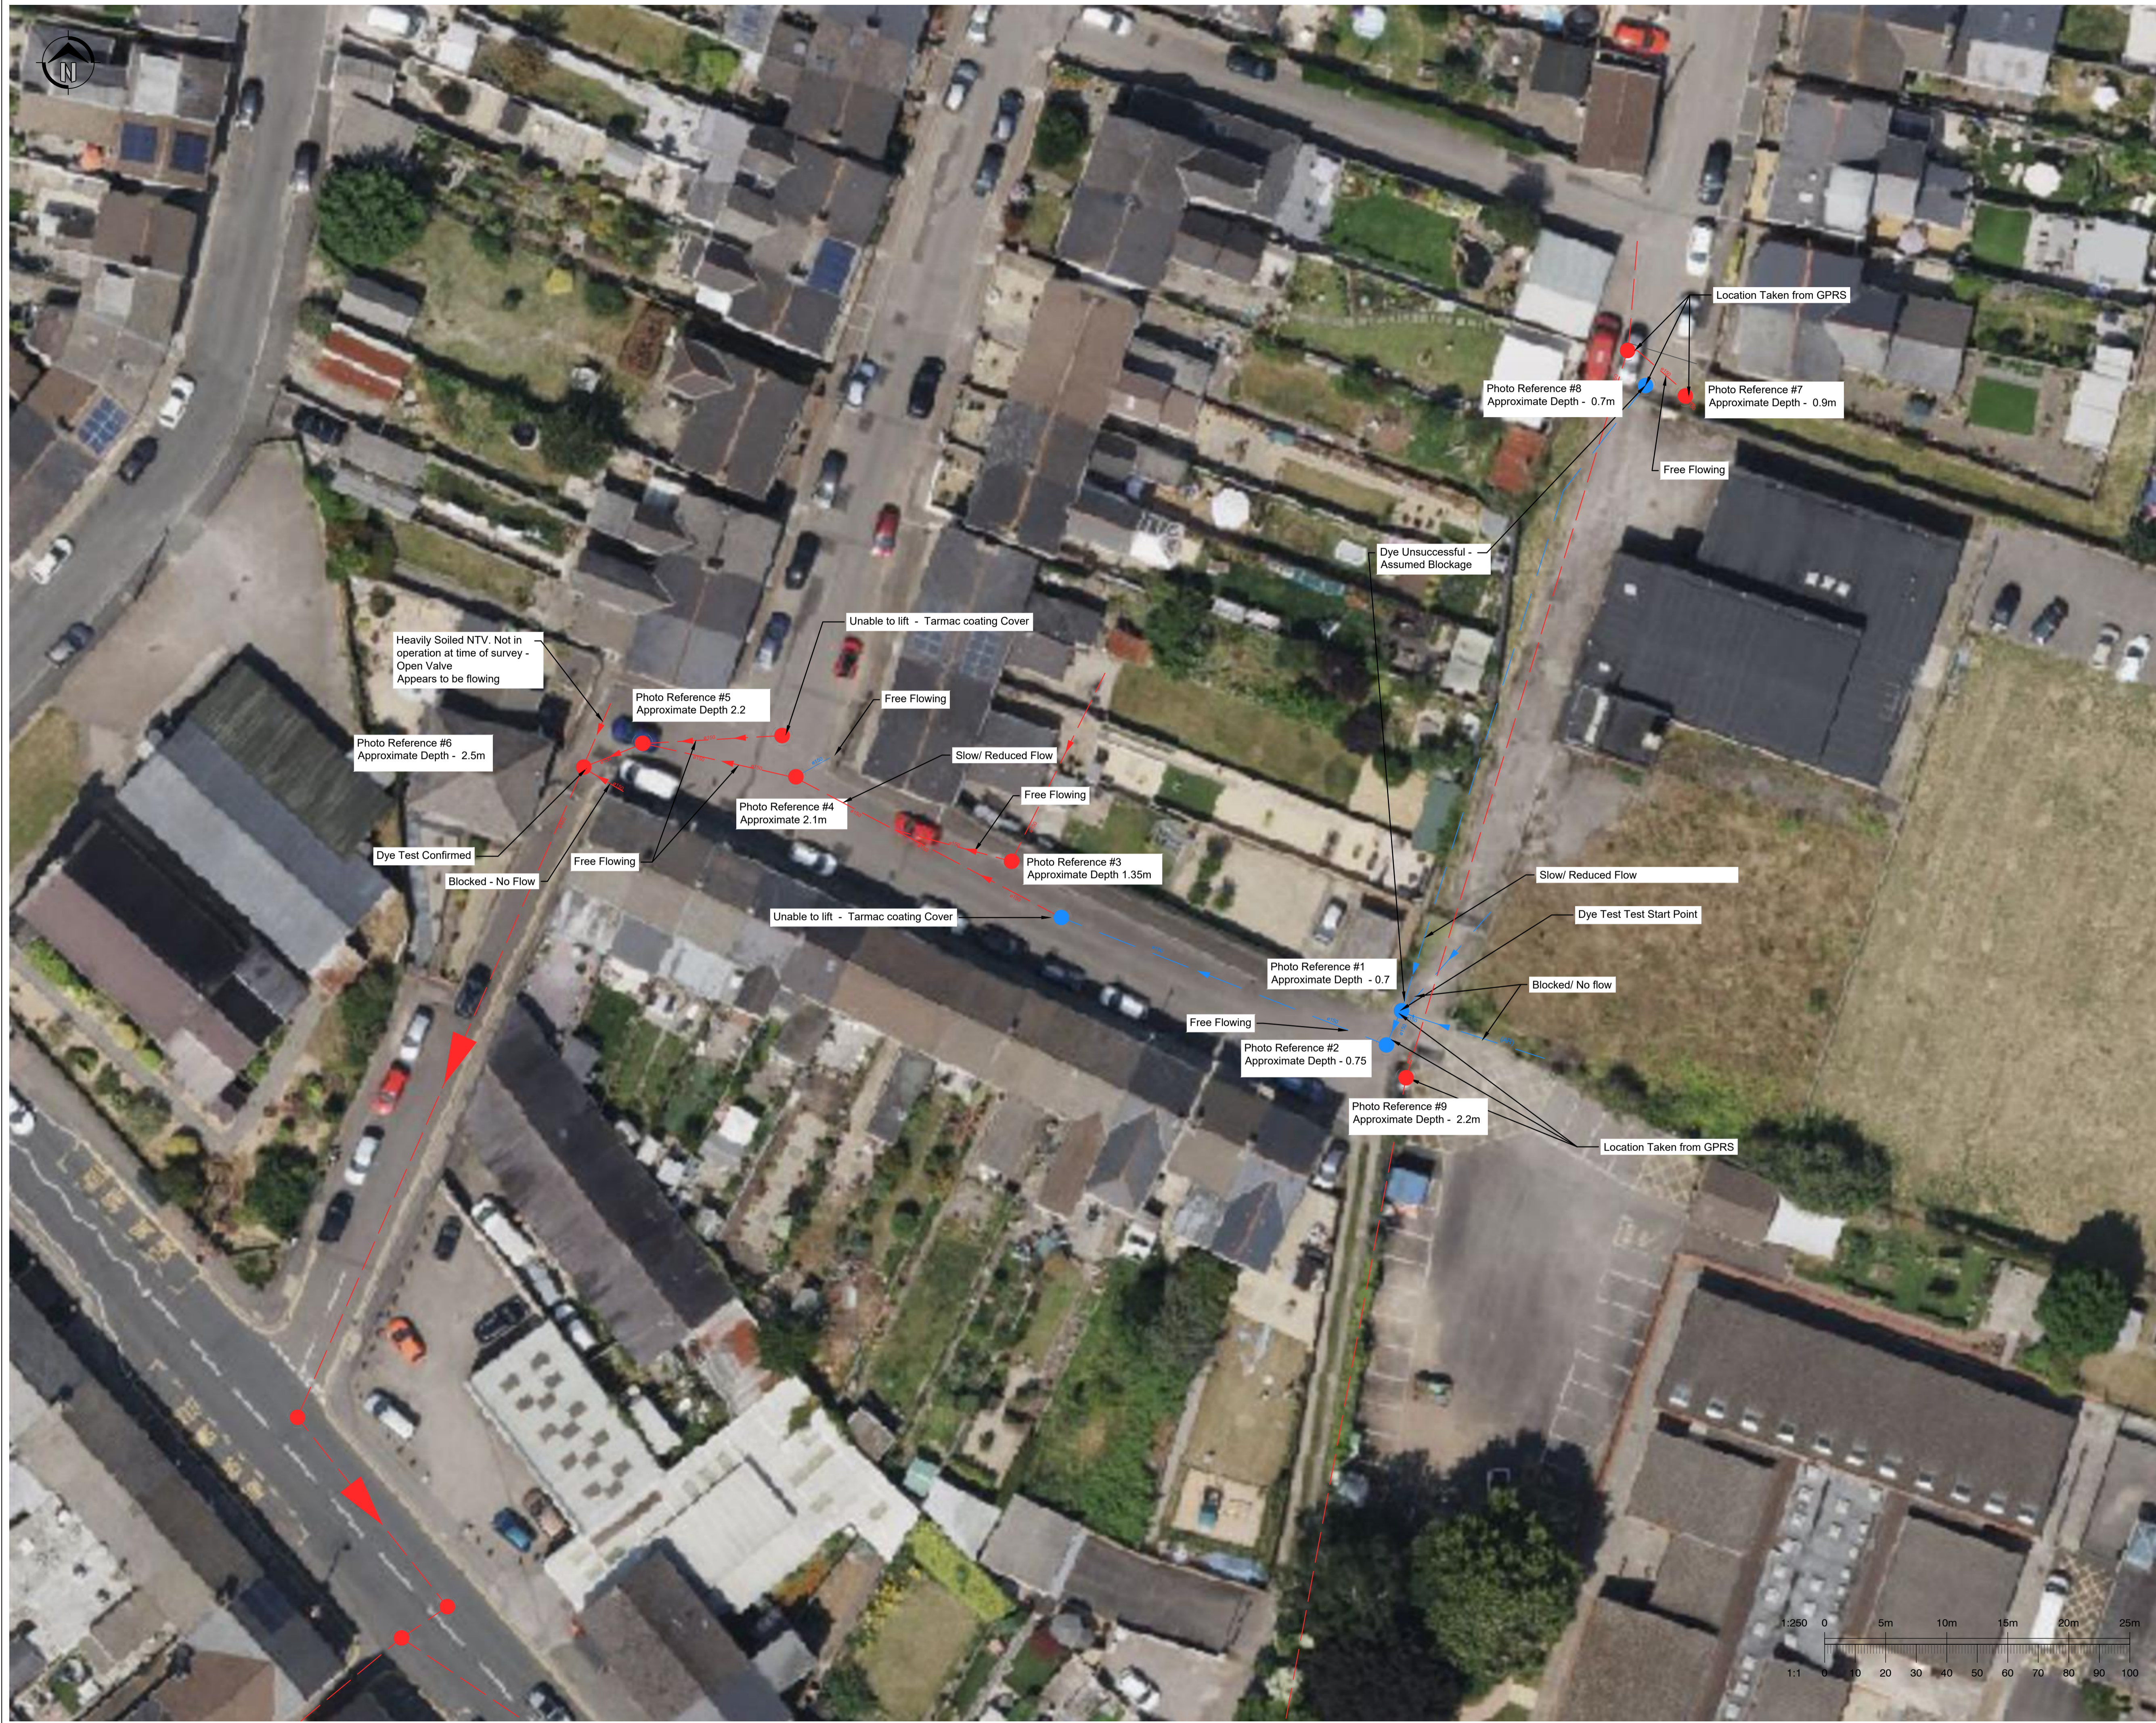
21575-SK-004-Dye Test Investigation.dwg

- GENERAL NOTES**
1. This drawing is to be read in conjunction with and checked against all other drawings, engineering details, specifications and any structural, geotechnical or other specialist document provided. Any discrepancies within all relevant drawings are to be reported to QuadConsult Ltd immediately.
  2. All dimensions and levels are in metres, U.N.O..
  3. Do not scale from this drawing - use figured dimensions only.
  4. This drawing is schematic for clarity only, positions of pipe runs and manholes may vary on site due to site conditions.
- Key:
- Assumed Highway Sewer
  - Assumed DCWW Sewer
  - ▶ Highway Flow Direction
  - ▶ DCWW Flow Direction
- PLEASE REFER TO 21575-MIS-800-DIE TEST INVESTIGATION PHOTOS-0 FOR PHOTO REFERENCES.

Flood mapping indicates surface water flooding west of the site. Considering the poor condition of the highway sewer highlighted in 21575-SK-004 and drainage backfalls identified in the GPR Survey, we believe these factors significantly contribute to the localized surface water flooding.

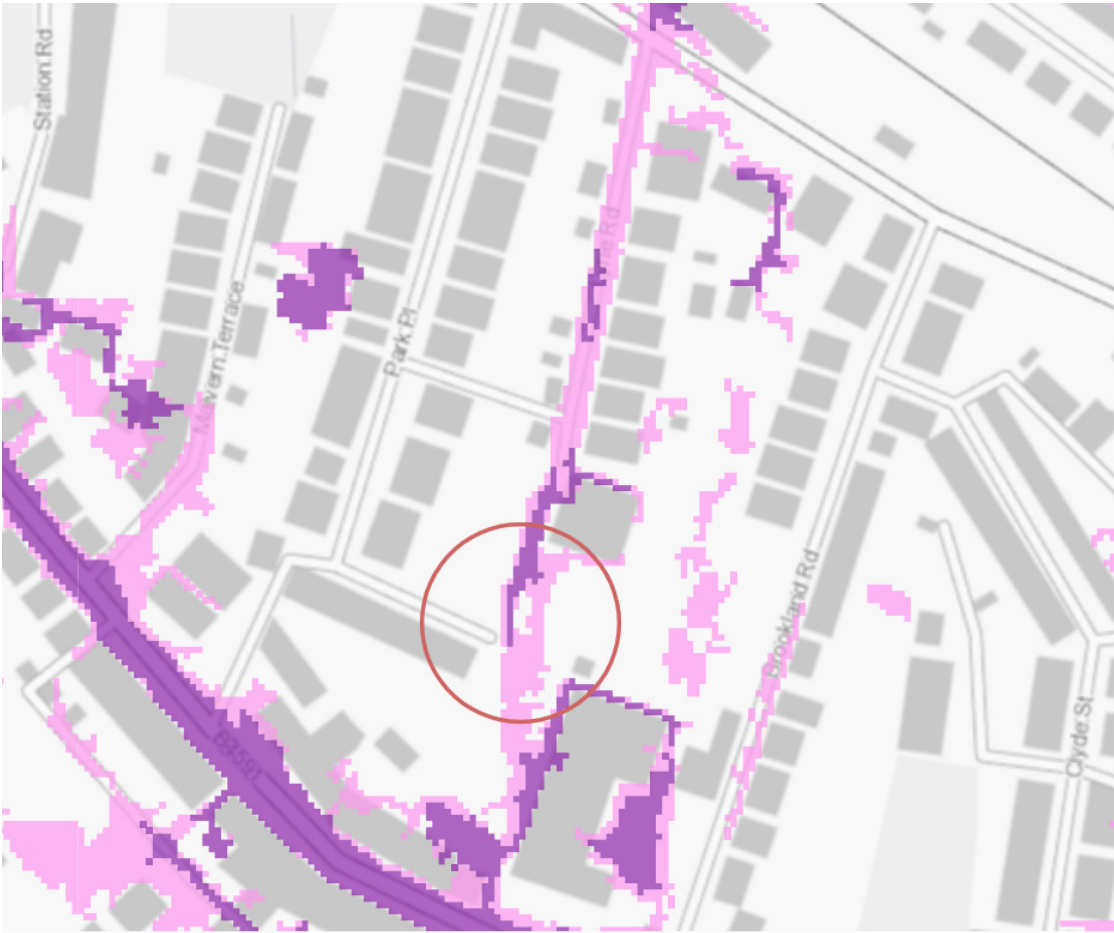
Our proposed drainage solution involves discharging the entirety of our site's water at a controlled rate into the deeper DCWW Network west of the site in Lyne Road.

By attenuating and discharging into this deeper network, we believe we will be aiding in alleviating the surface water flooding. Additionally, while this may increase flow in this Particular branch of the DCWW Network, the upstream and downstream branches of this network would see a reduction.
