DRAFT Tier 2 Geotechnical and Geoenvironmental Report

Site: Ysgol Iolo Morganwg Primary School

REPORT TITLE : DRAFT Geoenvironmental and Geotechnical Report: Proposed Primary School, on land opposite 31 Dunraven Close, Cowbridge, CF717FJ.

REPORT REFERENCE : GGR-07082025-648-CA-24-1

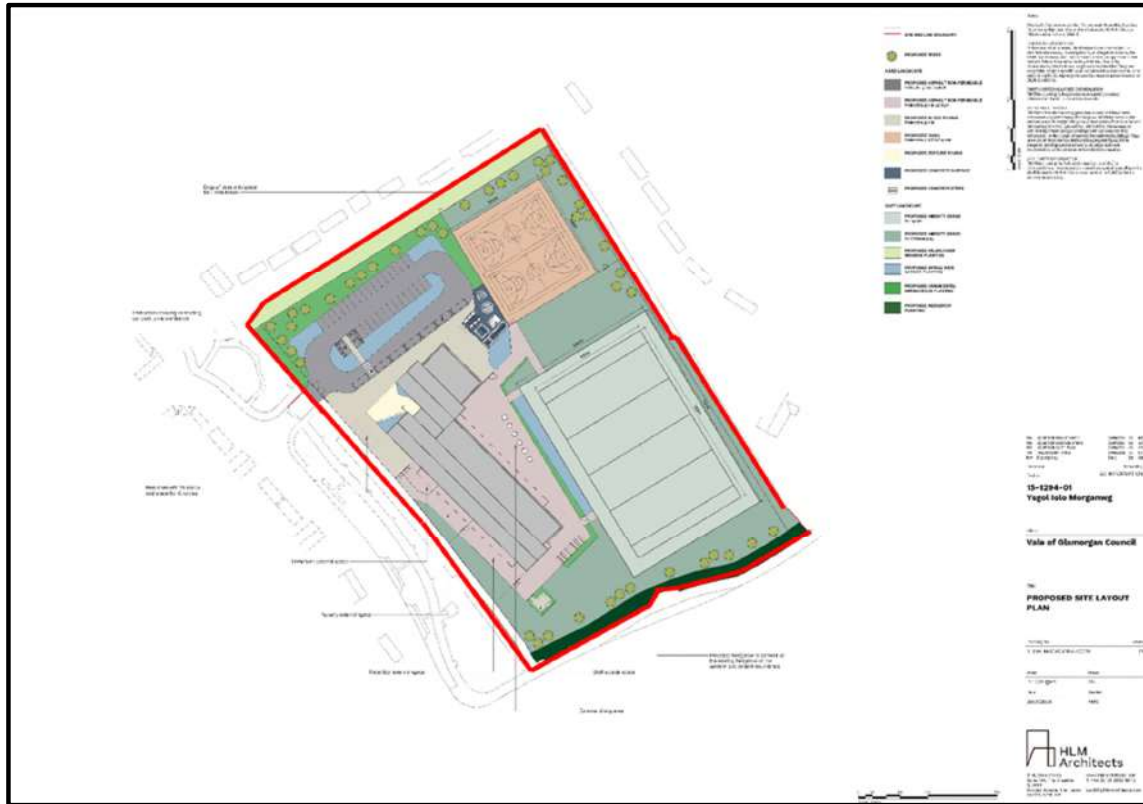
Figure 1.1 Proposed Site Layout

Kier Construction (the Client) is proposing the construction of a new Primary School on land opposite to 31 Dunraven Close, Cowbridge, CF71 7FJ. The proposed development will consist of a two storey primary school and associated infrastructure including access road, car parking, and soft and hard social areas. The proposed layout can be seen in **Figure 1.1**.

- Client provided information, plans etc. (**Figure 1.1**); and
- Tier 1 Assessment (*Hydrock, Phase 1 Ground Conditions Desk Study. Project Reference: 31793. Dated March 2024*).

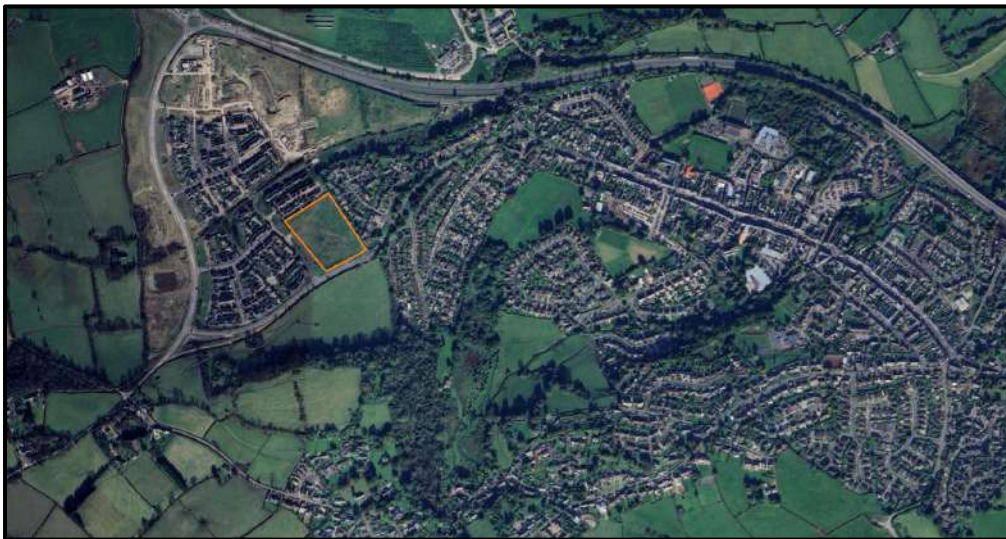
Plate 1: Geophysical survey area (orange outline) south of the A48, Cowbridge (Google Satellite Image, 2025).

The site is located at the western edge of Cowbridge and centred on National Grid coordinates 298359, 174664. The survey area (Plate 1) comprises an open field that measures approximately 1.9 ha and is situated at the southern margin of a new housing development. At the time of the survey, the field was covered by overgrown vegetation and was enclosed by Heras fencing on all sides. Previously, the site had been utilised as a compound and material store (Plate 2) during the construction of the adjacent housing estate. It is understood that no utilities cross the survey area.

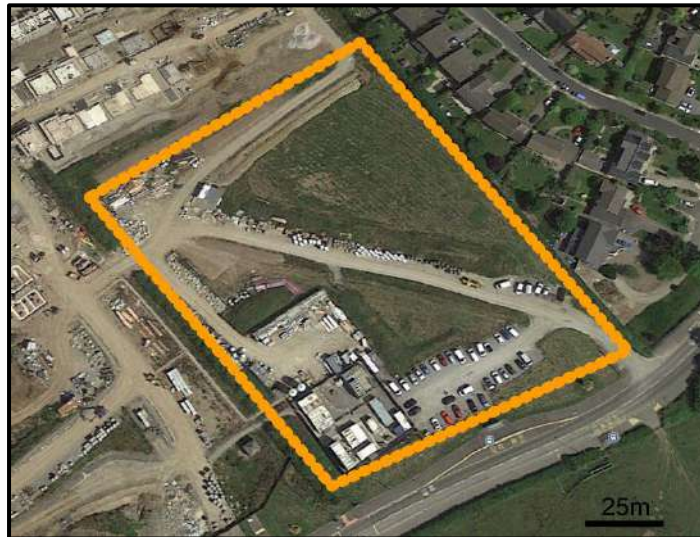
Plate 2: Former compound layout (Google Satellite Image, 2021).

The corresponding in-phase results (Figure 3) reveal a scattering of features which are consistent with disturbed/reworked ground. Many of the observed responses correlate with the features shown on the historical compound layout (Plate 2) and accompanying Lidar plan (Figure 1). The most significant are the increased response around the eastern entrance (**F4**) and linear zone (**F7**) in the north that follows the former track.

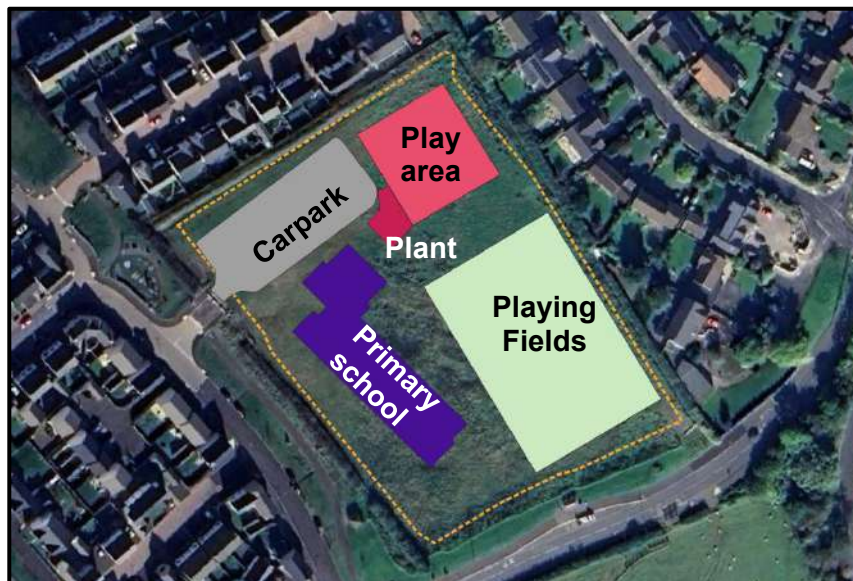
Plate 3: The approximate location of the planned primary school setup (Taken from documents supplied by the client).

The primary school development (Plate 3) plan includes a carpark in the north east corner of the site, a tarmacked play area to the north, playing fields in the eastern corner, and a small central area for plant and bin storage. The main primary school building is planned along the western portion of the site, and this is the main area of investigation.

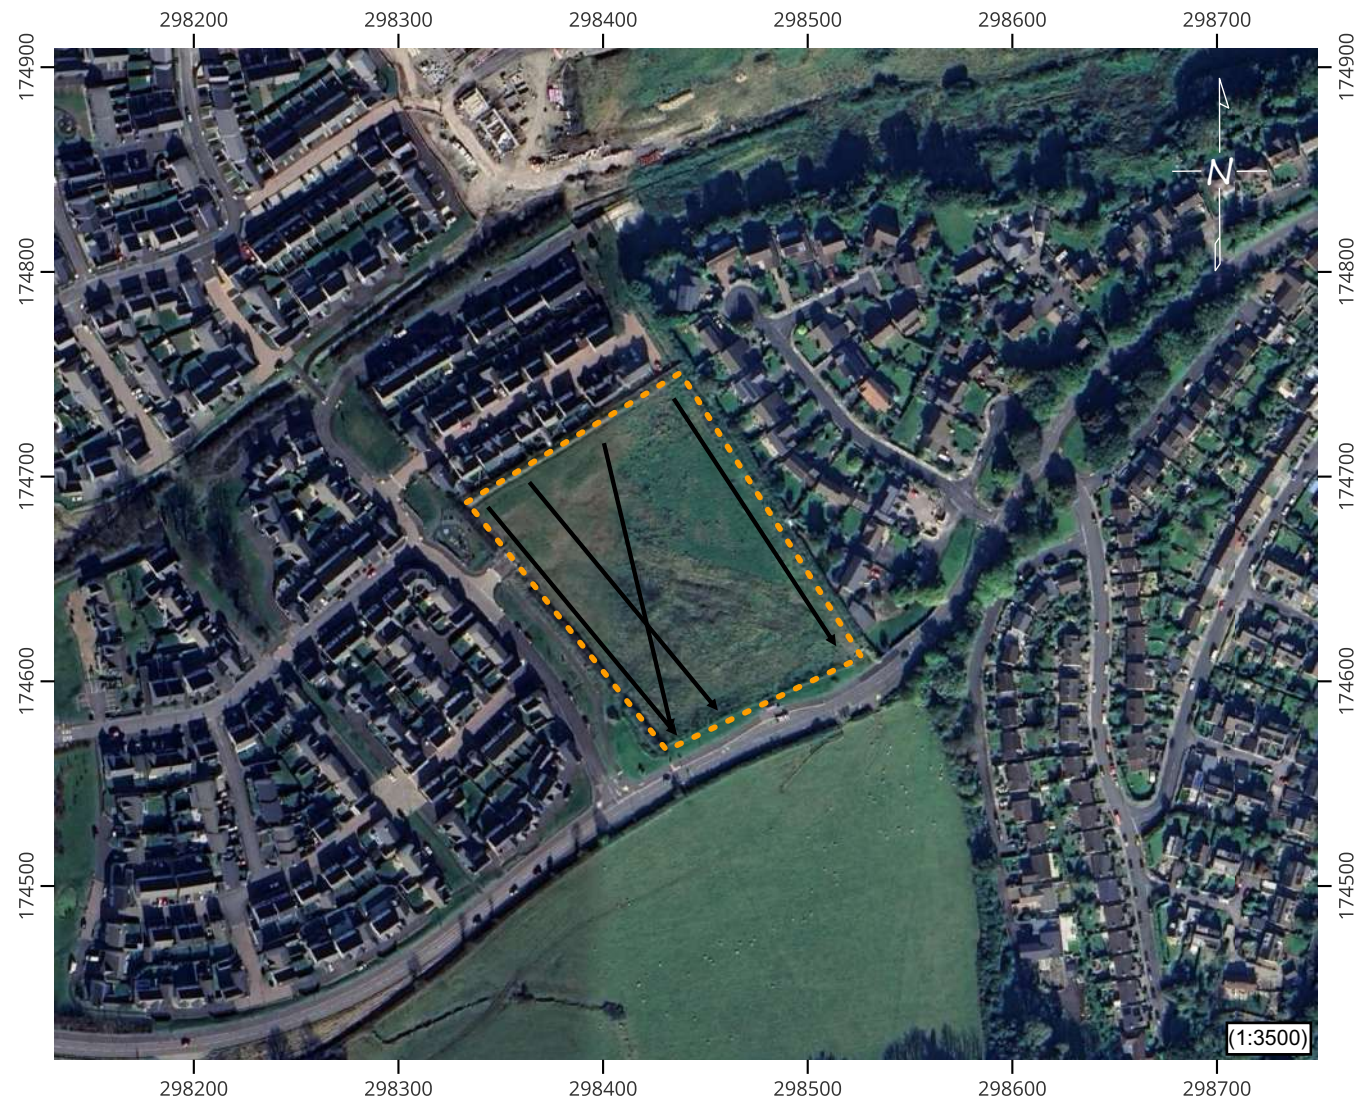
FIGURE 1

A) SITE OVERVIEW (Overlaid on Google Satellite Imagery, 2025)

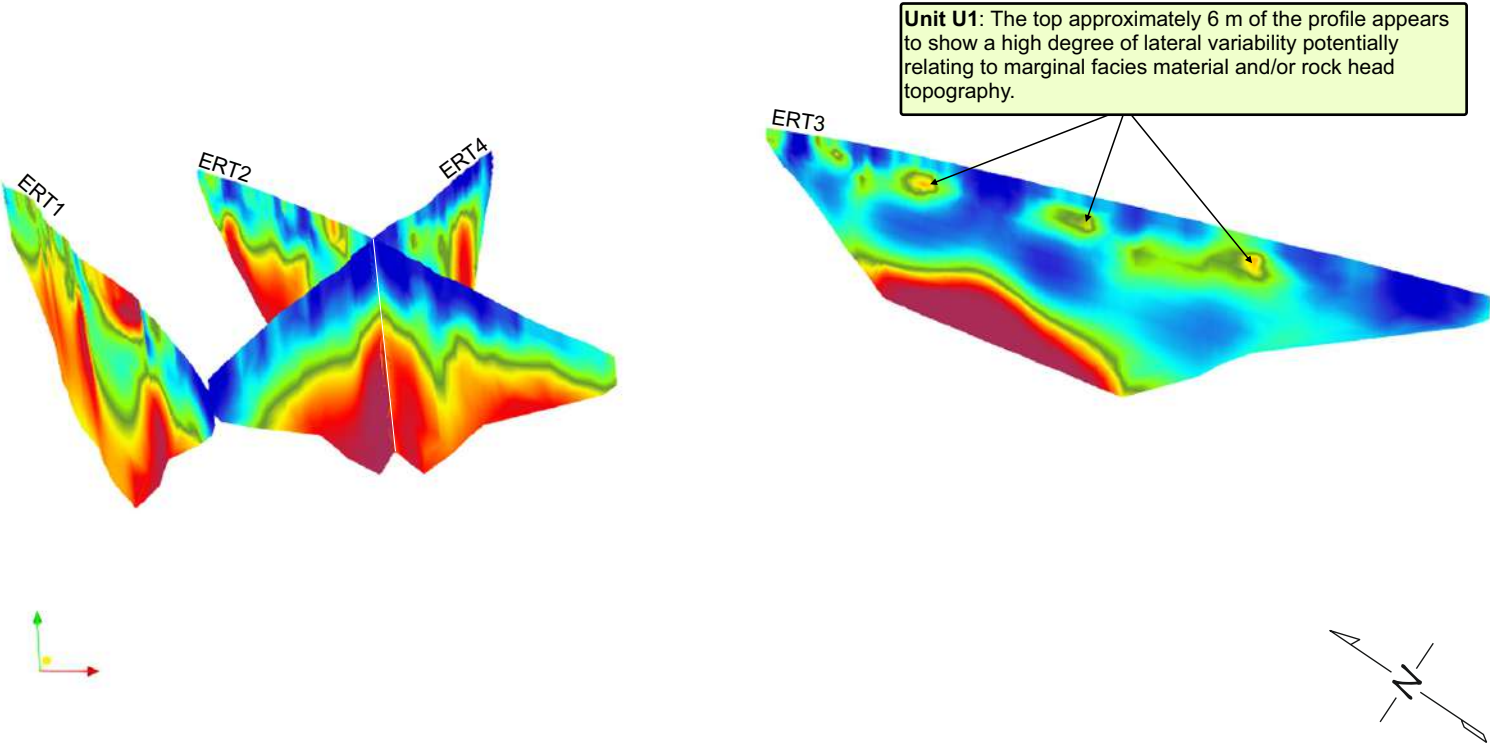
A) 3D ERT RENDER (Looking north)

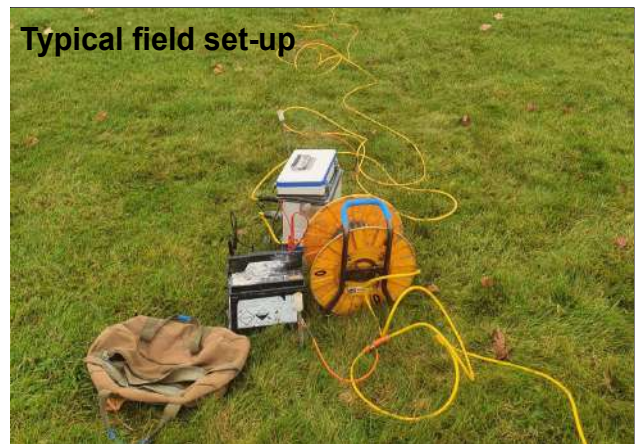
Typical field set-up

An ERT survey involves the injection of DC electrical current into the ground at various electrode locations along a profile line. An electrical cross-section of the subsurface is then derived from the recorded data. A diverse range of features such as clay-rich sediments, the water table, gravel lenses, fracture zones, infilled solution features, bedrock structure and leachate can be imaged in cross-section using a resistivity survey. A feature may be targeted using resistivity tomography, given sufficient electrical contrast with its surroundings. A description of the field activity is provided below, and some background information on the survey method is found in the Appendix.
