Penrhys Village, Rhondda Cynon Taff

Phase 1 Ground Conditions Desk Study

For Trivallis

Doc ref: 30603-HYD-XX-XX-RP-GE-1001

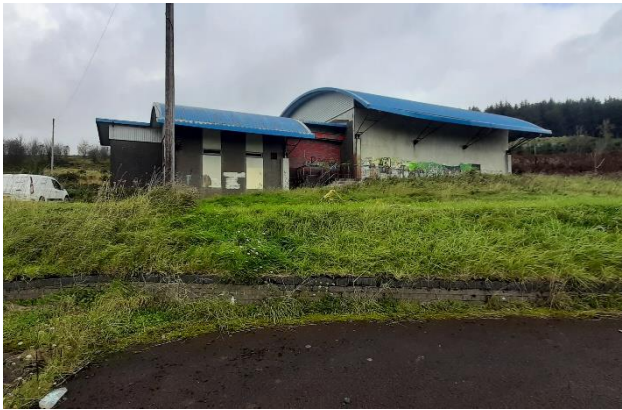
Figure 2.3: Former boiler house in the north of the site.

<table><tr><th>Source(s)</th><th>◀ potential impact on ▶</th><th>Receptor(s)</th></tr><tr><td>Hydrocarbon fuels, lubricants, solvents and asbestos associated with the boiler house in the north of the site and across the historic heating network from leaking/damaged pipework.</td><td></td><td>Site end users Groundwater/ surface waters.</td></tr></table>

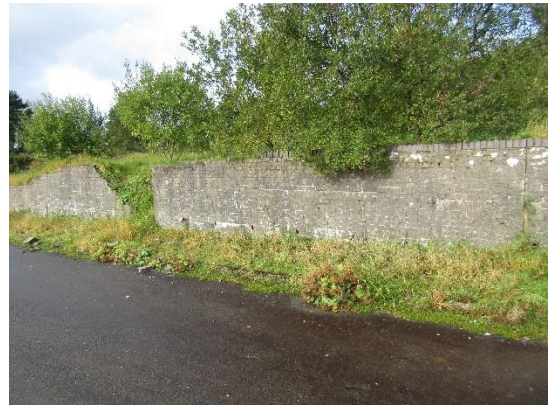
Figure 2.4: Collapsing Retaining wall in north east of the site.

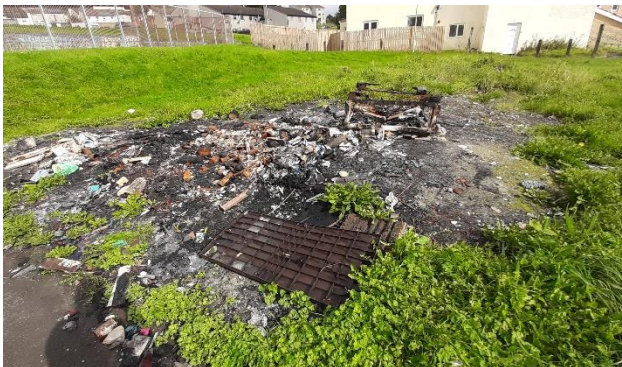
Figure 2.5: Rubble at the site of a former bonfire in the northern residential portion of the site.

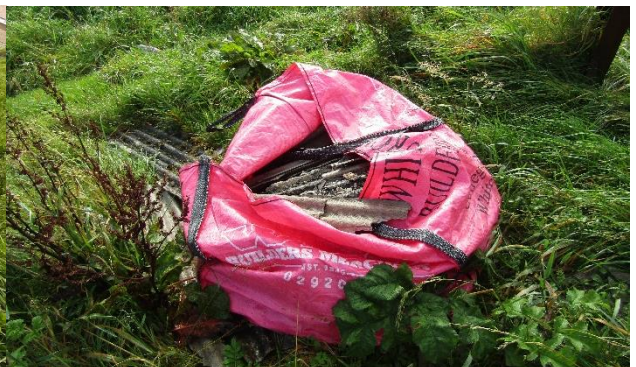
Figure 2.6: Fly tipping of asbestos sheeting in the north-east of the site.

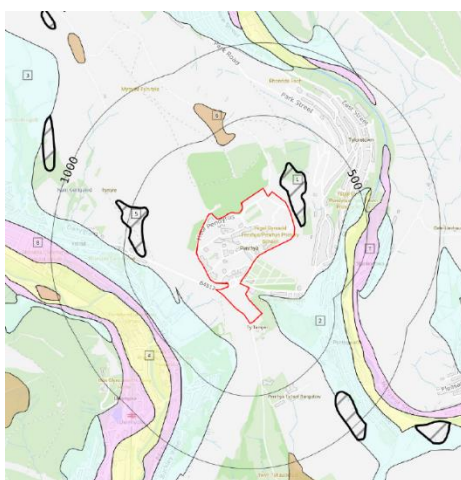
Ref. for Figures	Location	Stratigraphic Name	Description
Superficial Deposits (Figure 2.7)			
Not present on site.			
1	Off-site East boundary (Black Hatch)	Landslip	Landslip material.
2	Off-site South and west (Light blue)	Till	Consists of a heterogenous mixture of clay, sand, gravel, and boulders varying widely in size and shape (diamicton)
6	Off-site 391m North	Peat	Peat is a partially decomposed mass of semi-carbonized vegetation which has grown under waterlogged, anaerobic conditions, usually in bogs or swamps.
Solid Geology (Figure 2.8)			
1	On site.	Rhondda Member	Green-grey Pennant Sandstones with thin mudstone and siltstone interbedded and thin coal pairings.

Figure 2.7: Superficial deposits.

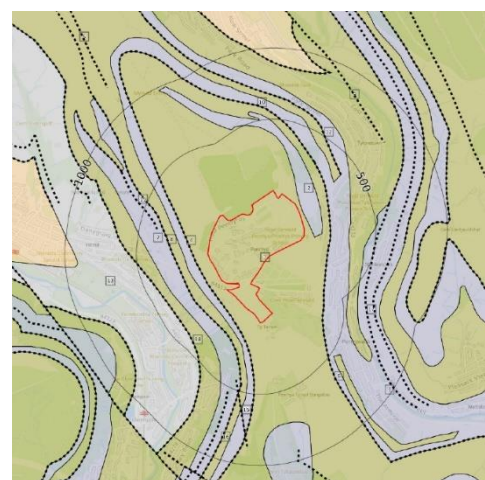
The BGS mapping indicates that there are no superficial deposits over the vast majority of the study area with a small area of peat mapped in the far north of the site and a small band of Glacial Till in the southeast of the site. Landslide deposits are mapped on the eastern boundary of the site and are thought to be related to the steeply sloping topography in this area.

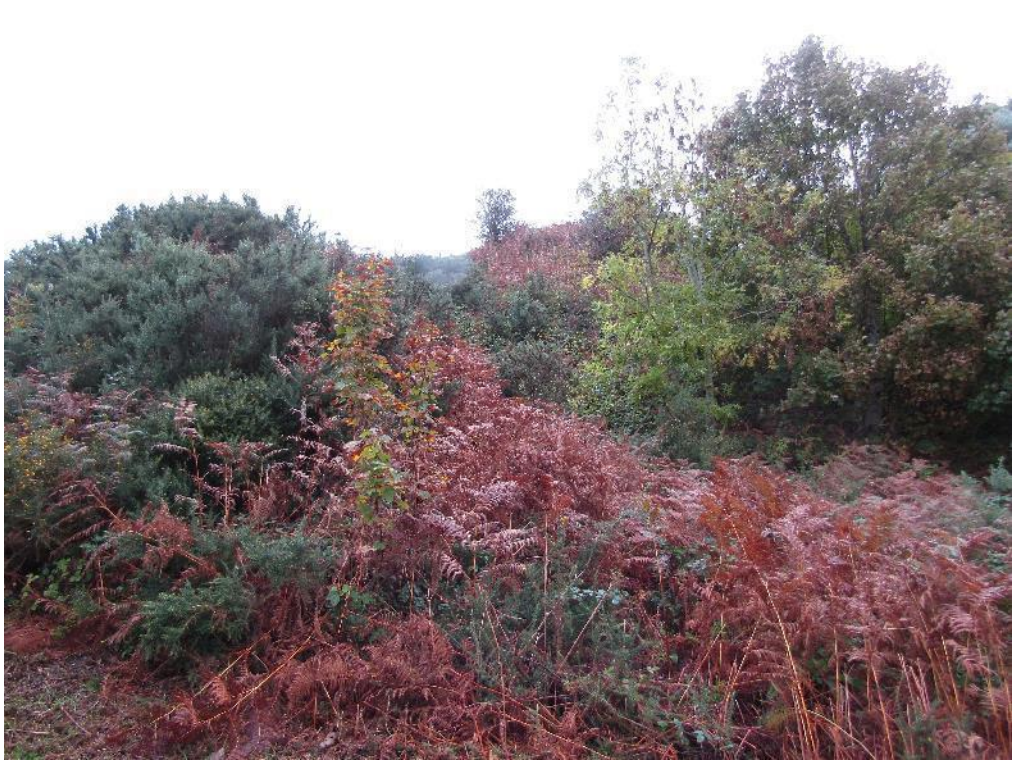
Desk Study Photograph 8

Date: 4/10/23	
Direction Photograph Taken: North-east.	
Description: Vegetated area concealing former quarry from view.

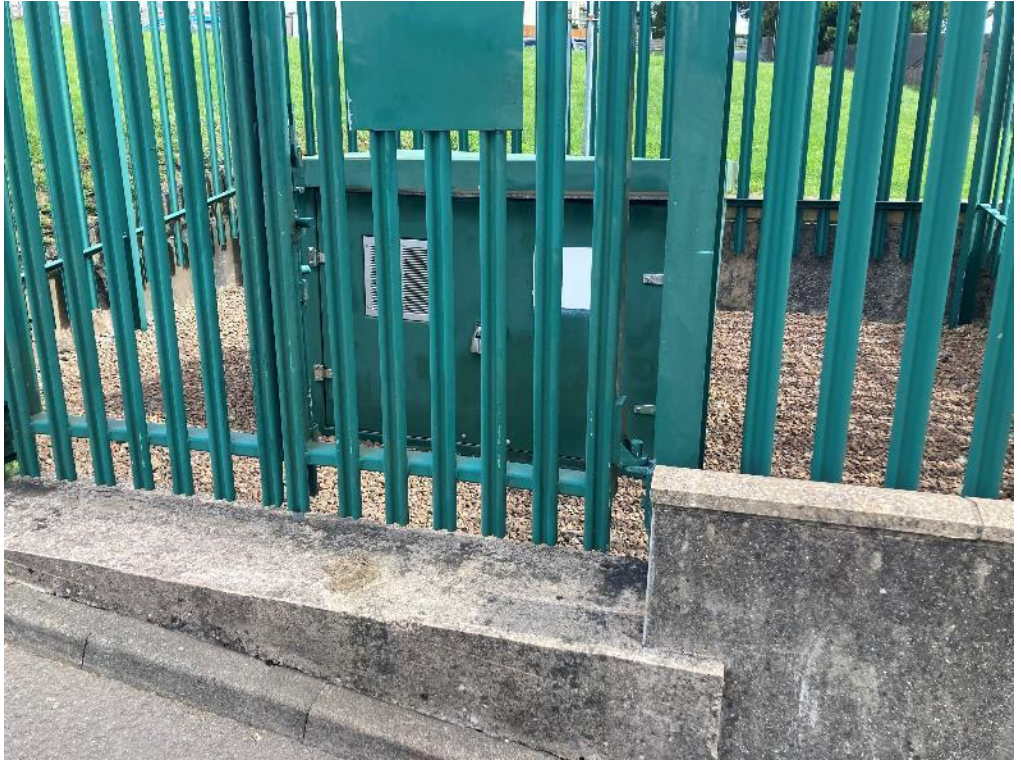
Desk Study Photograph 9

Date: 25/07/23	
Direction Photograph Taken: North-east.	
Description: Gas governor to the south of the Penrhys housing development.

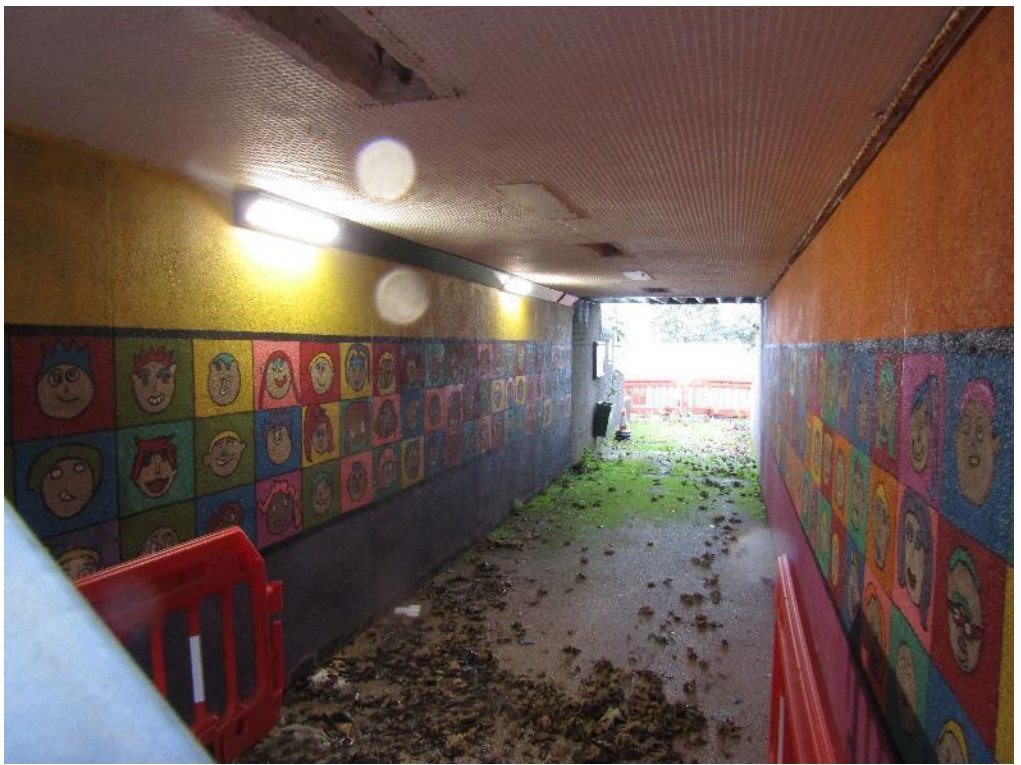
Desk Study Photograph 12

Date: 4/10/23	
Direction Photograph Taken: South-east.	
Description: Closed subway connecting Penrhys housing estate and Penrhys Primary School.

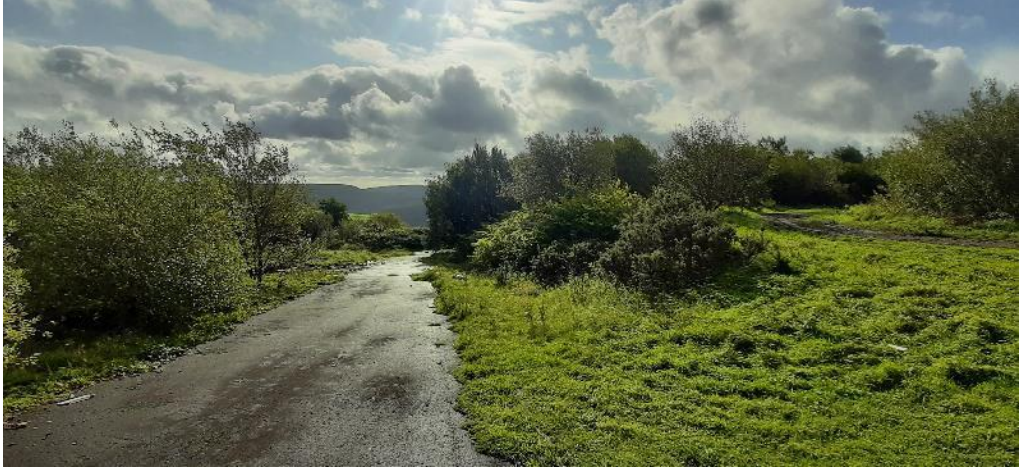
Desk Study Photograph 27

Date: 4/10/23	
Direction Photograph Taken: South.	
Description: Old road through previously demolished area of housing.

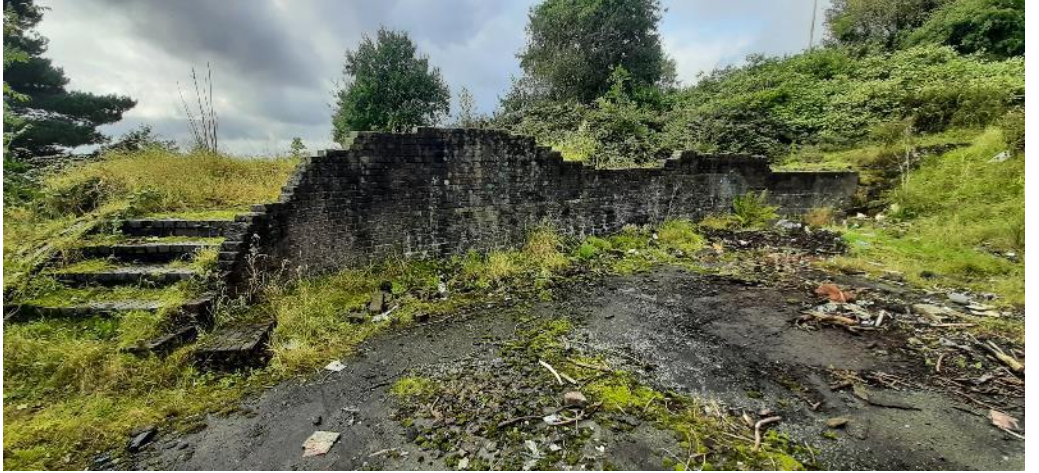
Desk Study Photograph 31

A photograph showing a dark, weathered retaining wall made of stone or concrete blocks. The wall is situated on a grassy slope. To the left of the wall, there are concrete steps leading up the slope. The ground in front of the wall is covered with dark, loose material, possibly soil or debris, and some scattered leaves. The background shows more greenery and a cloudy sky.
Date: 4/10/23	
Direction Photograph Taken: South-west.	
Description: Retaining wall in the previously demolished area of the site in the north-east.

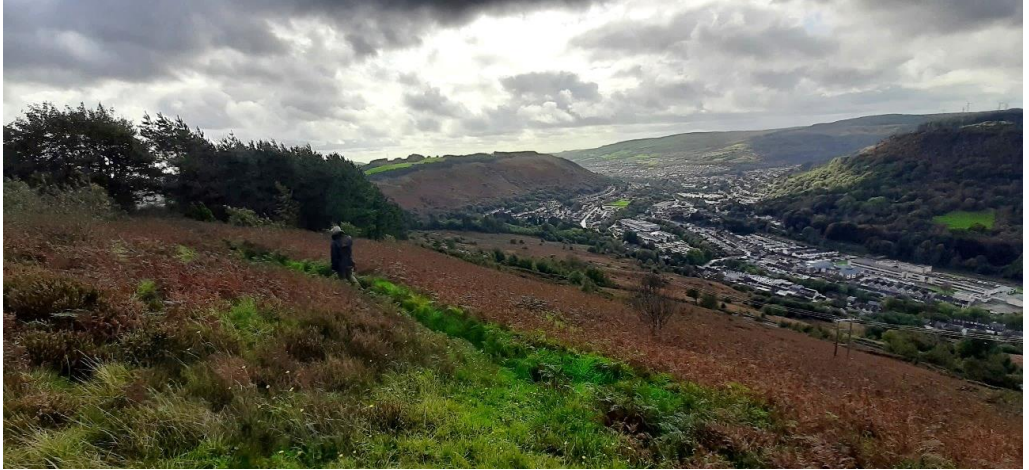
Desk Study Photograph 49

Date: 4/10/23	
Direction Photograph Taken: South-east.	
Description: Steep slope to the west of the site, looking towards the location of the former quarry/tip beneath the vegetation.

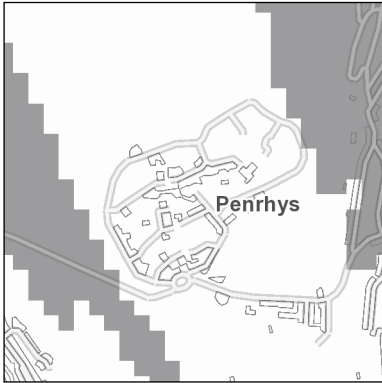
<p>Contains OS data © Crown Copyright and database right 2023</p>	<p><input checked="" type="checkbox"/> Very significant landslide hazard.</p> <p>Slope instability problems are almost certainly present and may be active. An increase in moisture content as a result of infiltration may cause the slope to fail. The site investigation should consider whether the potential for or the consequences of landslide as a result of infiltration are significant.</p>
