## Setting Assessment: Pibwr Lwyd Farmhouse, Coleg Sir Gâr, Carmarthen

Prepared for Wepco

Report No. 2369  
Project No.3205

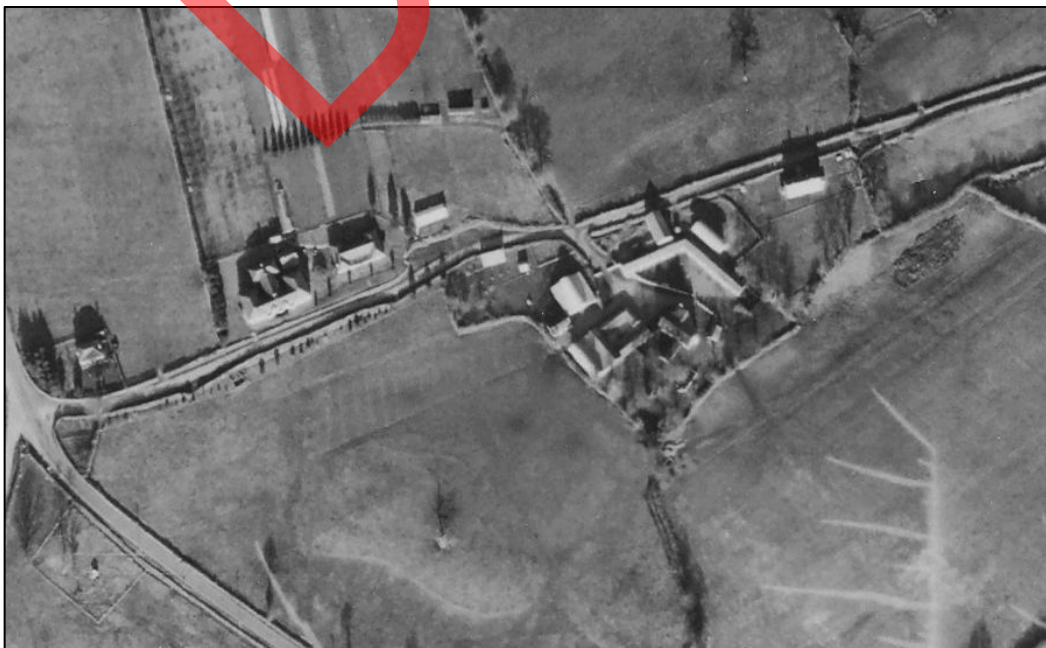
1946 4652 RAFCPEUK1903 4122

3.1.8. Pibwr Lwyd Farmhouse, and its curtilage, lay to the south of Pibwrlwyd Lane which has consistently formed the northern boundary of the farmyard from the earliest available mapping (Figure 3-6). All of the structures relating to the curtilage of the farmhouse are contained within a clearly defined enclosed area formed by Pibwrlwyd Lane and boundary banks and hedges. This is best illustrated on the aerial imagery dating from 1946 below.

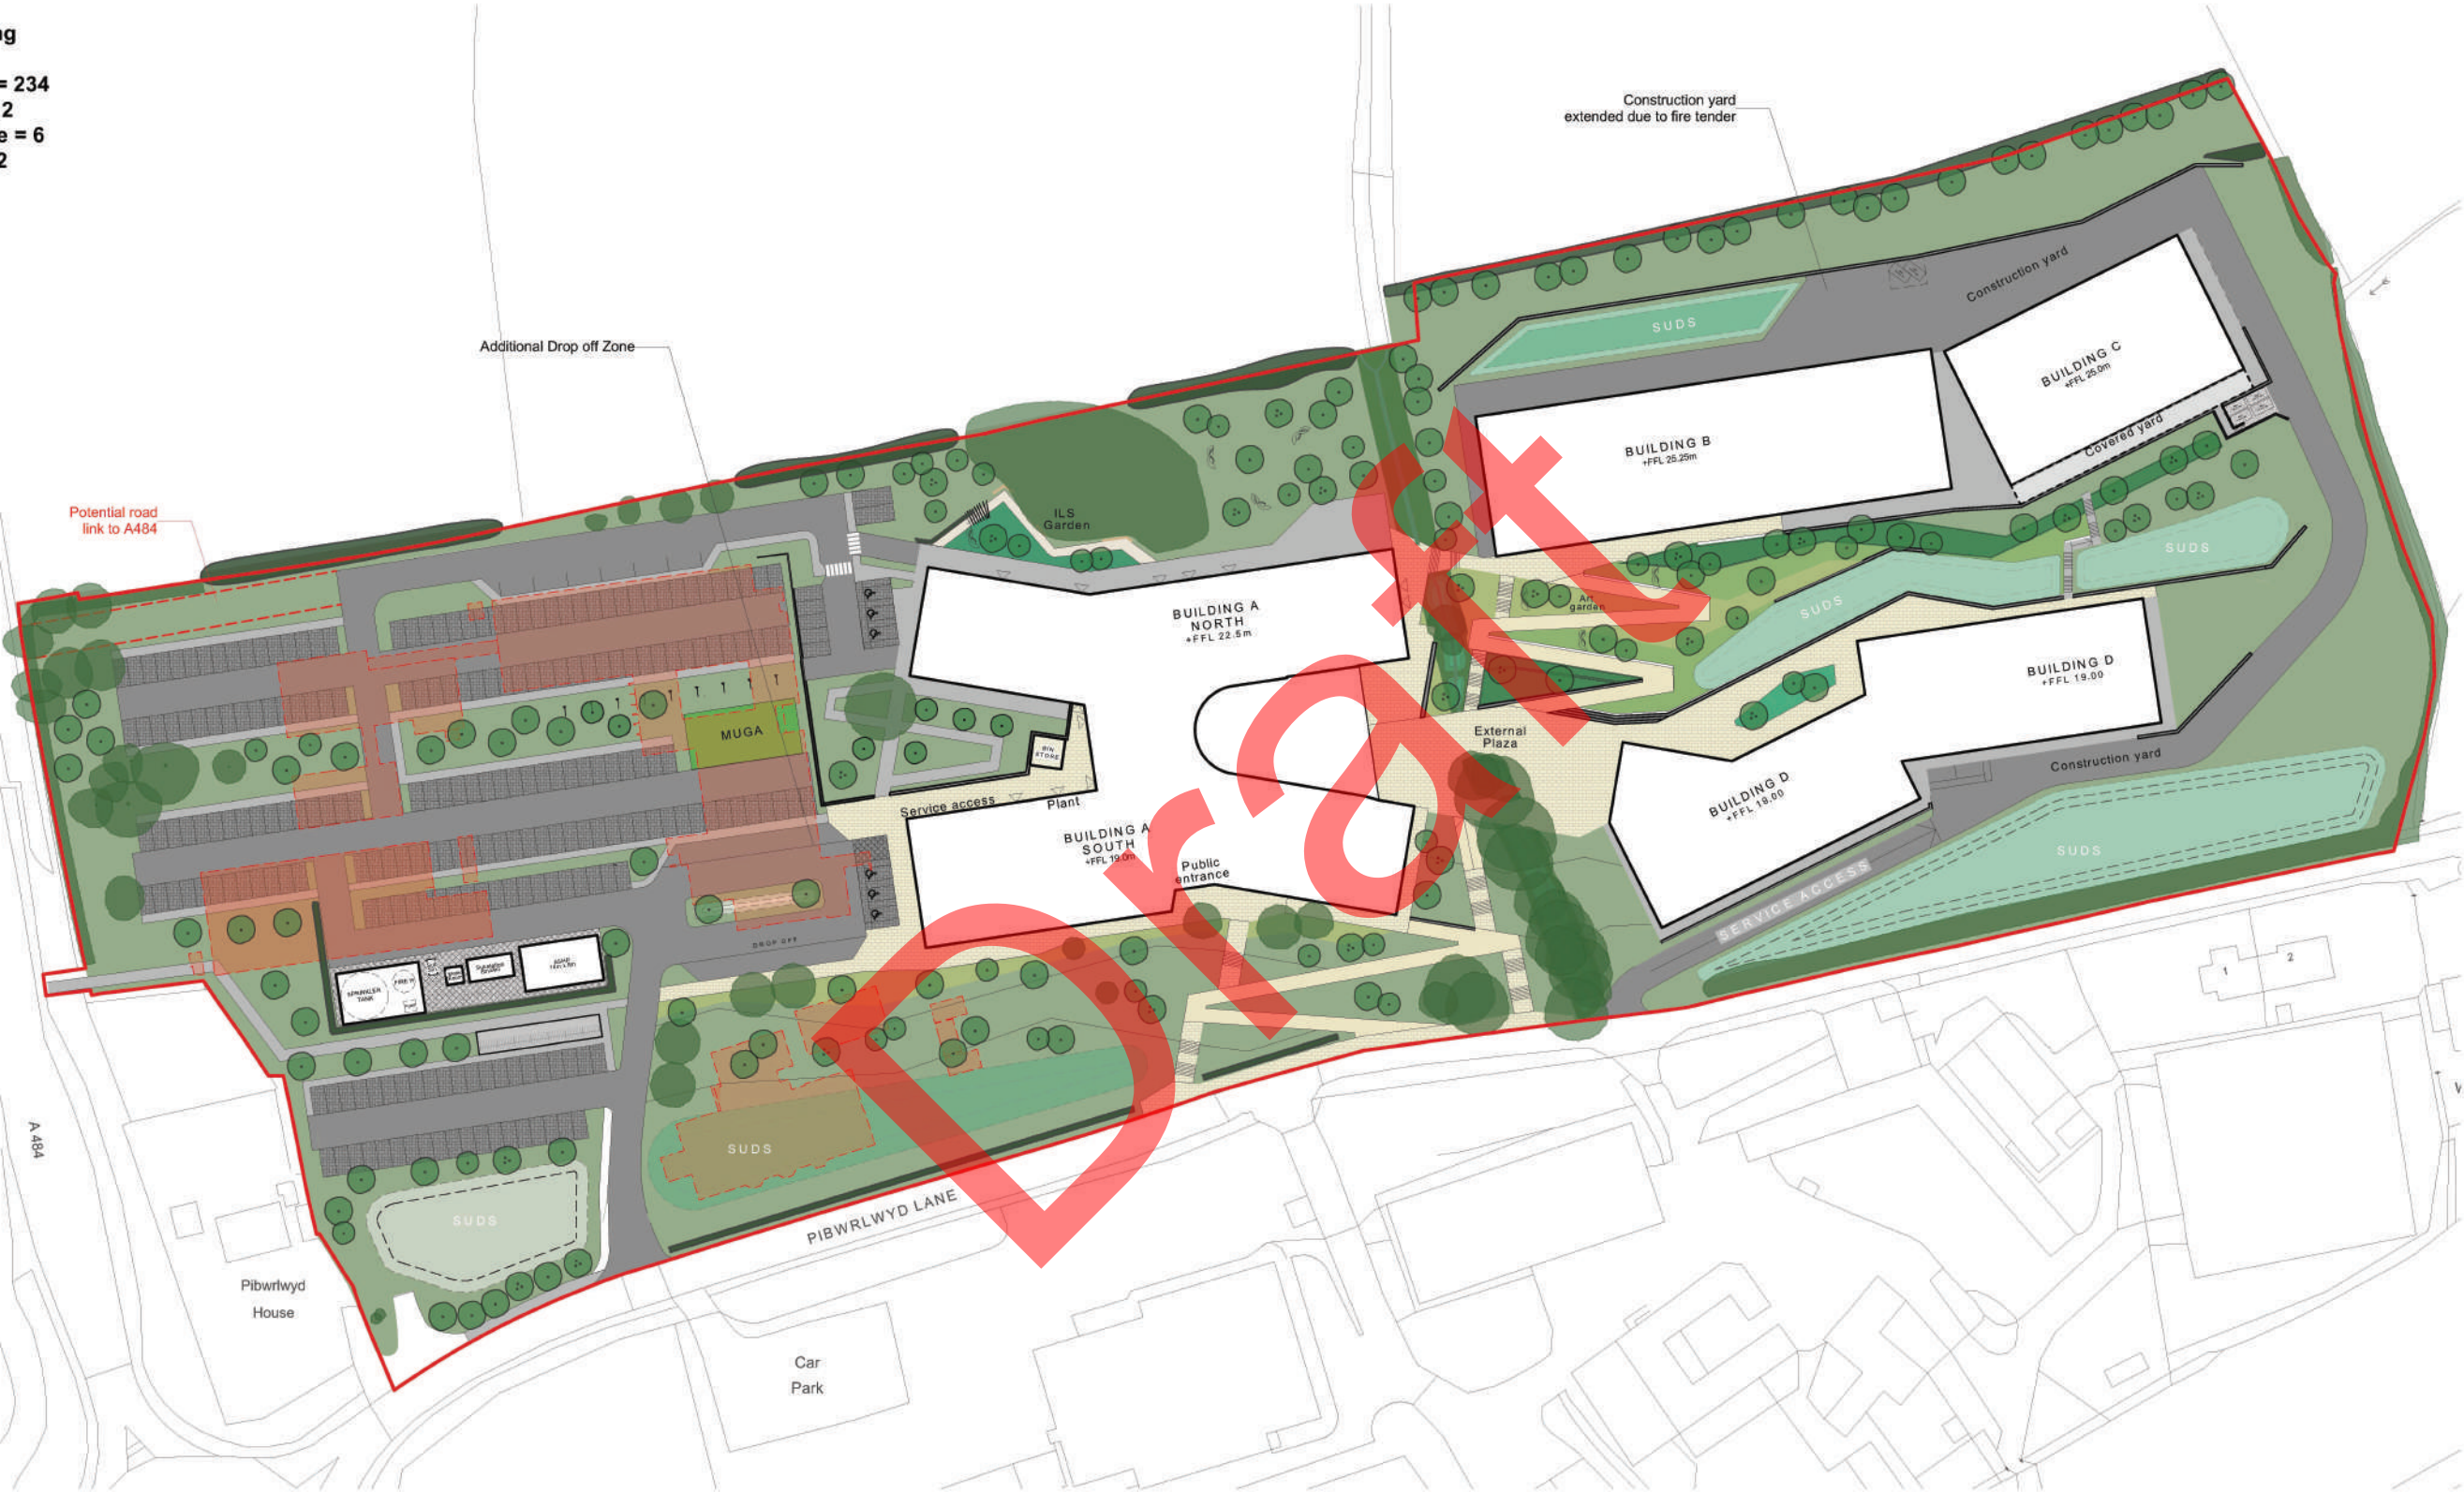
Figure 2. Proposed development plan

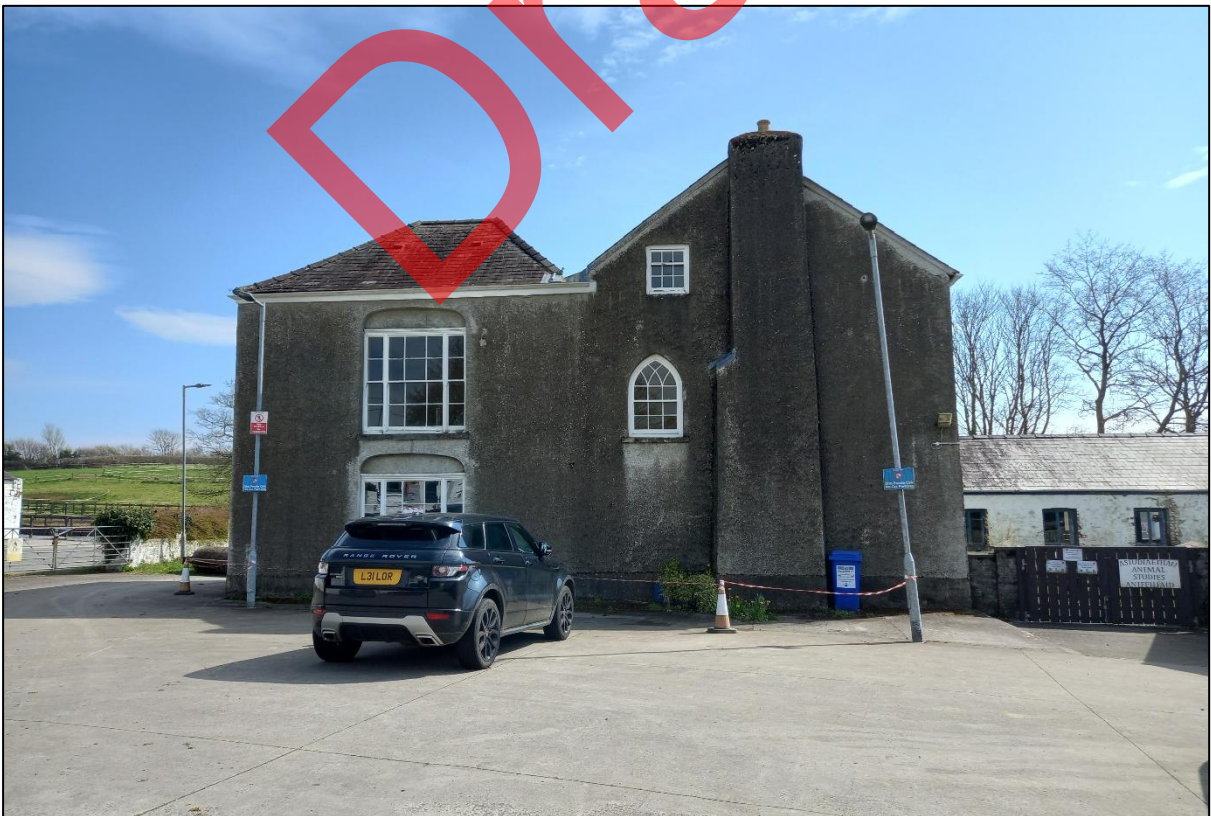
*Plate 2: North-west elevation of Pibwr Lwyd Farmhouse, looking south-east.*

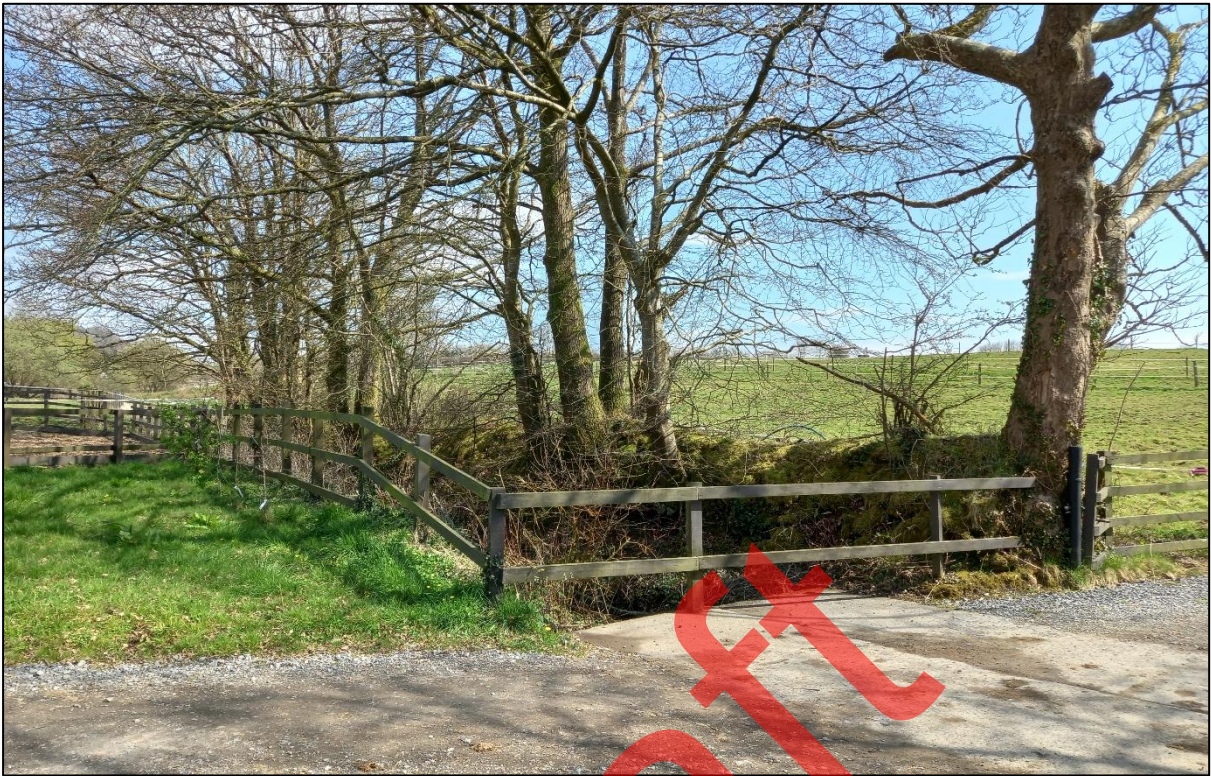
*Plate 3: Surviving section of former farmstead boundary to the south-east of Pibwr Lwyd Farmhouse, looking east.*

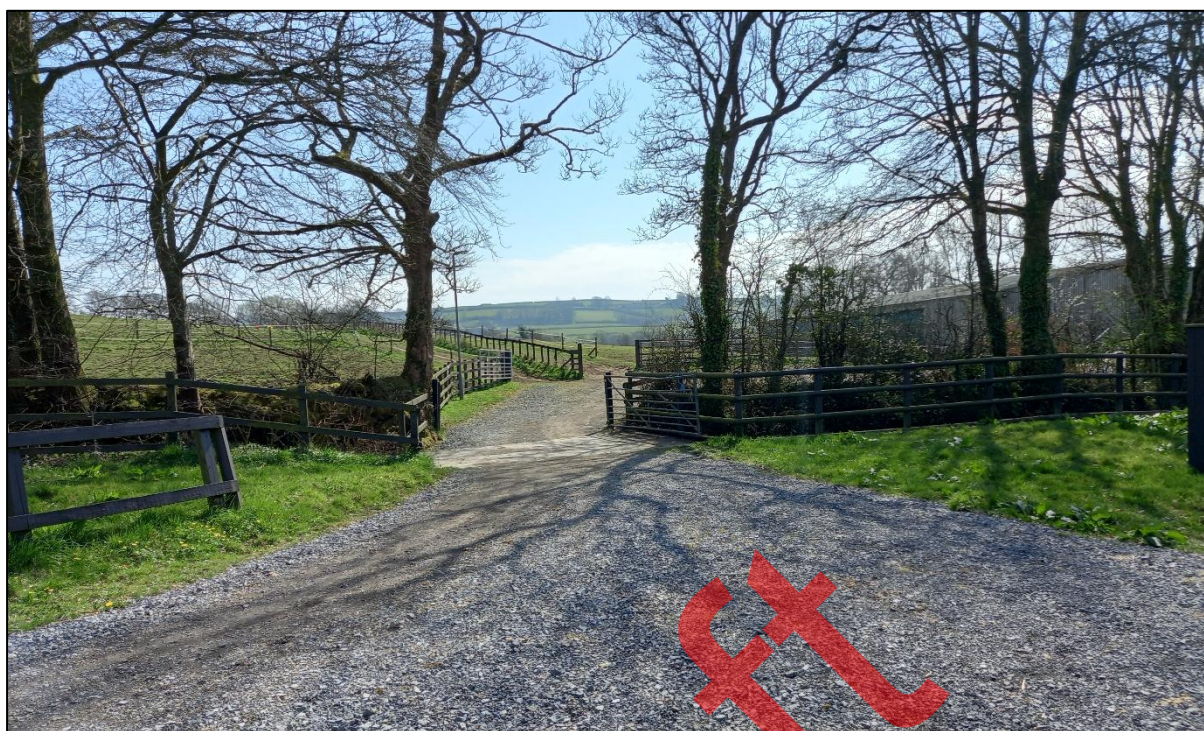
*Plate 5: Looking south-east from the south-east of Pibwr Lwyd Farmhouse through a modern opening in the former farmstead boundary.*

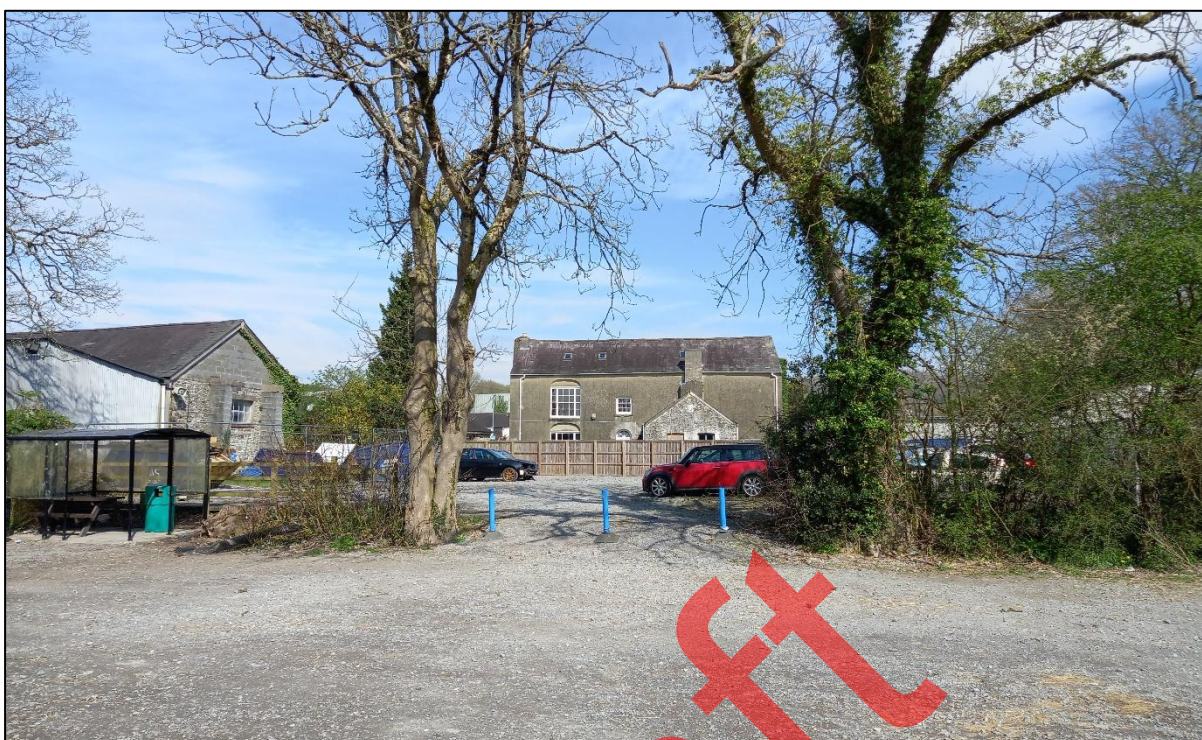
*Plate 7: Looking north-east towards Pibwr Lwyd Farmhouse through the disturbed former farmstead boundary, including a car park entrance and a shelter.*

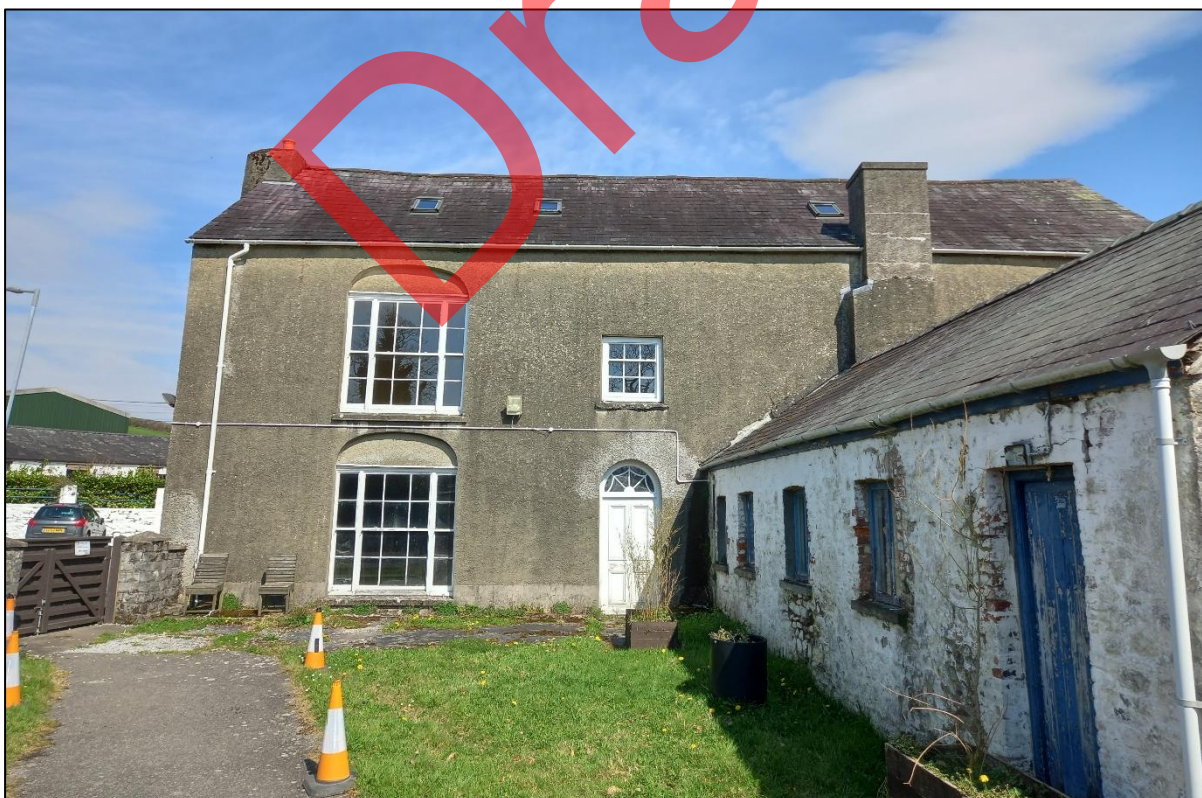
*Plate 8: Front, south-west facing elevation of Pibwr Lwyd Farmhouse, with workshop extension on the right, looking north-east.*

- 3.2.24. As noted in the Original Setting section above (Para 3.2.6), there is only one designed view associated with the Listed Building, which is the view from the front of the farmhouse west over the Twyi Valley. The addition of the single storey workshop wing on the right side of this elevation and the change of use of the building from a dwelling has reduced the significance of this view (Plate 8).

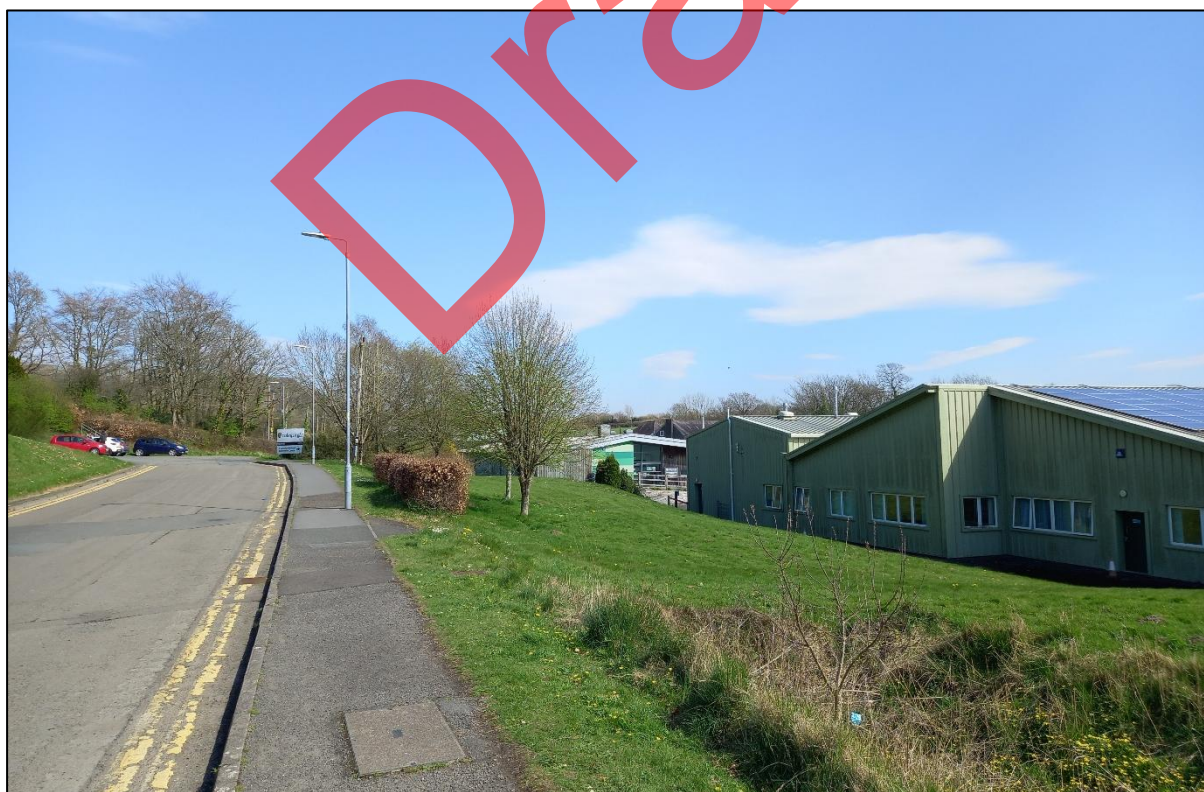
*Plate 10. Approaching Pibwr Lwyd Farmhouse along Pibwrlwyd Lane, looking east.*

- 3.2.26. The modern visitor approaches Pibwr Lwyd from the west along Pibwrlwyd Lane. Understanding of the Listed Building as a farmhouse within its own farmstead is damaged by the various modern college buildings along the road, and which disconnect it from its original isolated setting (Plate 10).

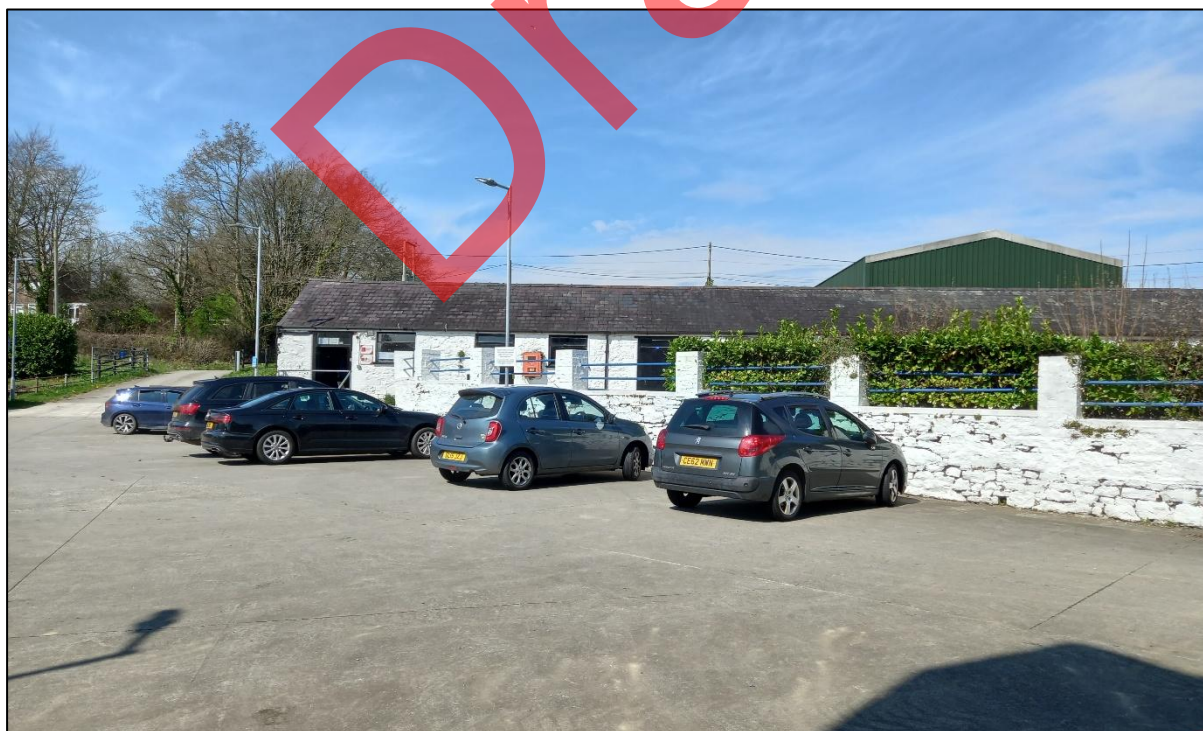
*Plate 12. View north from Pibwr Lwyd Farmhouse towards eastern part of the proposed development area, showing stable block.*
