LAND AT CARMARTHEN WEST

Site Investigation Report

14439/JM/25/SI

CLIENT: Lovell Partnerships

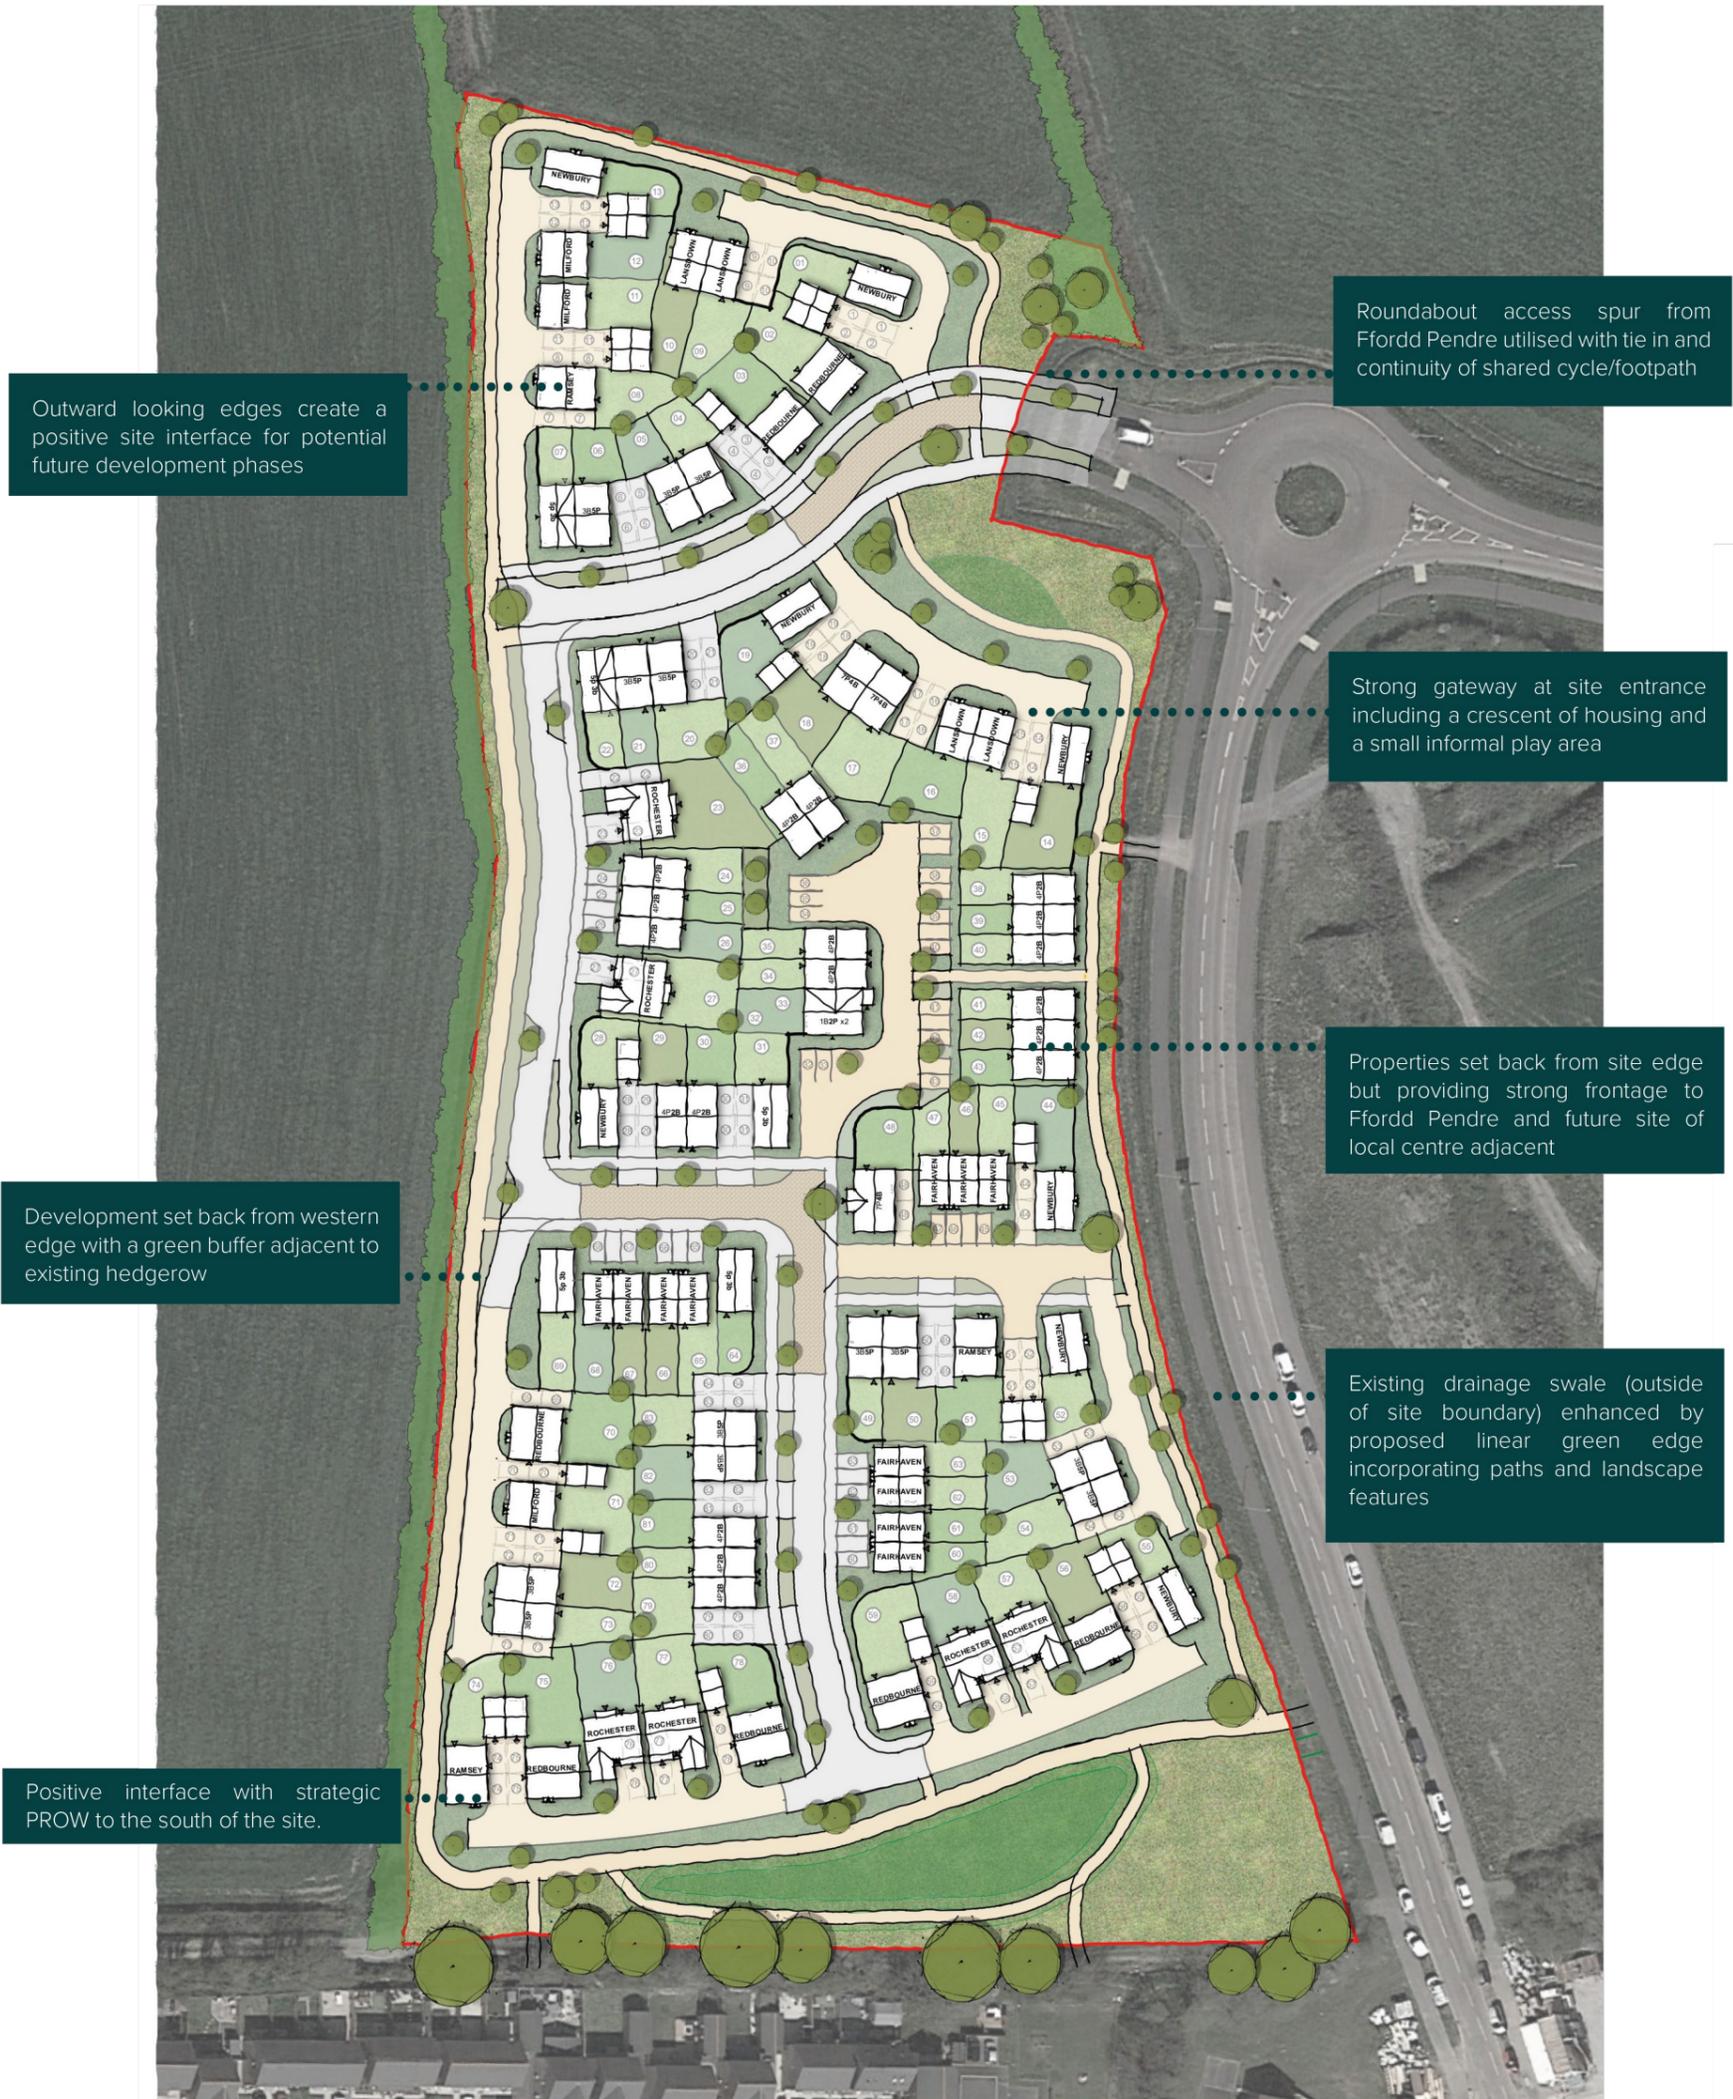
Question 3: Placemaking, Site Tenures & Phasing: 3.1 Proposed Masterplan

Land at Carmarthen West
Residential Development Opportunity
