Parc Pelenna Holiday Resort

Phase 1 Ground Conditions Desk Study

For Trivselhus UK

Doc ref: 16044-HYD-XX-XX-RP-GE-1000

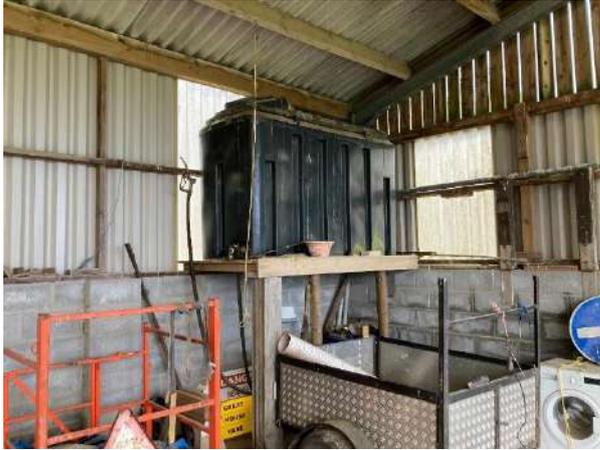
Figure 2.3: Above ground fuel storage tank in the farm building in the south-central area of the site.

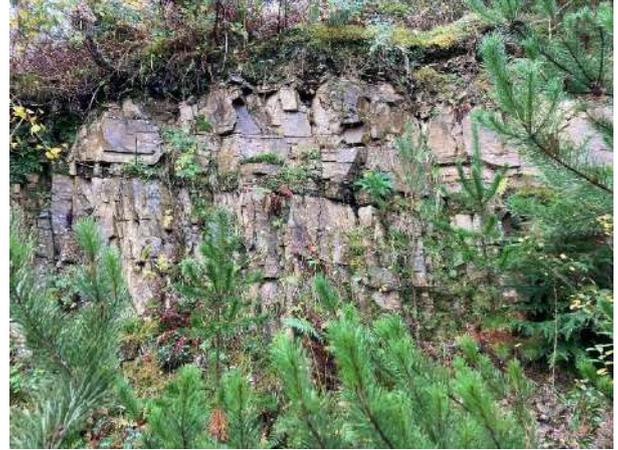
Figure 2.4: Sandstone bedrock exposure in the northwest of the site.

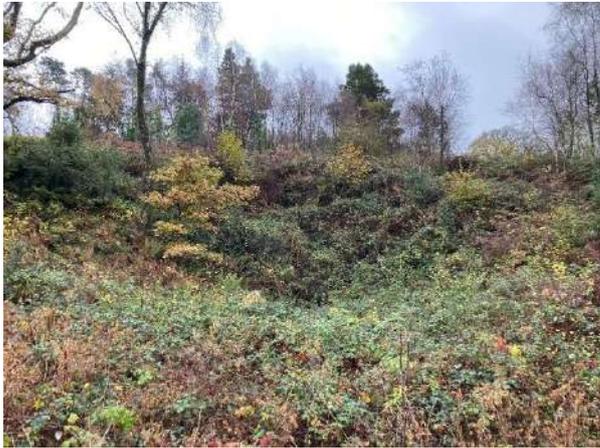
Figure 2.5: Site of the historical Cefn-mawr Colliery.

It is likely that shallow coal seams would have been worked on site and within the vicinity due to the general absence of superficial deposits. However, historical maps indicate that sluice valves came from the area of mining on site which may signify the presence of large volumes of water which needed to be pumped from the workings. This could have caused issues for the potentially extensive shallow workings.

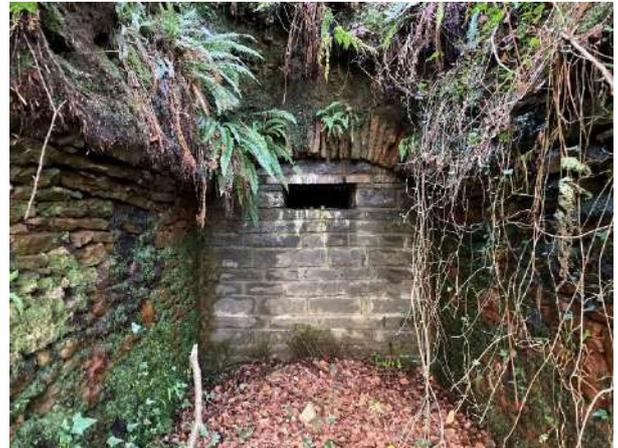
Figure 2.6: Mine adit in the north of the site.

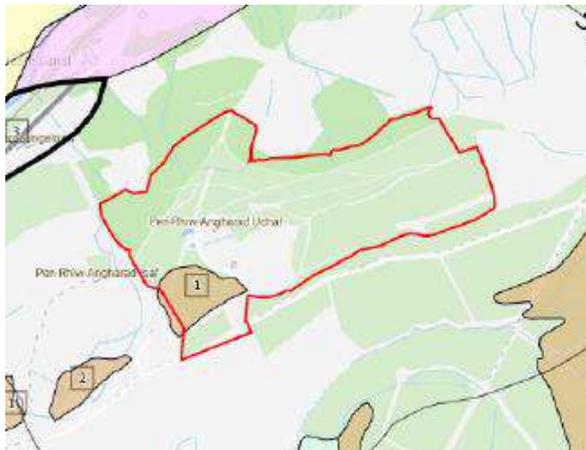
Figure 2.7: Superficial deposits.

Ref. for Figures	Location	Stratigraphic Name	Description
Superficial Deposits (Figure 2.7)			
1	On site (west).	Peat	Partially decomposed mass of semi-carbonised vegetation.
Solid Geology (Figure 2.8)			
8	On site.	Hughes Member	Green-grey 'Pennant sandstones' with thin mudstones/siltstone, seatearth interbeds and thin coals.
6	On site.	Brithdir Member	Green-grey 'Pennant sandstones' with thin mudstones/siltstone, seatearth interbeds and thin coals.

Superficial deposits are generally absent across the site except for a pocket of Peat in the west. These deposits are likely to act as sponge for surface water and gradually release it into the surrounding ground. The BGS Infiltration SuDS report supports this and shows the mapped superficial deposits to be poorly draining.

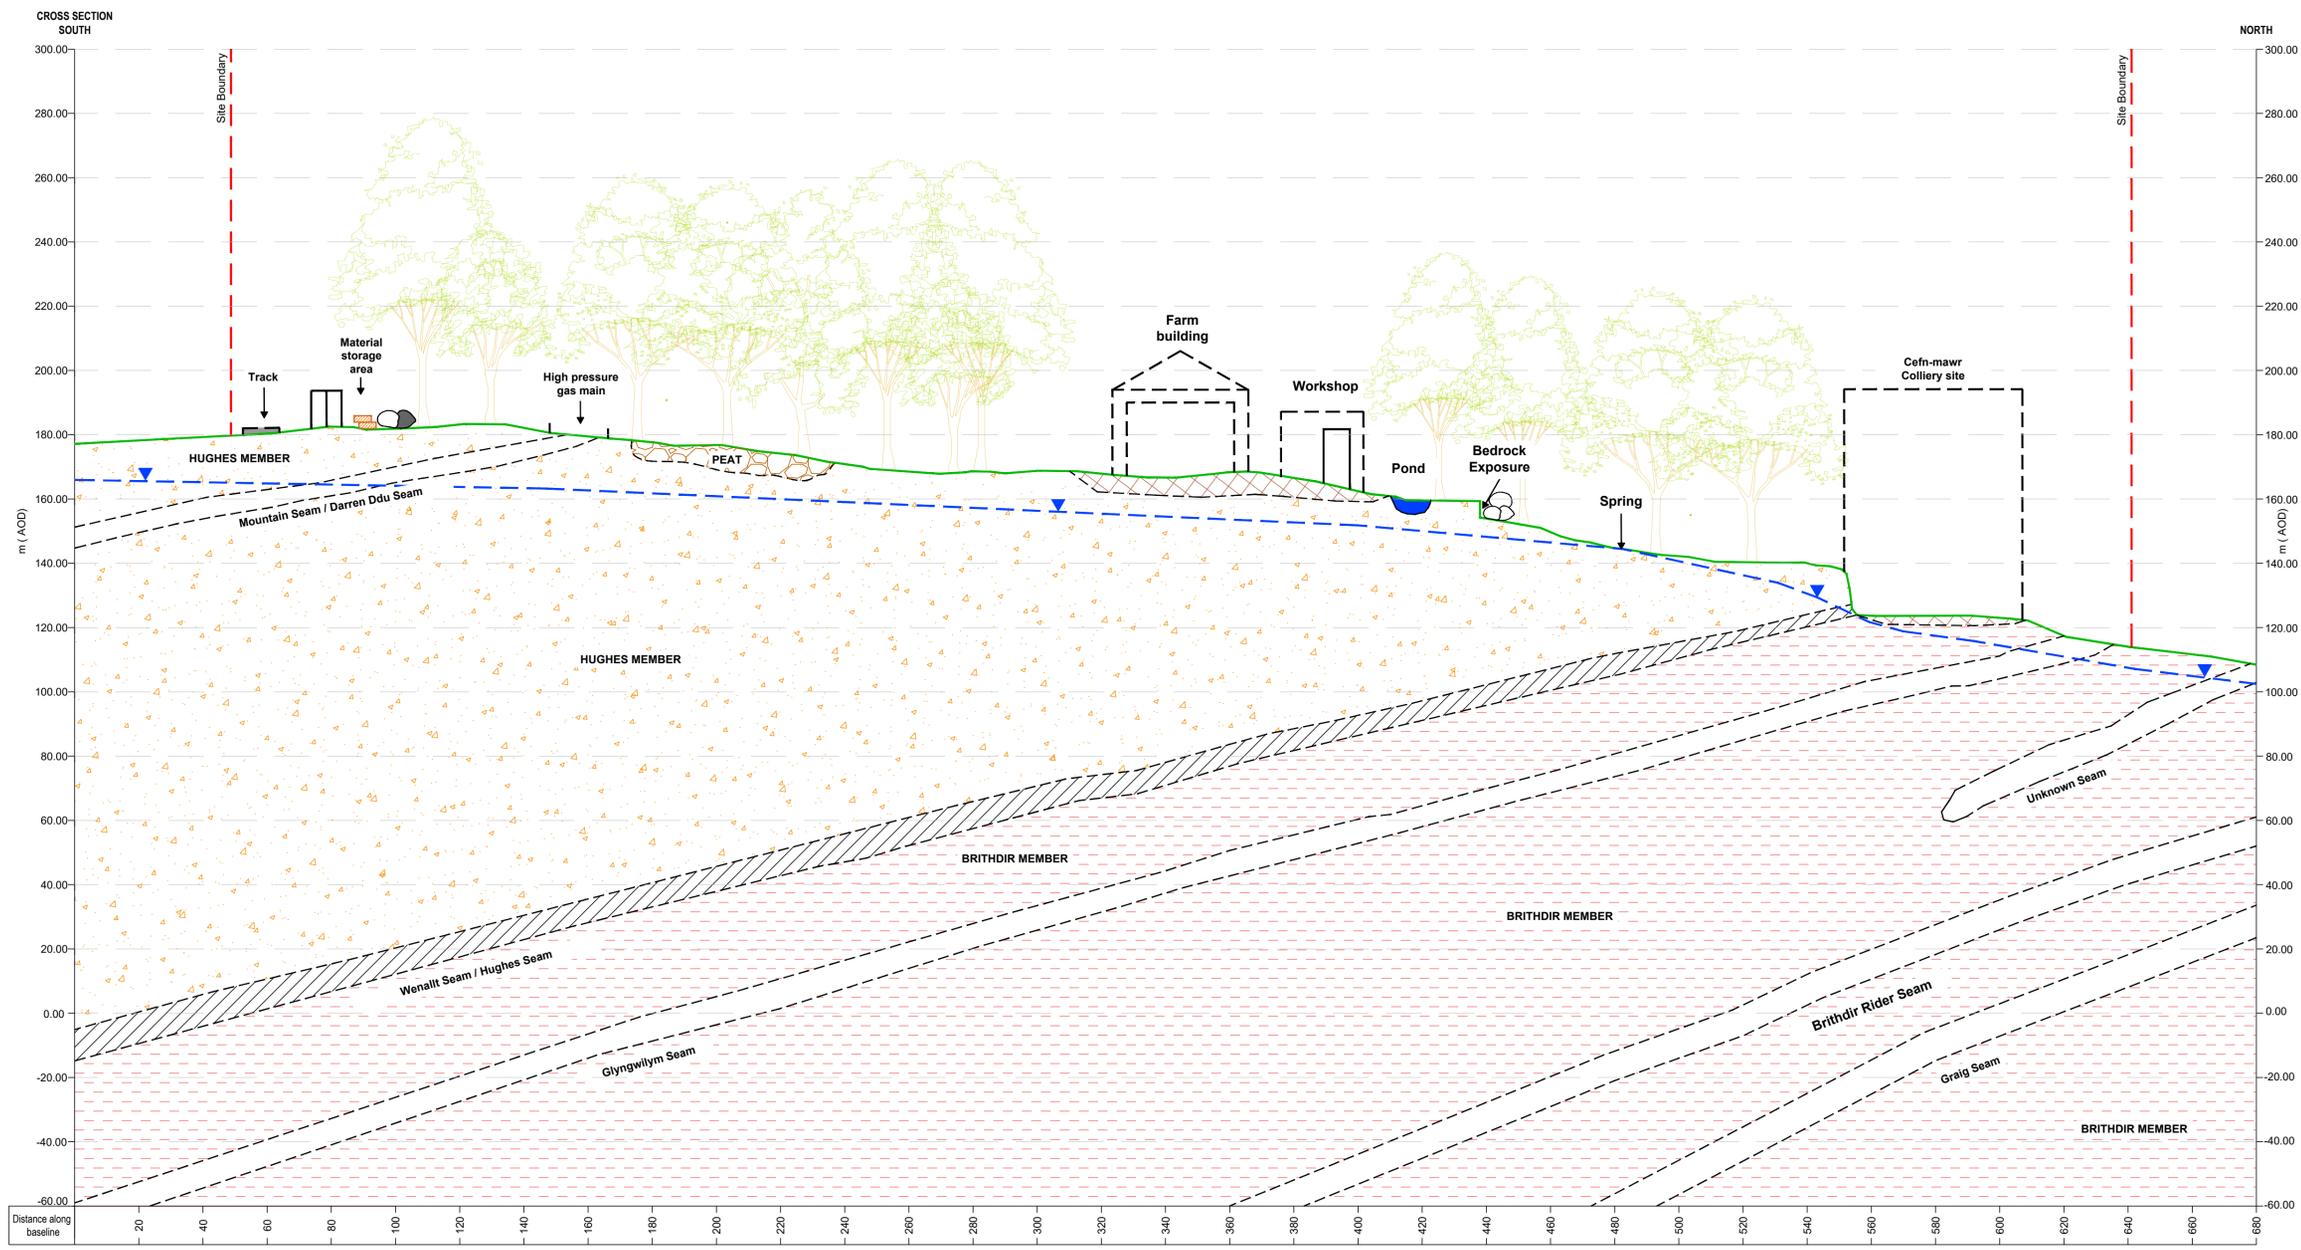
TITLE SITE WALKOVER PLAN	
HYDROCK PROJECT NO. C-16044	SCALE @ A3 1:3,300
PURPOSE OF ISSUE SUITABLE FOR INFORMATION	STATUS S2
DRAWING NO. (PROJECT CODE-ORIGINATOR-ZONE-LEVEL-TYPE-ROLE-NUMBER) 16044-HYD-XX-XX-DR-GE-1001	REVISION P01

- Existing ground profile
- Conjectural geological boundary
- Conjectural groundwater level
- Made Ground
- Peat
- Hughes Member
- Brithdir Member
- Coal seam
- Known worked coal seam

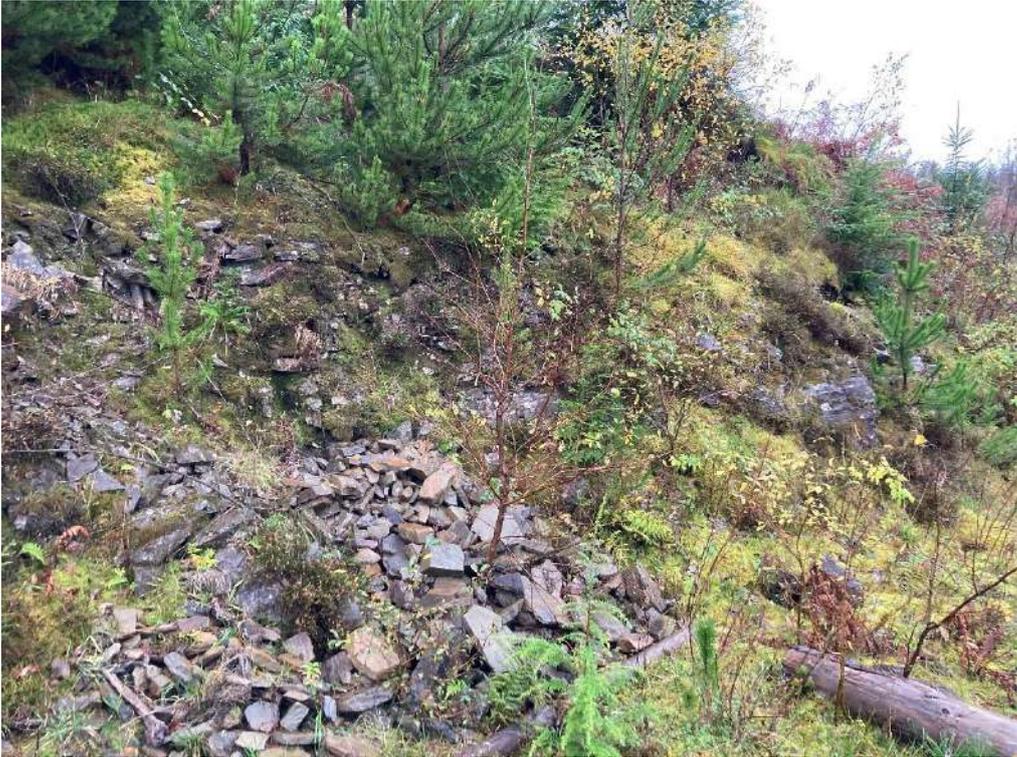
Desk Study Photograph 1

Date: 14/11/23	
Direction Photograph Taken: Southeast.	
Description: Exposure of superficial weathered bedrock ~60-degree slope. Likely cut during track construction.

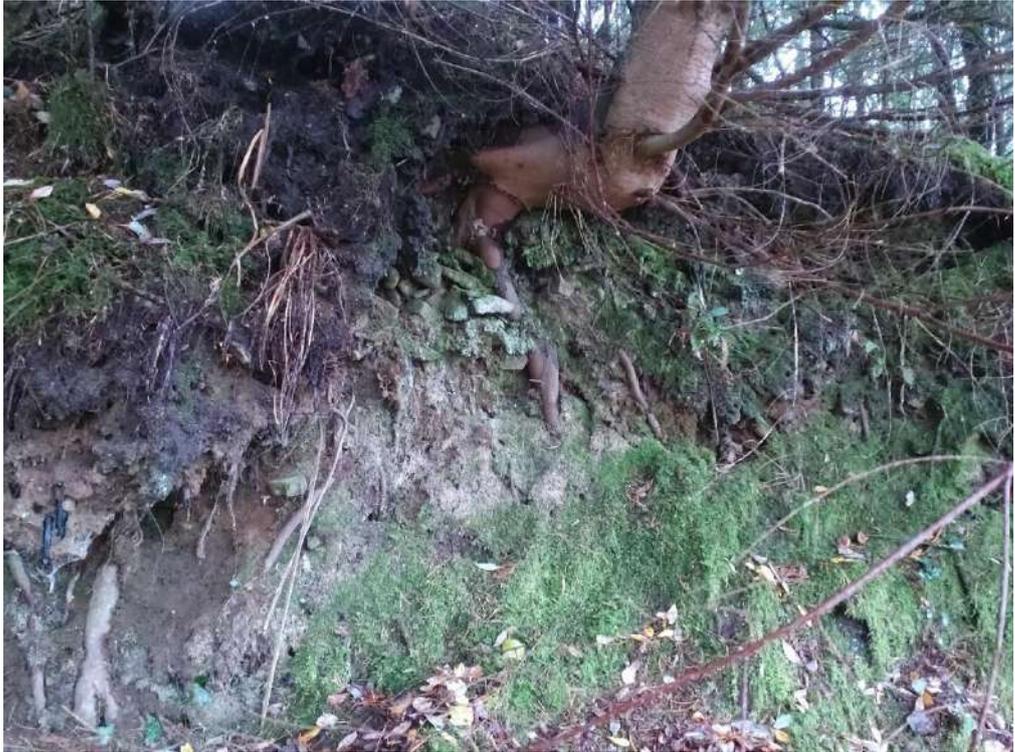
Desk Study Photograph 5

Date: 14/11/23	
Direction Photograph Taken: Southeast.	
Description: Track cutting exposing superficial weathered bedrock. 2m to 3m high and appeared unstable.

Generally, given the absence of superficial deposits on site it is unlikely to be unstable. However, the site generally slopes steeply towards the north and during the site walkover it was noted that there was a thickness of weathered bedrock and superficial deposits on some of the slopes. Slopes, in places, appeared unstable as there was evidence of localised unravelling and distinct slip surfaces. Elsewhere, during the site walkover the ground conditions in the east and west of the site, in the areas of plantation forests, were extremely boggy and soft. In the far west this also coincides with the area of mapped superficial Peat.

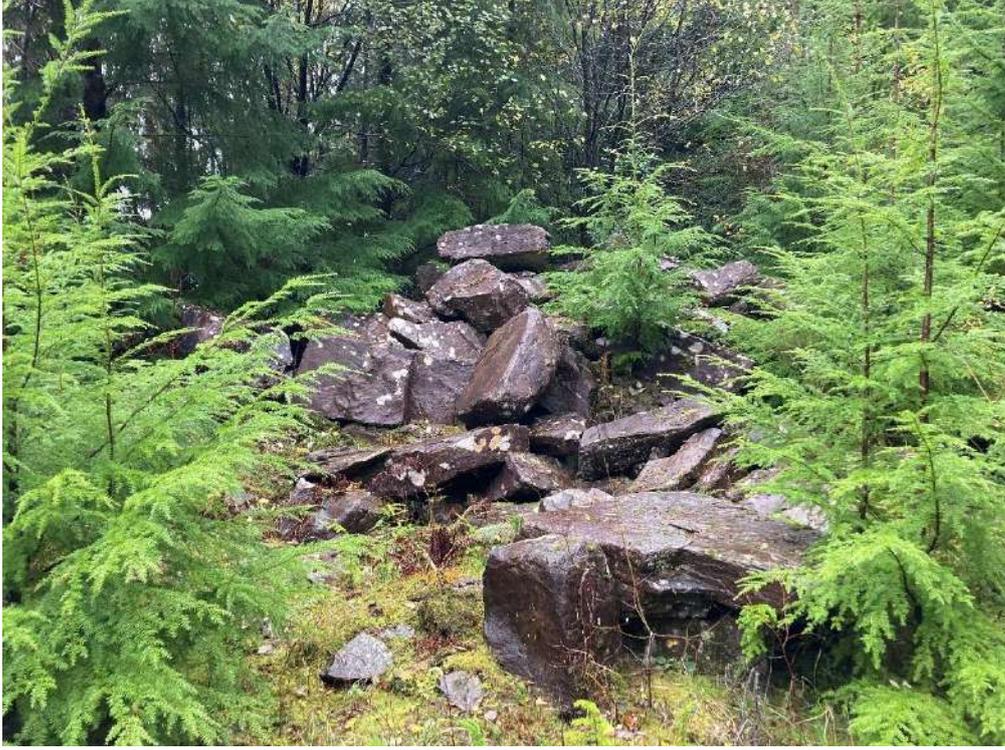
Desk Study Photograph 7

Date: 14/11/23	
Direction Photograph Taken: East.	
Description: Pile of sandstone blocks at the base of the disused quarry.

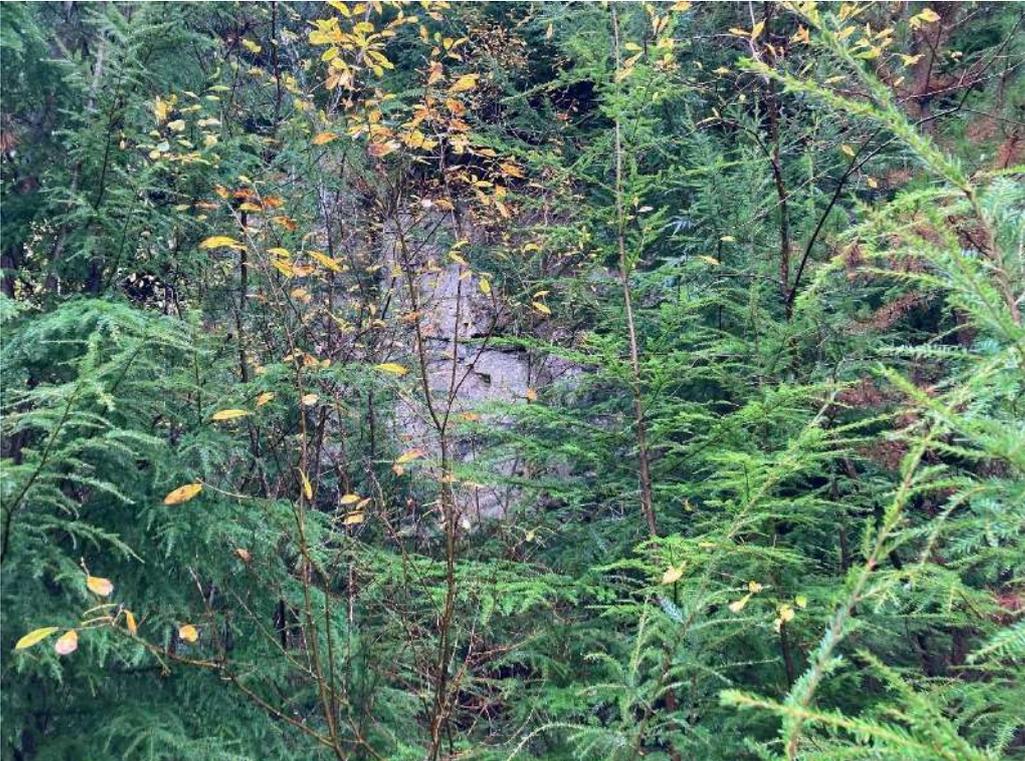
Desk Study Photograph 8

Date: 14/11/23	
Direction Photograph Taken: Southeast.	
Description: walls of the disused quarry. 10m to 15m high, competent, thickly bedded sandstone. Vertical to sub-vertical wide joints.

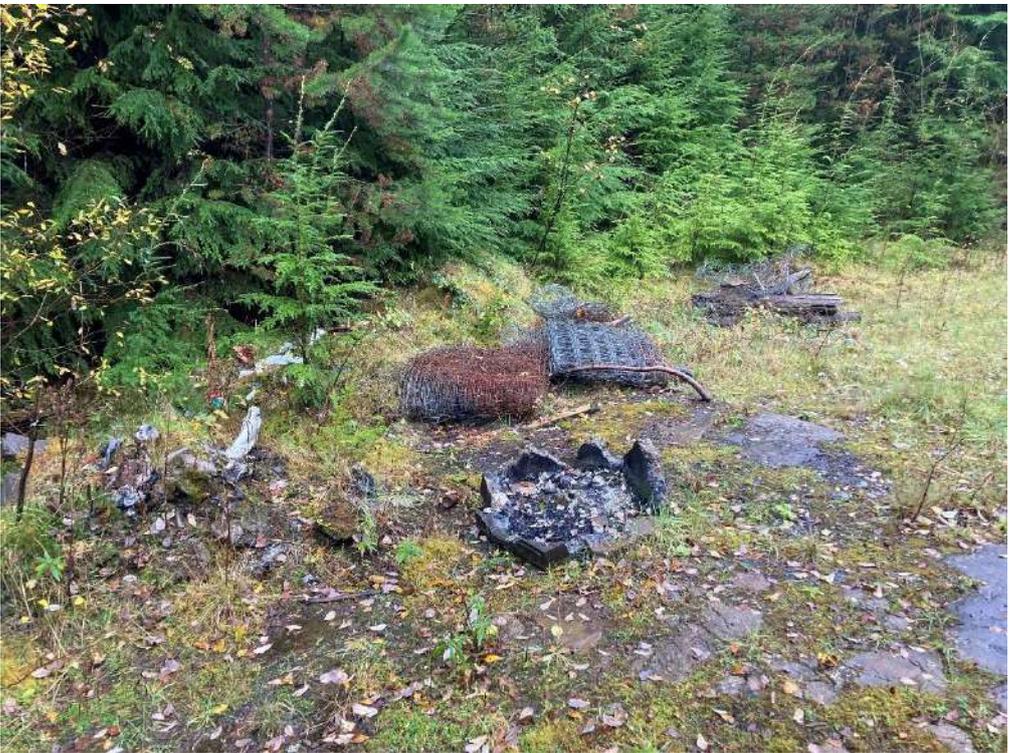
Desk Study Photograph 10

Date: 14/11/23	
Direction Photograph Taken: South.	
Description: pile of waste including burned paint cans, metals and plastics.

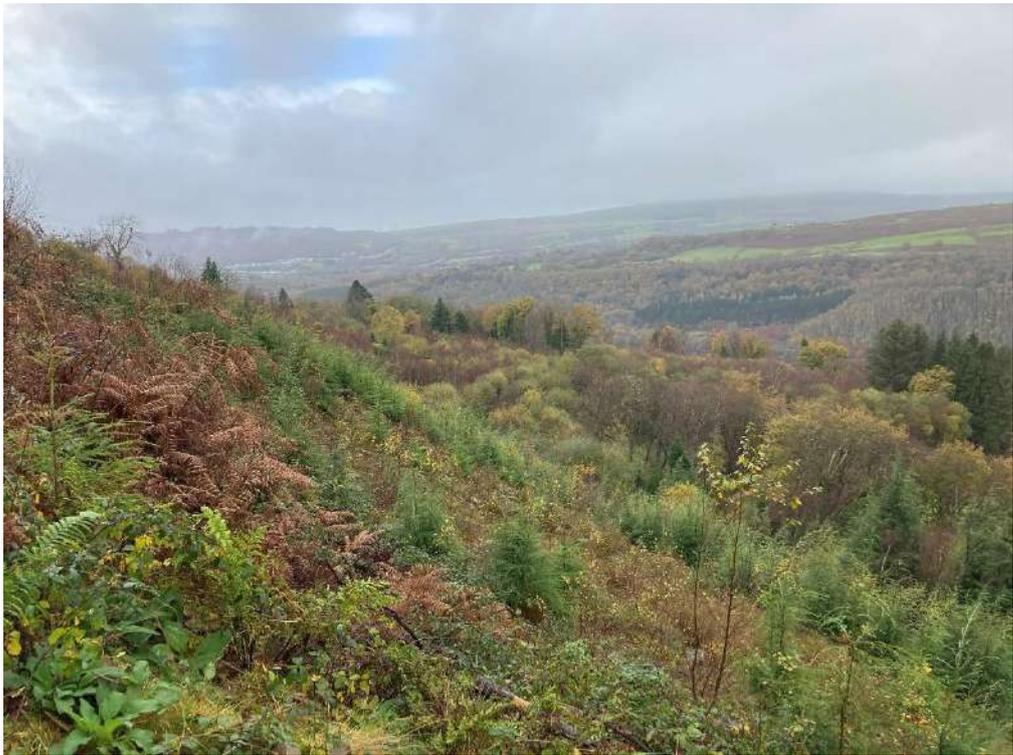
Desk Study Photograph 11

Date: 14/11/23	
Direction Photograph Taken: Northwest.	
Description: Steep slope covered in tree stumps and conifer saplings. Slope was 45 to 70 degrees and steepens to the east.

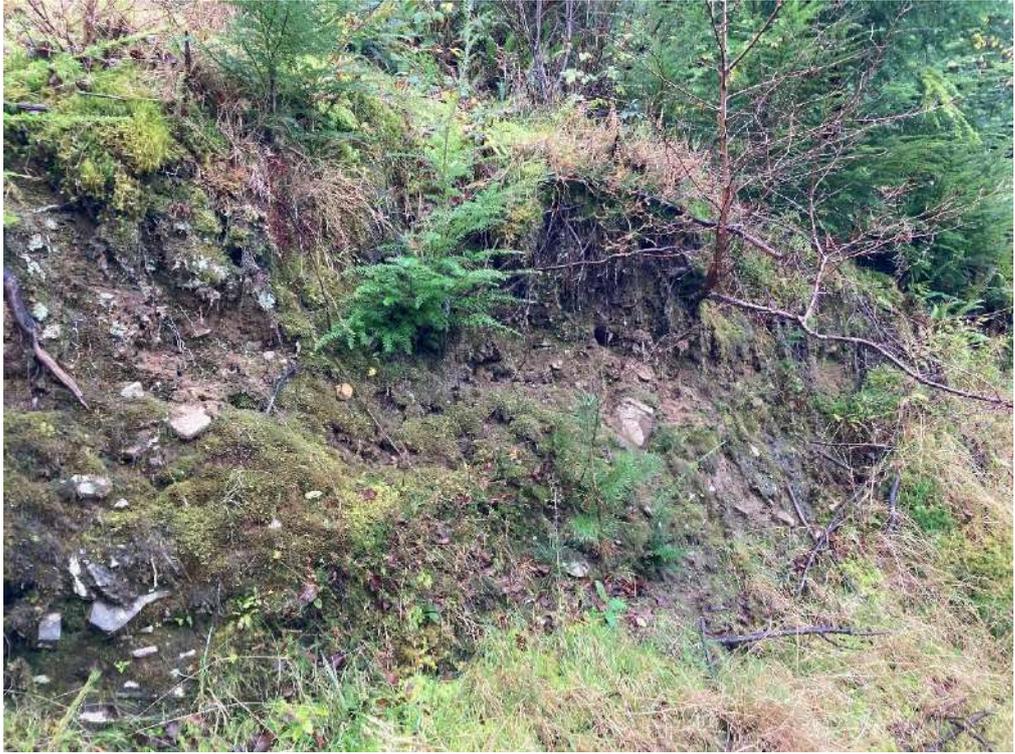
Desk Study Photograph 13

Date: 14/11/23	
Direction Photograph Taken: Southwest.	
Description: weathered superficial bedrock material, likely exposed by cutting for track construction.

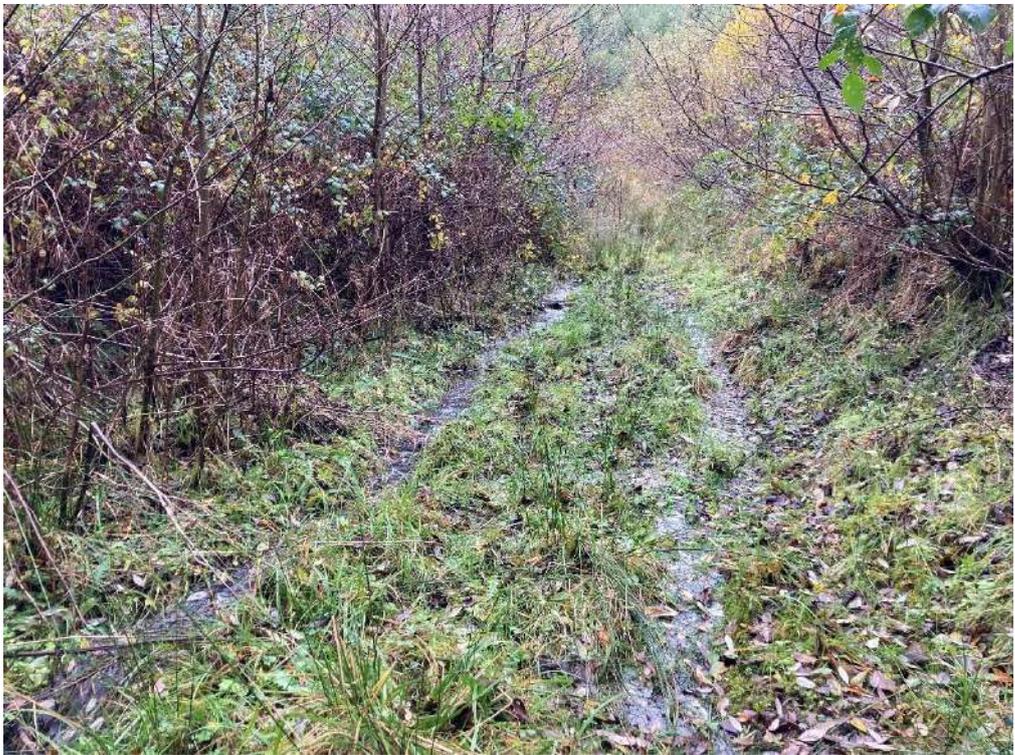
Desk Study Photograph 14

Date: 14/11/23	
Direction Photograph Taken: Southeast.	
Description: Waterlogged ground in the north of the site.

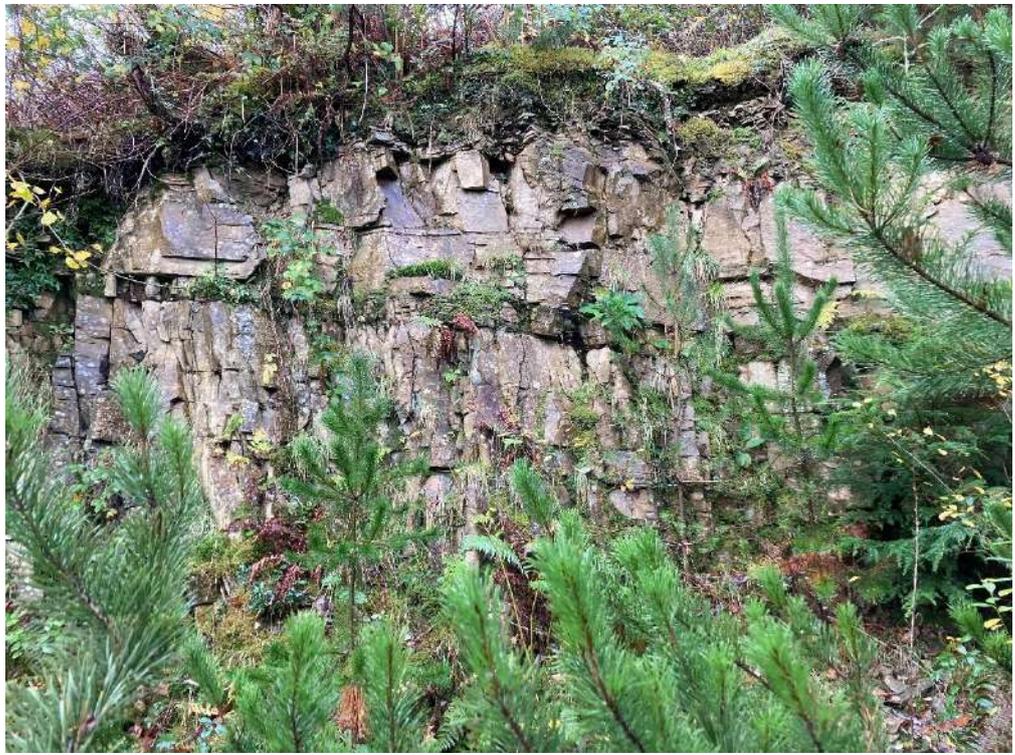
Desk Study Photograph 16

Date: 14/11/23	
Direction Photograph Taken: East.	
Description: bedrock exposure of vertically jointed with possible folding/faulting sandstone. Some conjugate jointing. Appeared unstable.

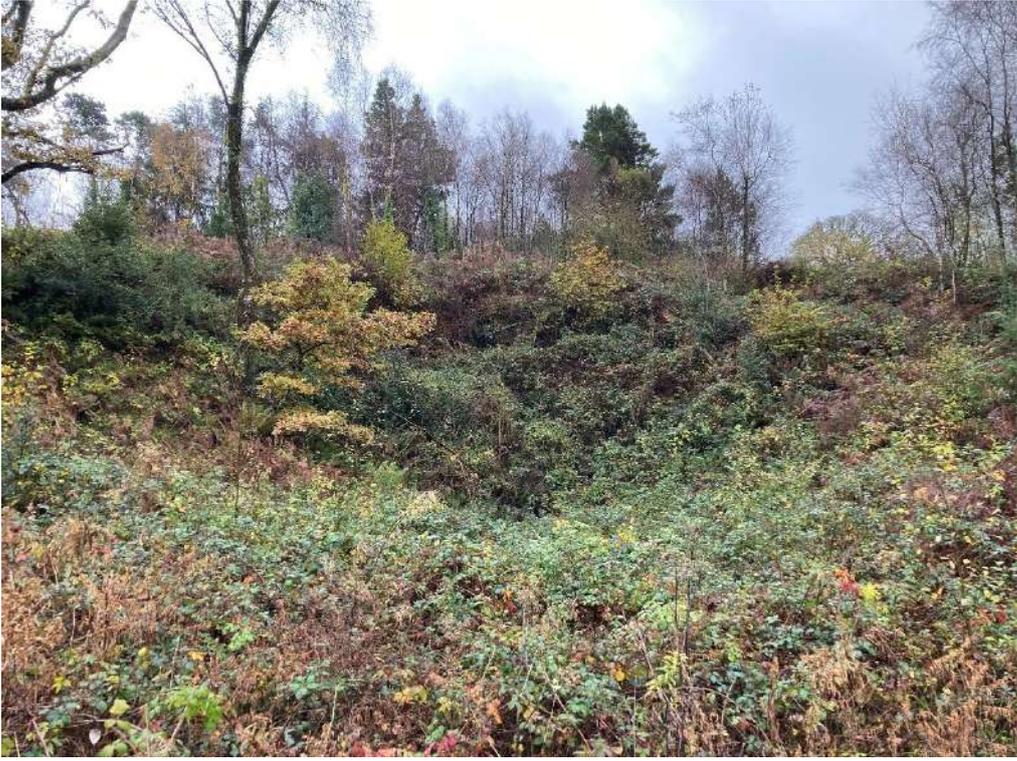
Desk Study Photograph 17

Date: 14/11/23	
Direction Photograph Taken: South.	
Description: Steep curved slope in the north of the site in the area of the former Cefn-mawr Colliery. Roughly 15m to 20m high and densely vegetated.

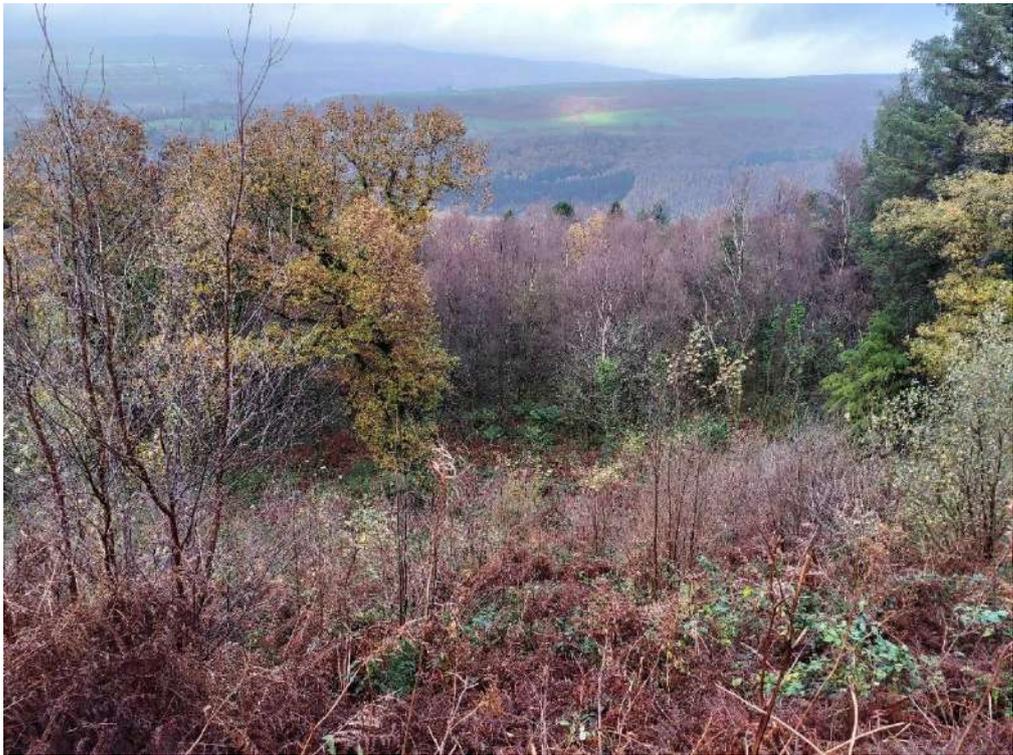
<p>Desk Study Photograph 19</p>

<p>Date: 14/11/23</p>	
<p>Direction Photograph Taken: North.</p>	
<p>Description: Steep slope in the northwest roughly 20 to 40 degrees and densely vegetated.</p>

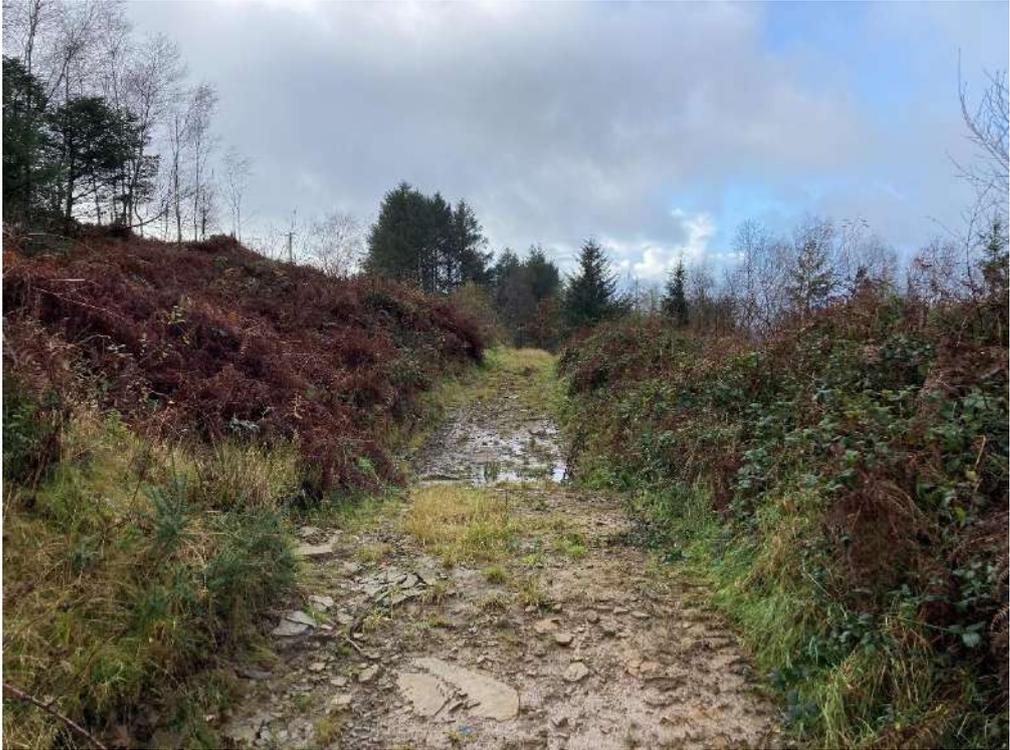
<p>Desk Study Photograph 21</p>

<p>Date: 14/11/23</p>	
<p>Direction Photograph Taken: Northeast.</p>	
<p>Description: Hummocky land in the west of the site along a track.</p>

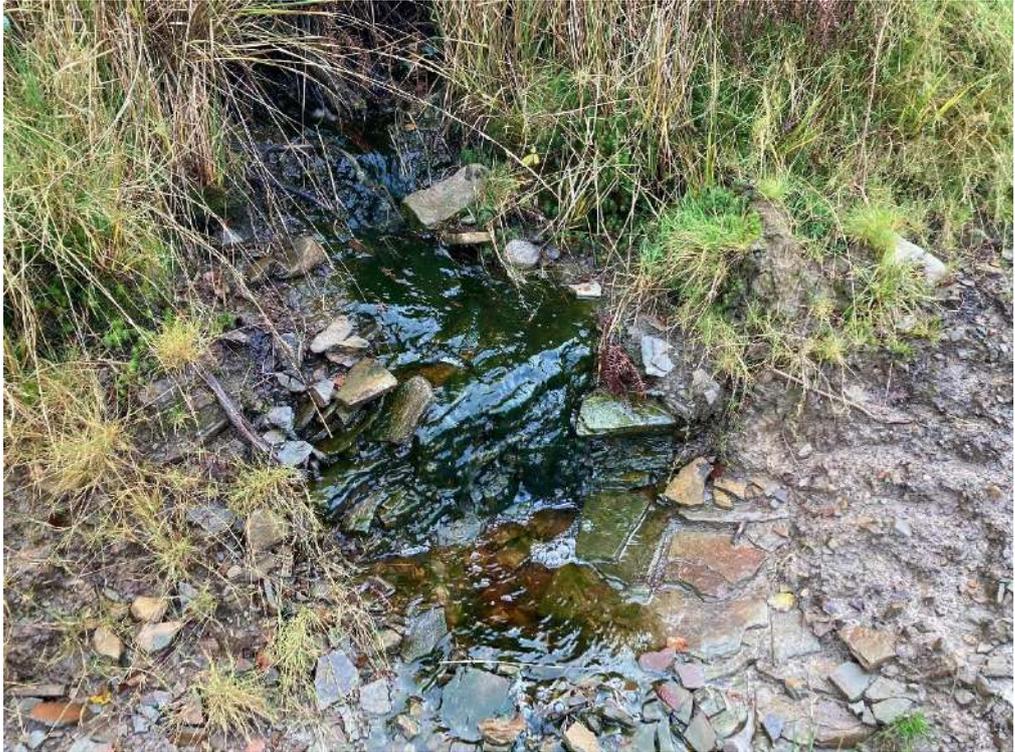
Desk Study Photograph 23

Date: 14/11/23	
Direction Photograph Taken: South.	
Description: Dark runoff indicating possible presence of Peat.

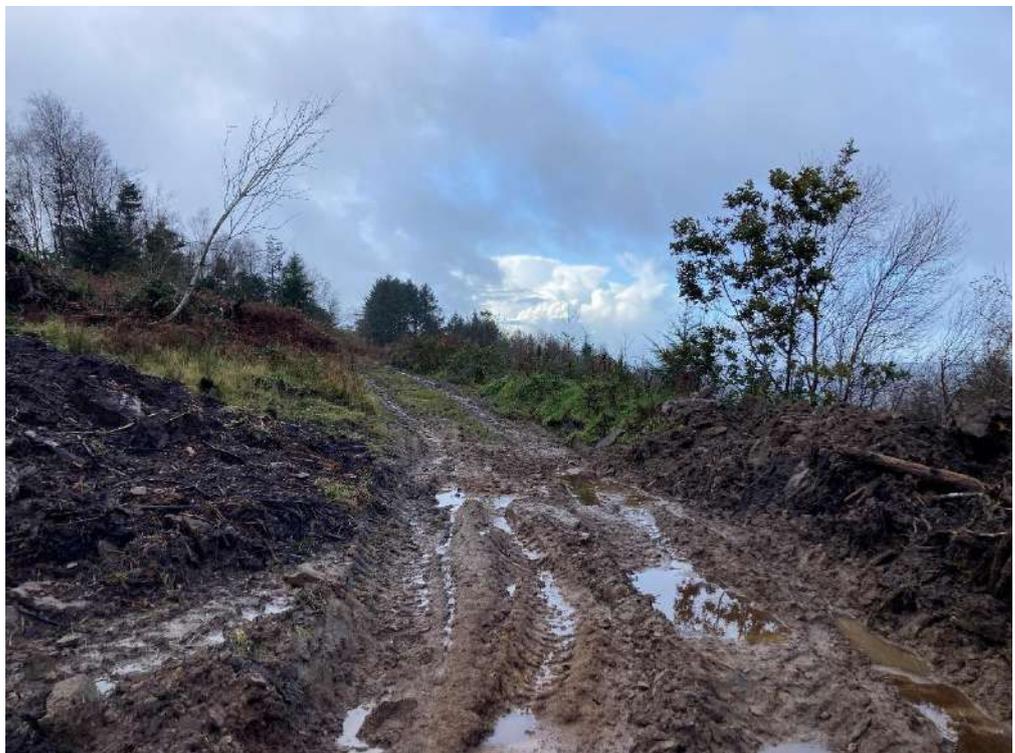
Desk Study Photograph 24

Date: 14/11/23	
Direction Photograph Taken: West.	
Description: Excavated material possibly consisting of Peat.

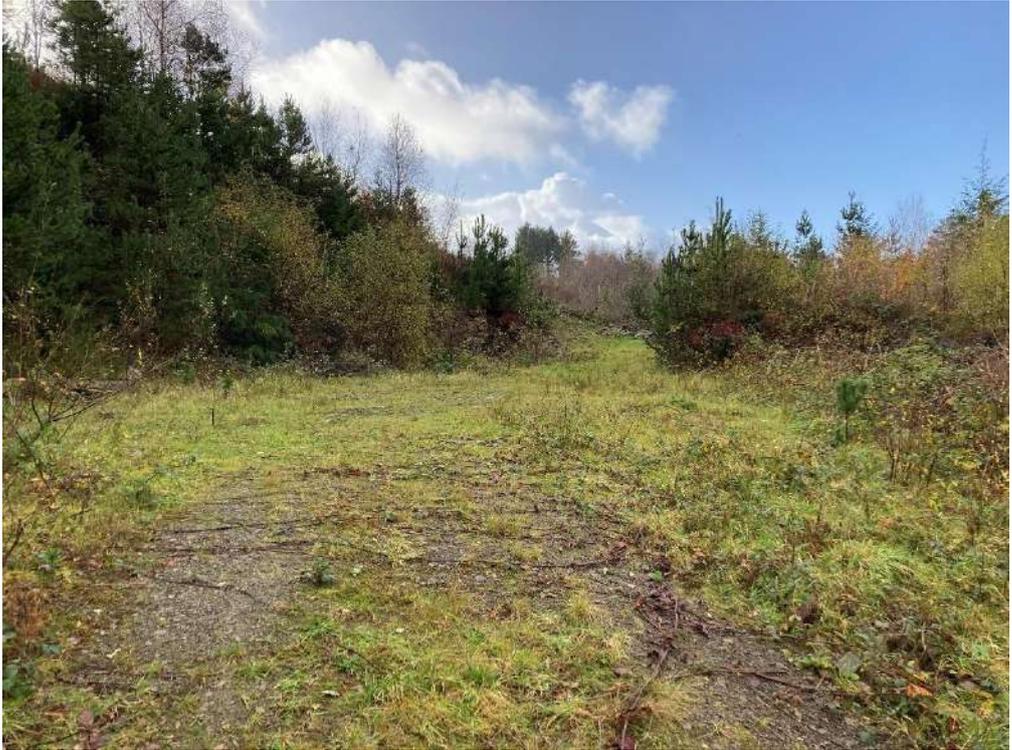
Desk Study Photograph 25

Date: 14/11/23	
Direction Photograph Taken: Southwest.	
Description: Plateau in the central area of the site which appeared to be cut and fill.

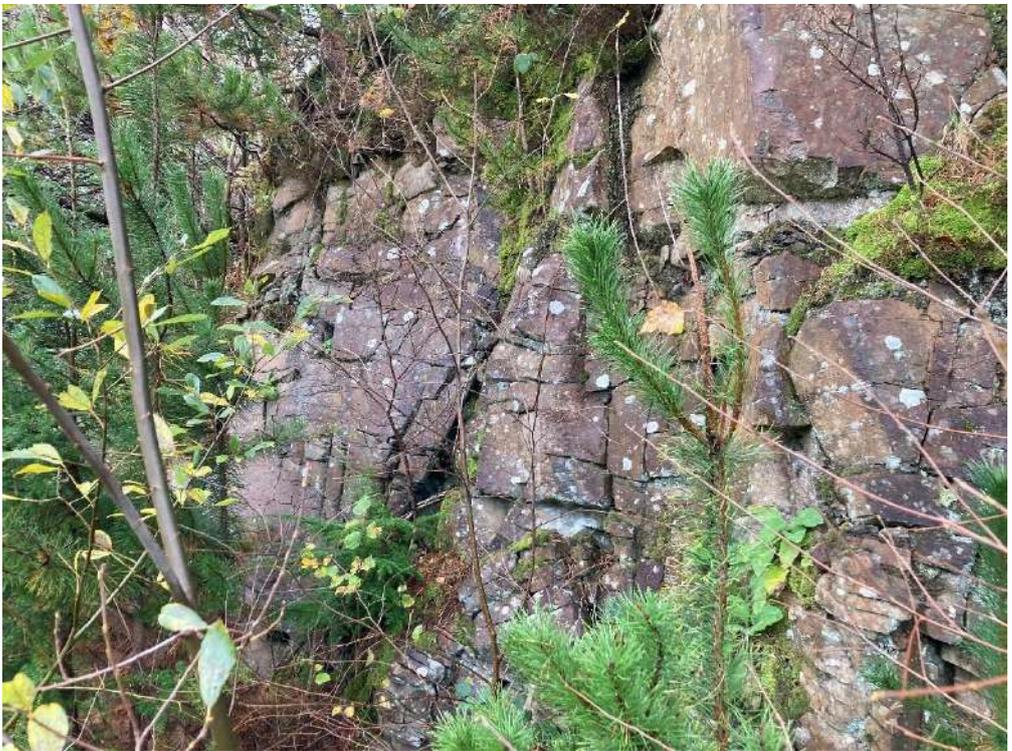
Desk Study Photograph 26

Date: 14/11/23	
Direction Photograph Taken: East.	
Description: Bedrock exposure, thin to thickly bedded, frequently faulted and jointed with some folding. 5m to 15m high. Appeared mostly stable.

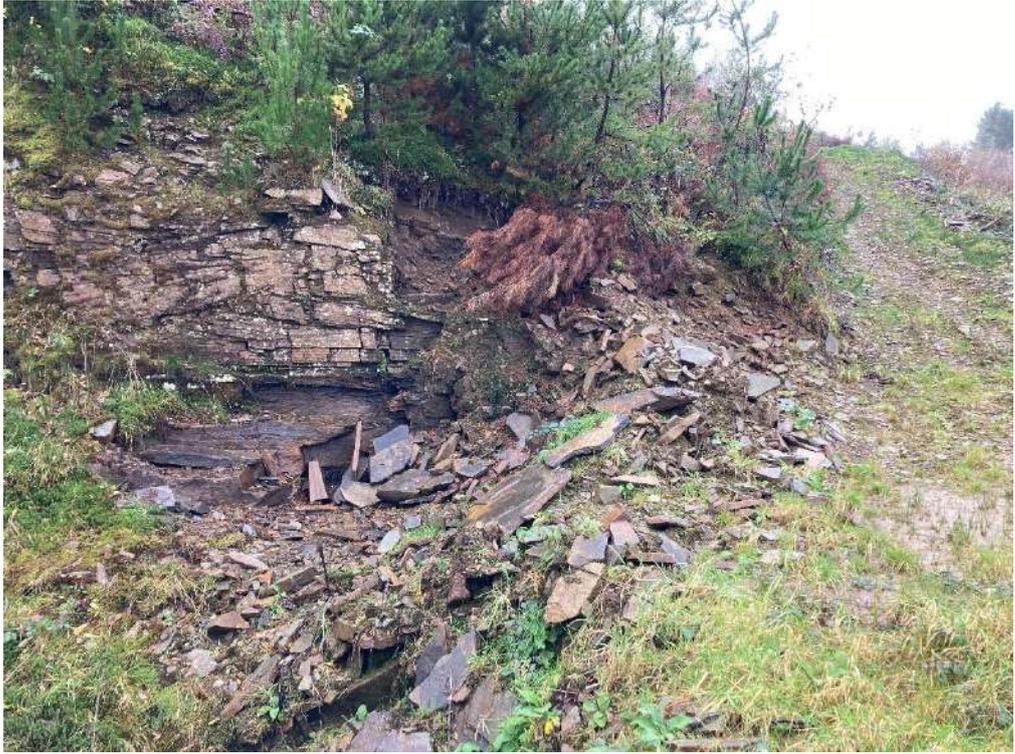
<p>Desk Study Photograph 27</p>

<p>Date: 14/11/23</p>	
<p>Direction Photograph Taken: North.</p>	
<p>Description: Bedrock exposure showing some instability, however this appeared to be human caused.</p>

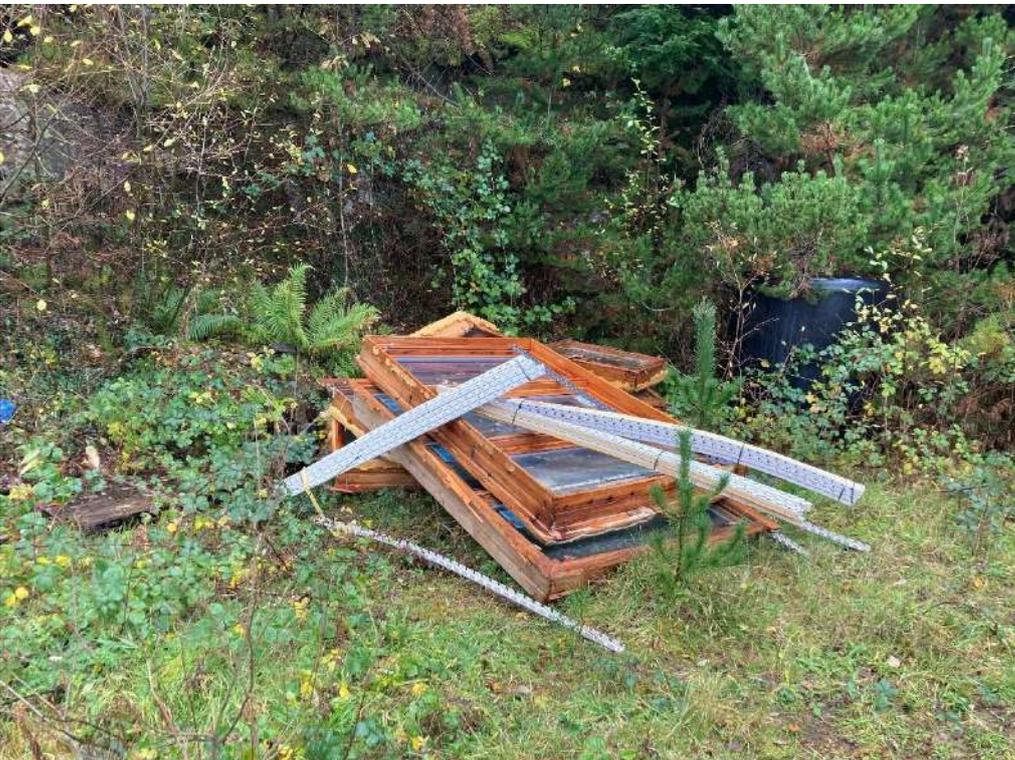
<p>Desk Study Photograph 28</p>

<p>Date: 14/11/23</p>	
<p>Direction Photograph Taken: Southeast.</p>	
<p>Description: Materials and waste stored on the cut and fill plateau in the central area of the site.</p>

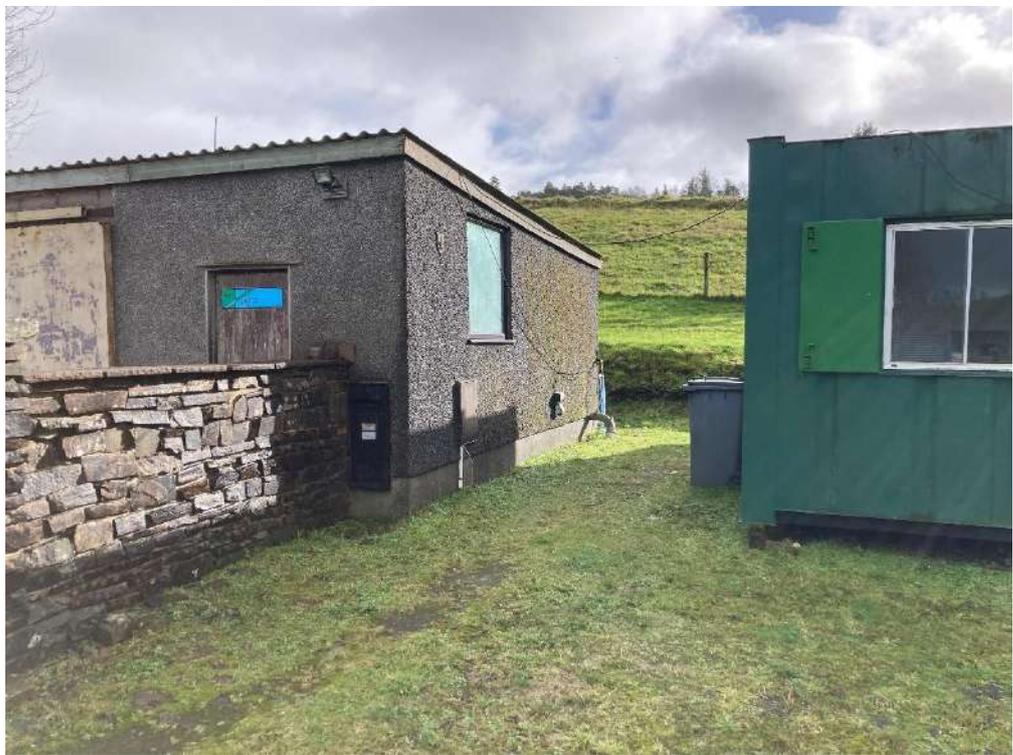
Desk Study Photograph 30

Date: 14/11/23	
Direction Photograph Taken: Southeast.	
Description: Side of the garage / workshop showing an outlet leading from the structure.

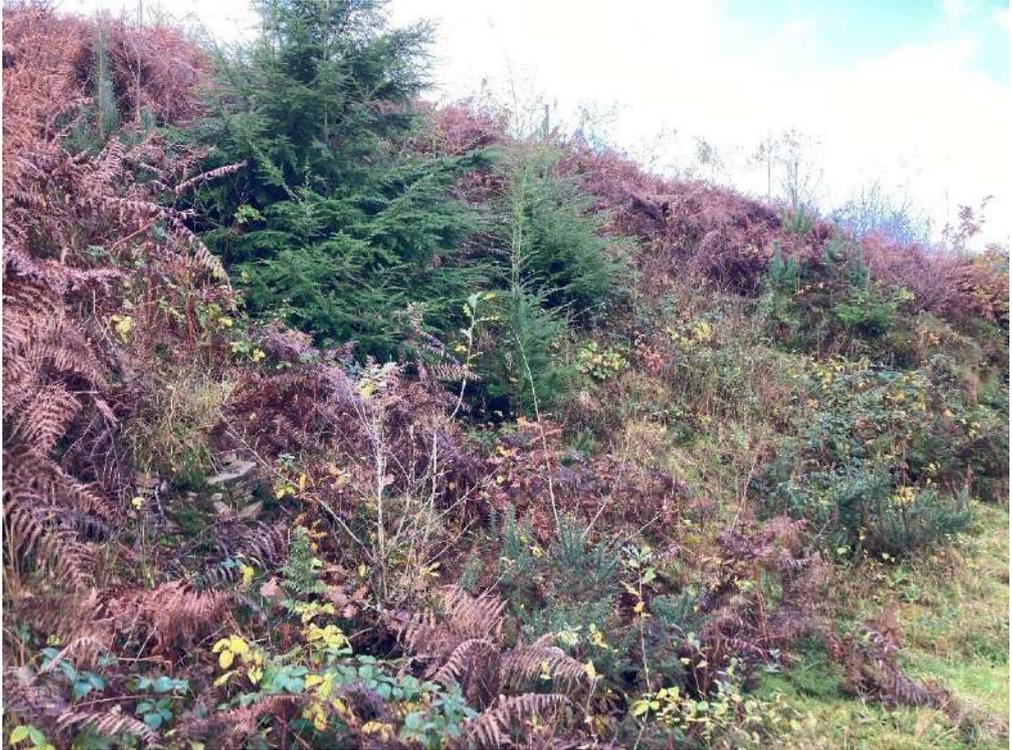
Desk Study Photograph 31

Date: 14/11/23	
Direction Photograph Taken: West.	
Description: Localised shallow circular failure in the slope.

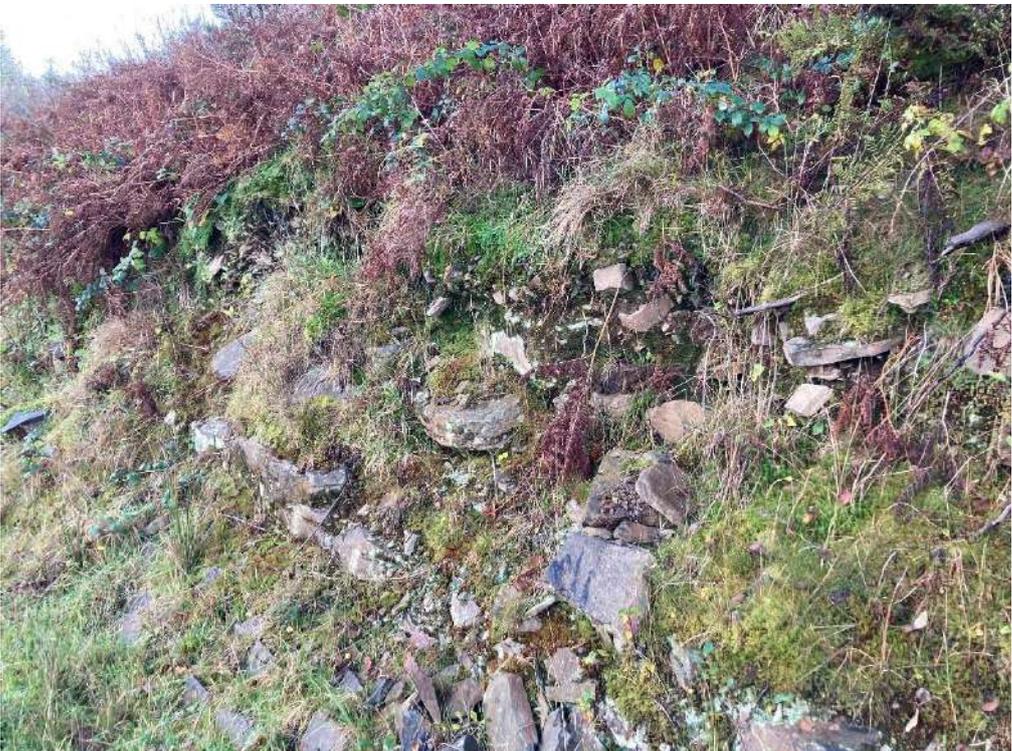
Desk Study Photograph 32

Date: 14/11/23	
Direction Photograph Taken: East.	
Description: Superficial weathered bedrock exposure. 15 to 20 degree slope, roughly 2m high.

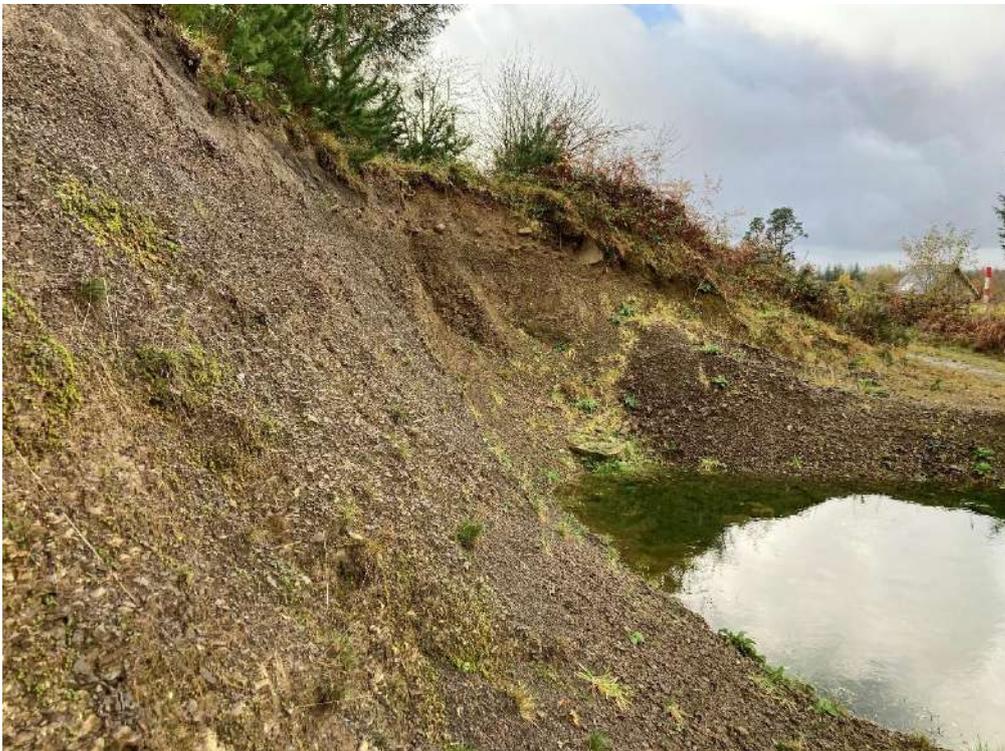
<p>Desk Study Photograph 34</p>

<p>Date: 14/11/23</p>	
<p>Direction Photograph Taken: West.</p>	
<p>Description: Superficial weathered bedrock exposure roughly 3m high with standing water at the base. Appeared fairly stable.</p>
