Parc Pelenna Holiday Resort

Phase 1 Ground Conditions Desk Study

For Trivselhus UK

Doc ref: 16044-HYD-XX-XX-RP-GE-1000

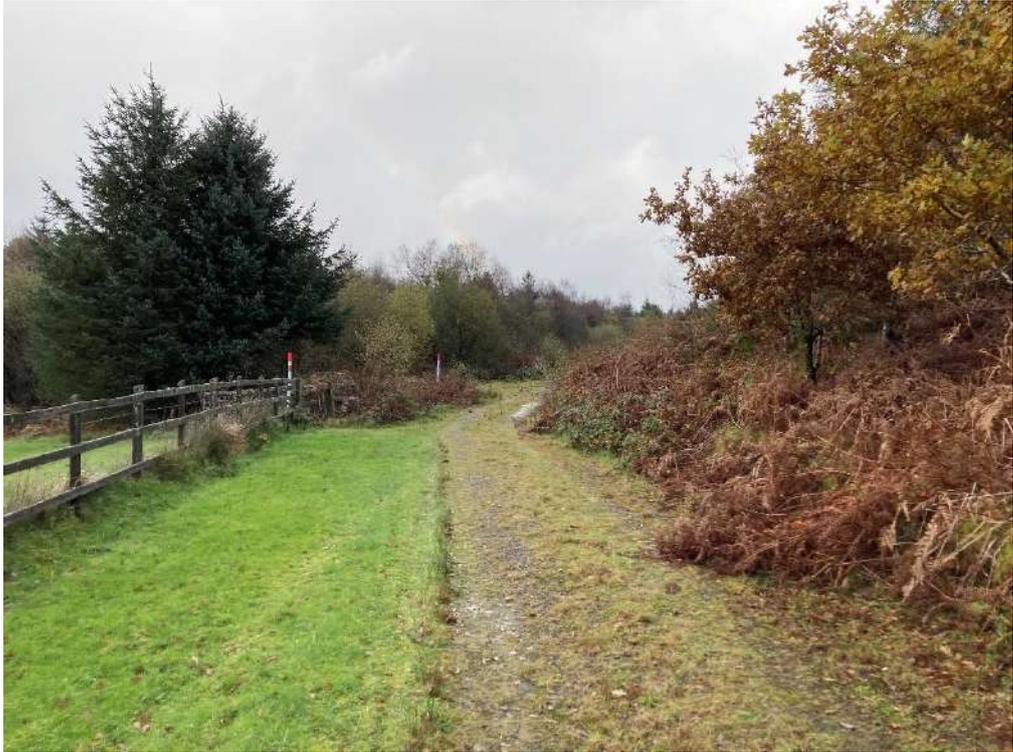
Desk Study Photograph 35

Date: 14/11/23	
Direction Photograph Taken: Northeast.	
Description: Track in the south of the site showing the high-pressure gas main trending east to west.

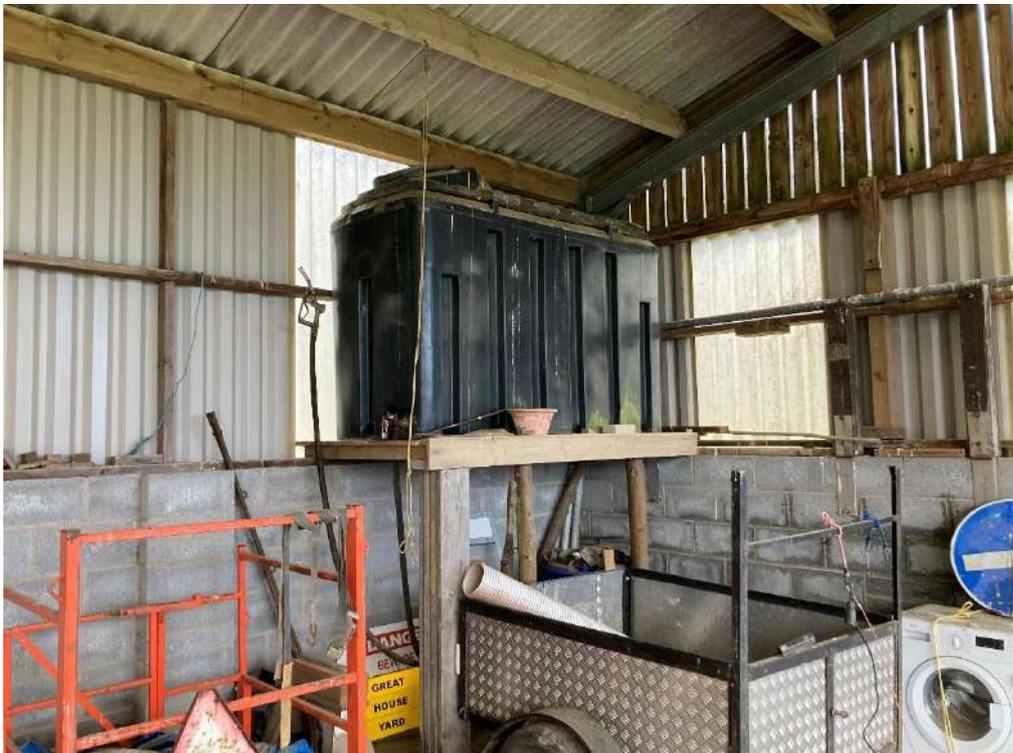
Desk Study Photograph 36

Date: 14/11/23	
Direction Photograph Taken: South.	
Description: Above Ground Storage Tank with a fuelling hose attached in the farm building in the central area of the site. Appeared in good condition with no signs of leaks.

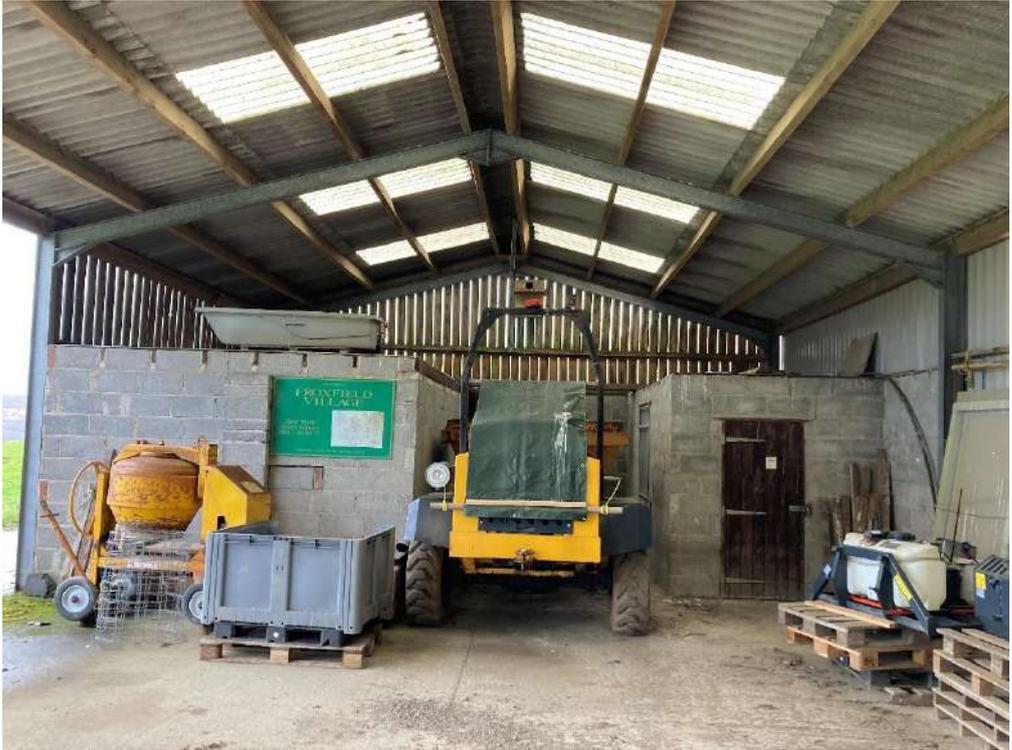
Desk Study Photograph 37

Date: 14/11/23	
Direction Photograph Taken: Northeast.	
Description: Equipment and vehicle storage in the farm building in the central area of the site.

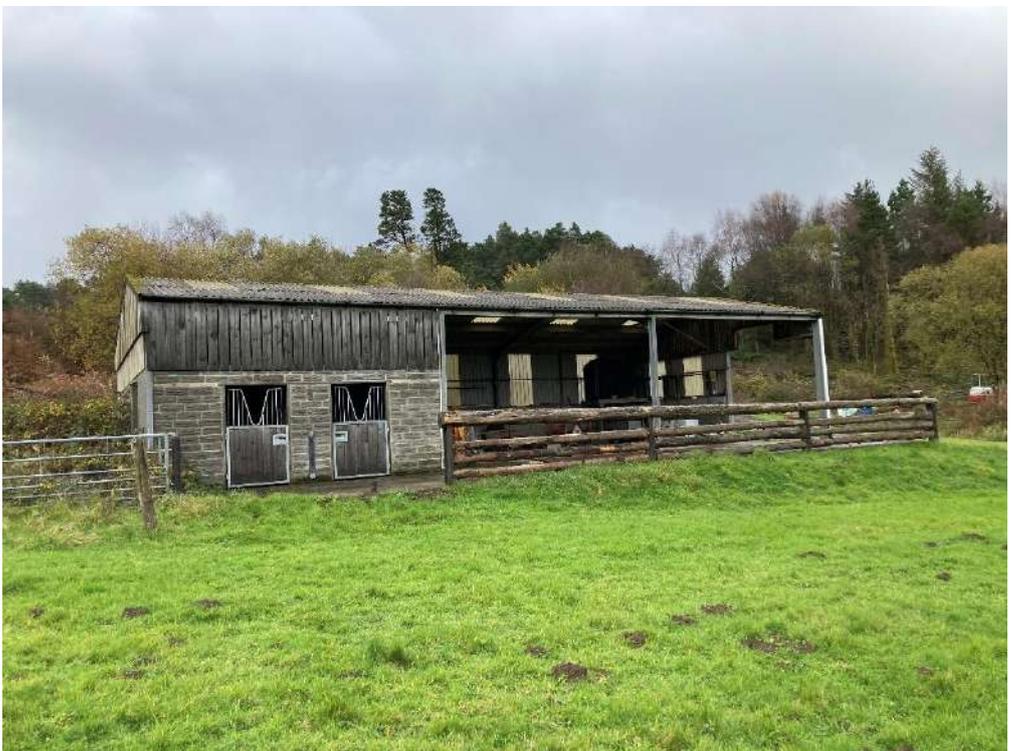
Desk Study Photograph 38

Date: 14/11/23	
Direction Photograph Taken: Southeast.	
Description: Farm building in the south-central area in the site showing the asbestos tiled roof.

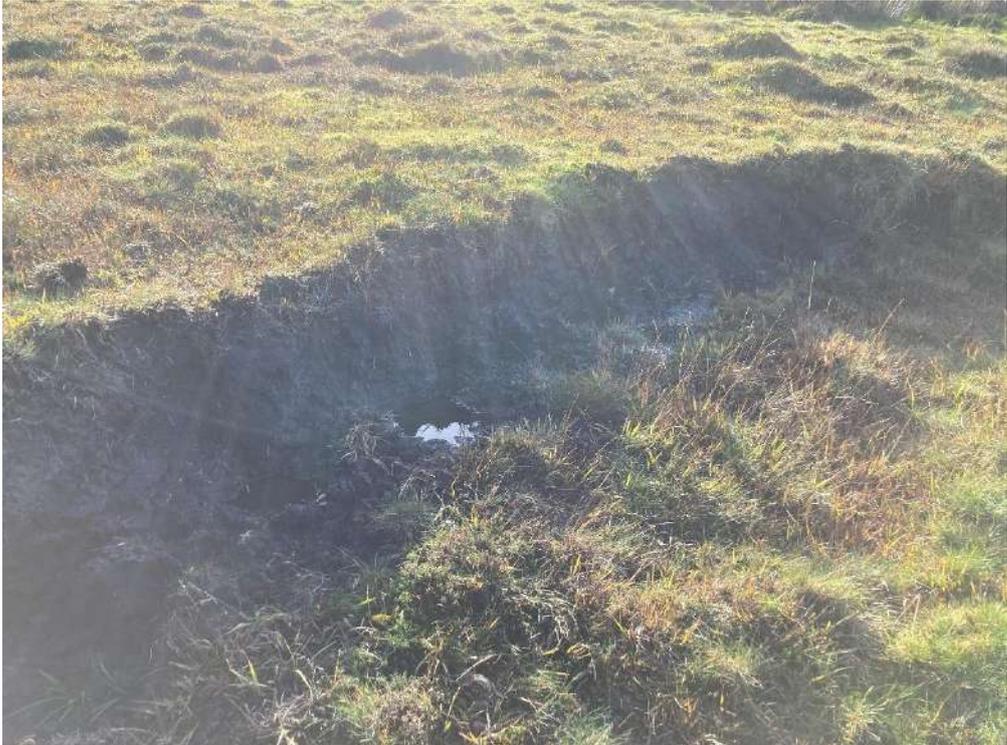
Desk Study Photograph 48

Date: 15/11/23	
Direction Photograph Taken: Northeast.	
Description: Looking northeast across the pathway of the high- pressure gas main.

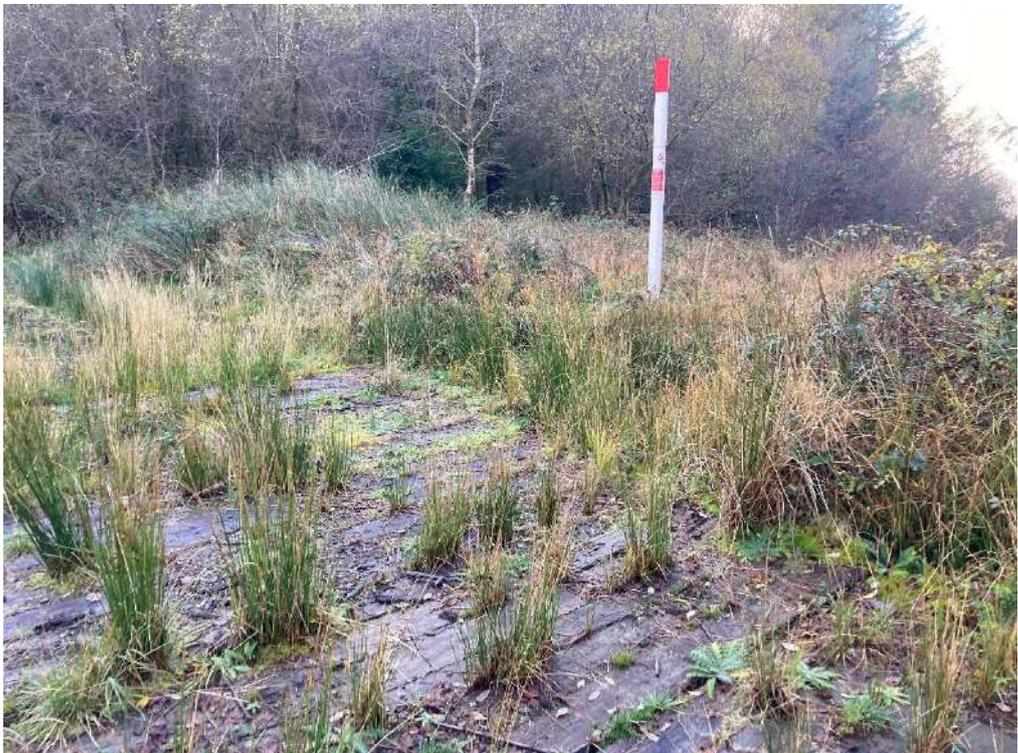
<p>Desk Study Photograph 50</p>

<p>Date: 15/11/23</p>	
<p>Direction Photograph Taken: Southwest.</p>	
<p>Description: Wooden planked bridge crossing over the high-pressure gas main.</p>

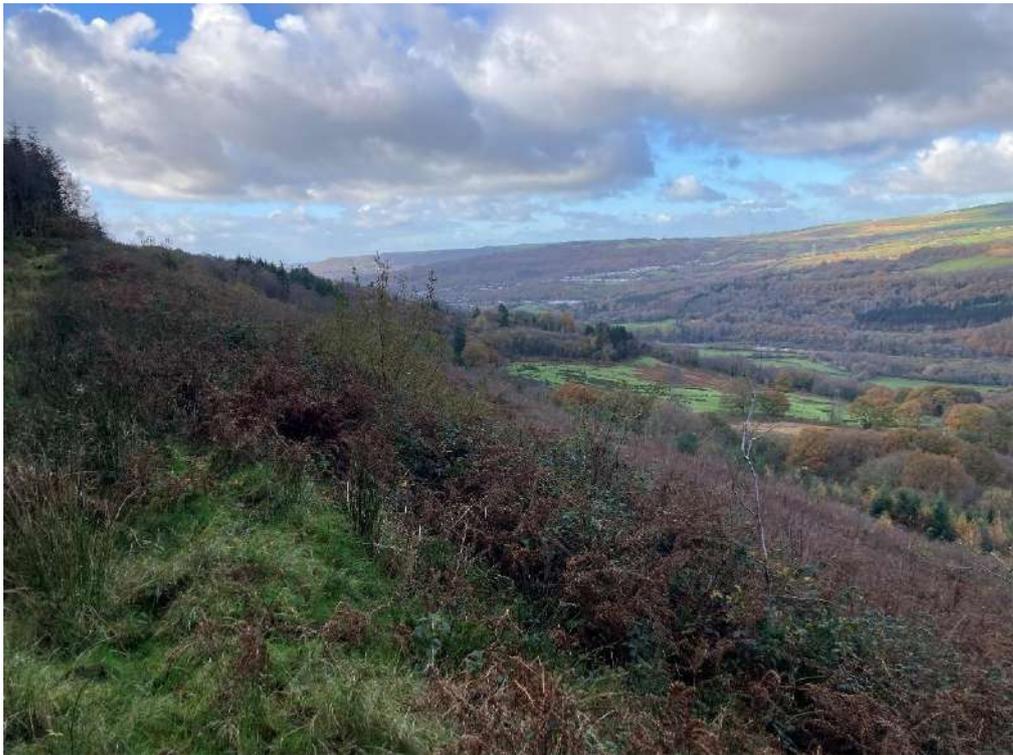
Desk Study Photograph 52

Date: 15/11/23	
Direction Photograph Taken: East.	
Description: Looking east across the lands at the eastern boundary. Note the ancient woodland in the left side of the photograph.

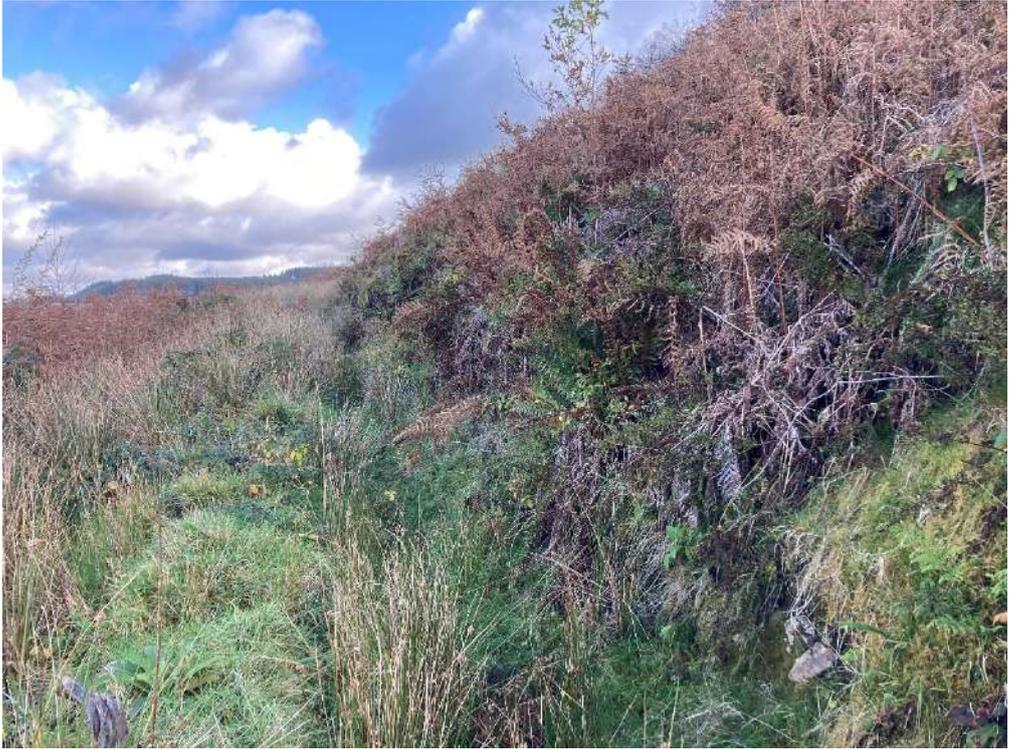
Desk Study Photograph 54

Date: 15/11/23	
Direction Photograph Taken: South.	
Description: Close- up of the exposed superficial weathered bedrock.

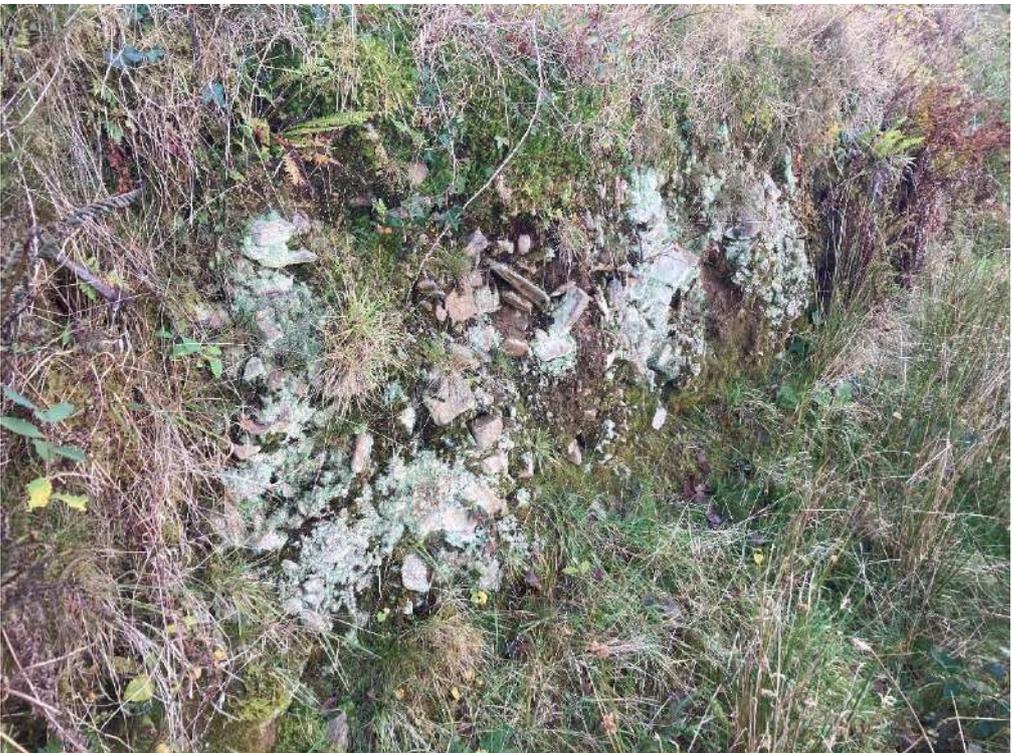
<p>Desk Study Photograph 55</p>

<p>Date: 15/11/23</p>	
<p>Direction Photograph Taken: South.</p>	
<p>Description: Possible washout features on one the slopes in the east of the site.</p>

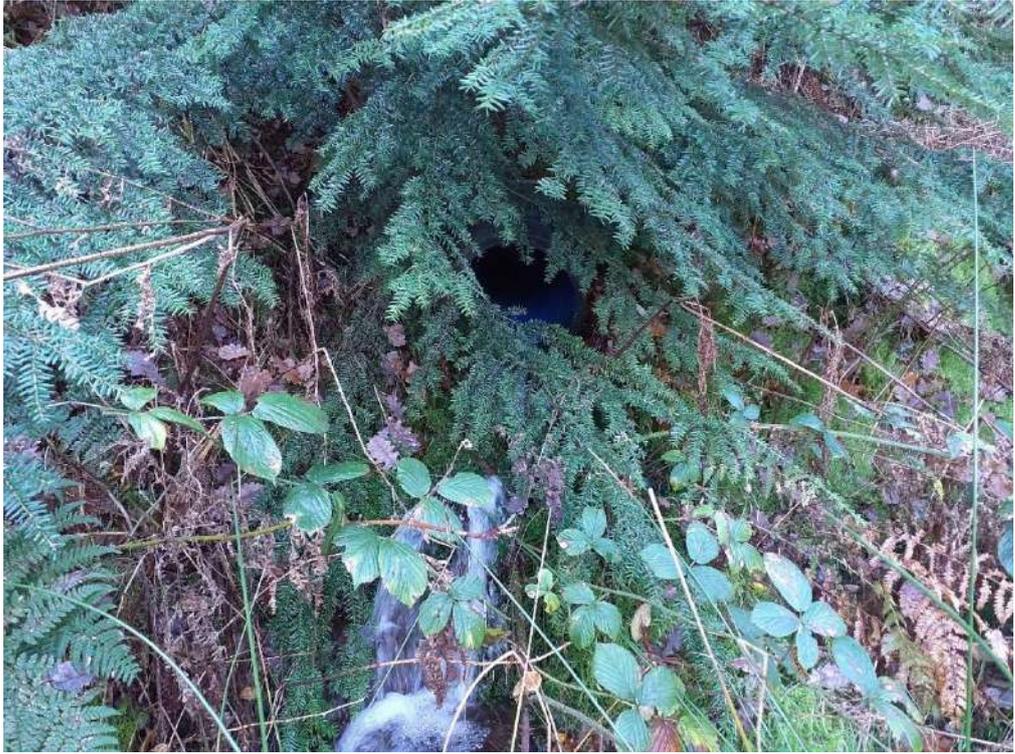
Desk Study Photograph 57

Date: 15/11/23	
Direction Photograph Taken: South.	
Description: Culvert coming down the slope in the north of the site.

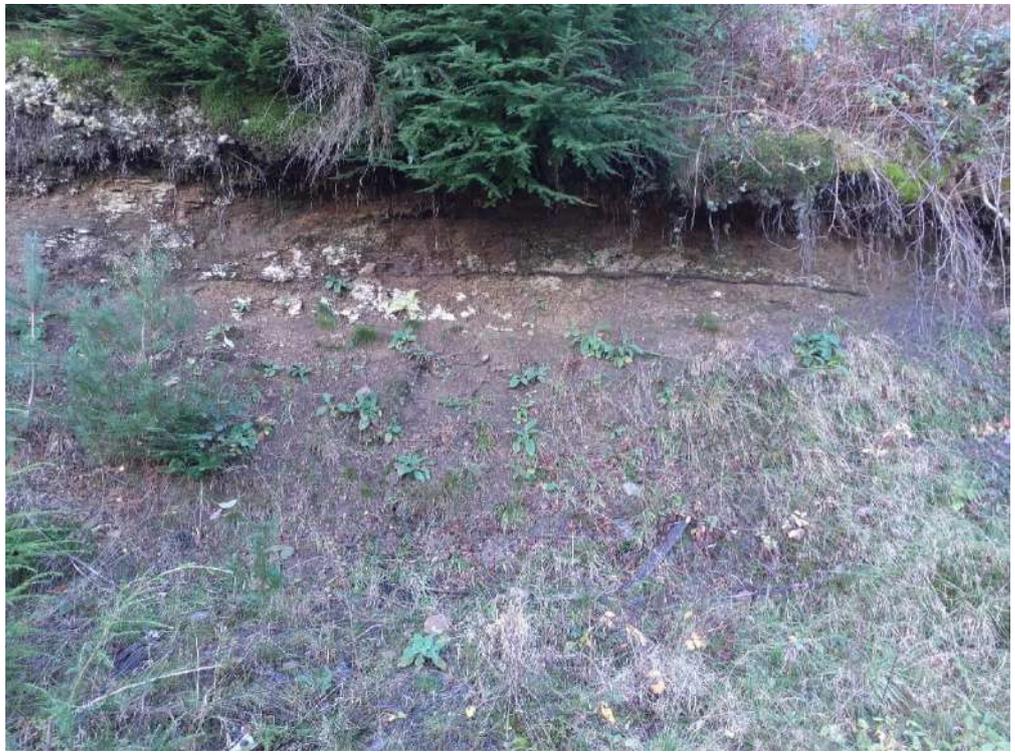
Desk Study Photograph 58

Date: 15/11/23	
Direction Photograph Taken: South.	
Description: Superficial weathered bedrock exposure, possibly a failure plane. 3m to 4m high. Note the band of coal.

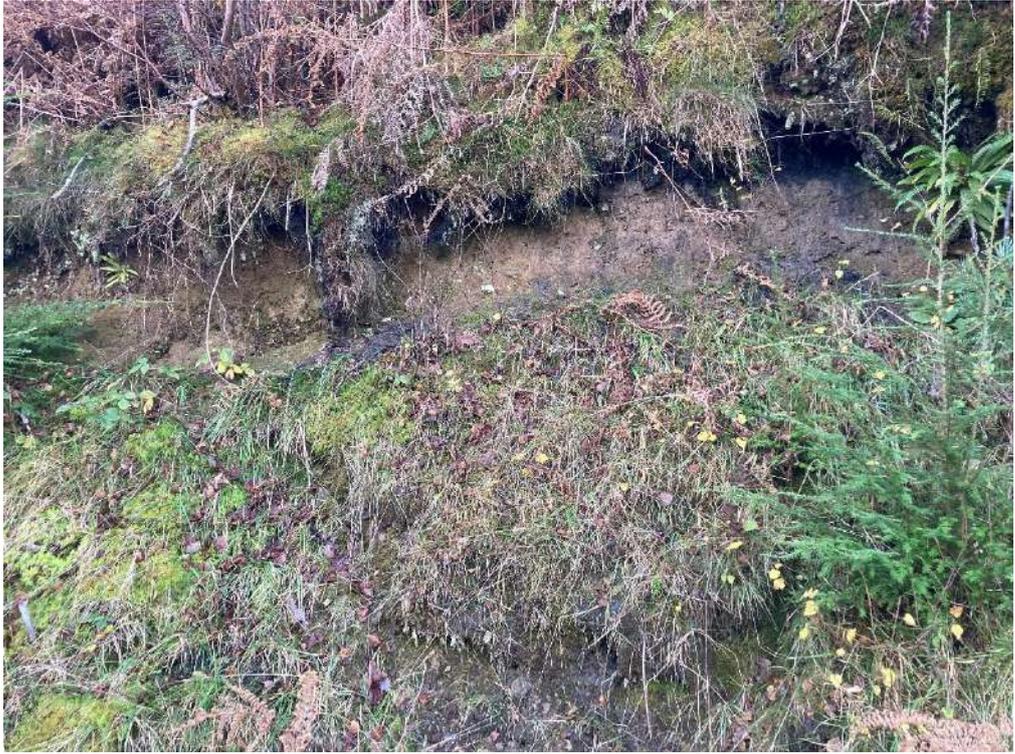
Desk Study Photograph 59

Date: 15/11/23	
Direction Photograph Taken: South.	
Description: Failure in the superficial weathered bedrock at the base of the slope.

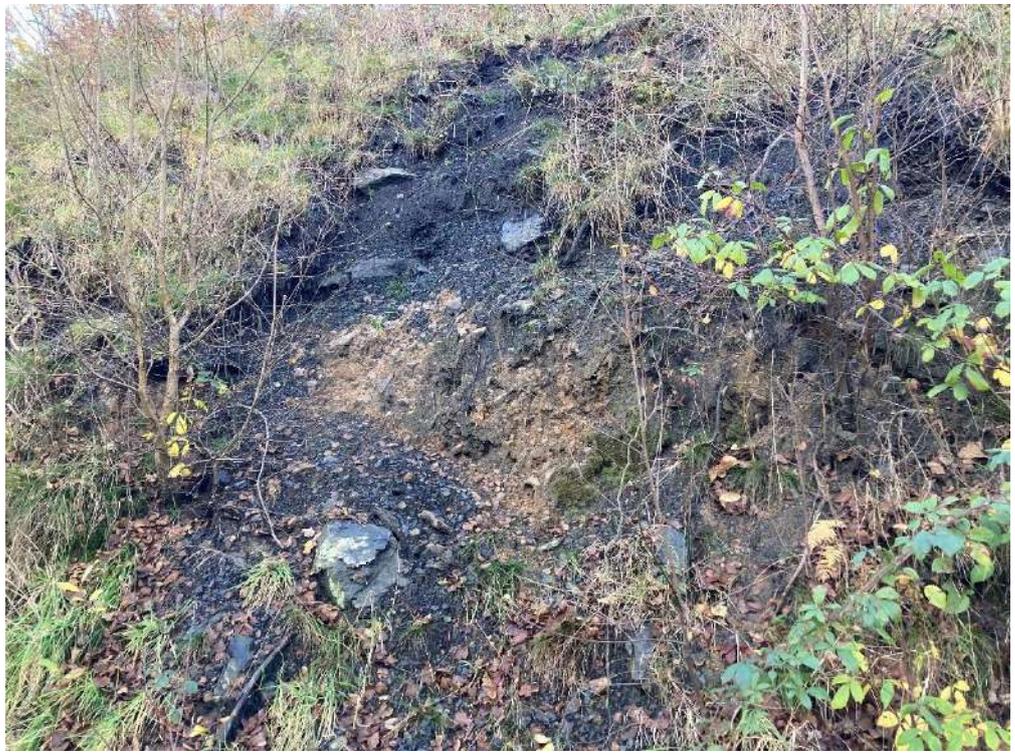
Desk Study Photograph 60

Date: 15/11/23	
Direction Photograph Taken: South.	
Description: Coal tip material at the base of the slope in the north of the site.

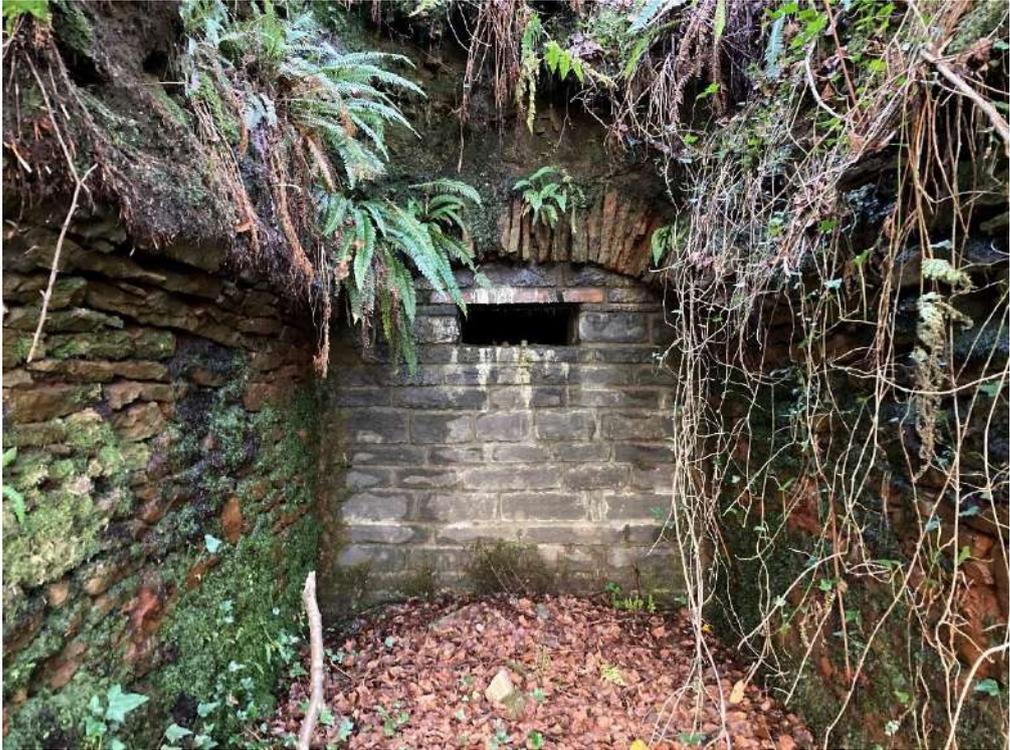
Desk Study Photograph 62

Date: 15/11/23	
Direction Photograph Taken: South.	
Description: Photograph showing the inside of the mine adit.
