2433 Bridgend Clusters

Report on a Preliminary Roost Assessment

Fulcrum Group
2433
September 2023

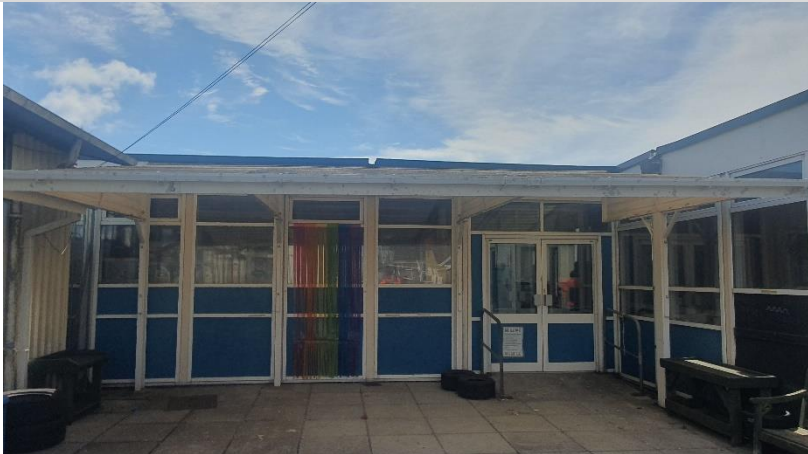
<p style="text-align: center;">Image 18</p>
B1 (d)	Corrugated metal tower and minor gaps behind plastic panelling along the roof edging offered limited potential for roosting

3.2.16 **Section 1(d)** is an L-shaped entirely flat-roofed section, with a small porch area covered in a polycarbonate roof on the north-west facing side (Image 18). Gaps were present behind the plastic fascia on this side although careful checking provided no indication of roosting and overall potential was considered low. A corrugated metal tower on the

Building	Description	Image
B1 (d)	Porch area with polycarbonate roof

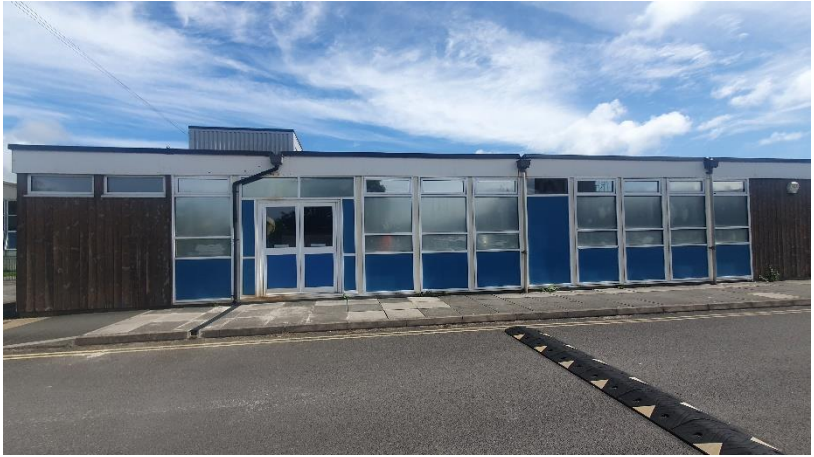
<p data-bbox="1018 1753 1150 1785">Image 22</p>

3.2.17 The south-west side (Image 22) had a mix of wood panelling and plastic walls with windows, all of which was well sealed with no potential roost features. Minor gaps were present in sections along the roof edge but were generally considered to have low roost potential. Similarly along the south-east facing walls (Images 23-24), minor gaps were present behind some of the plastic panelling and behind the fascia but was considered to have low roost potential.

<p data-bbox="1018 1232 1150 1263">Image 21</p>
B1 (d)	SW side of section.

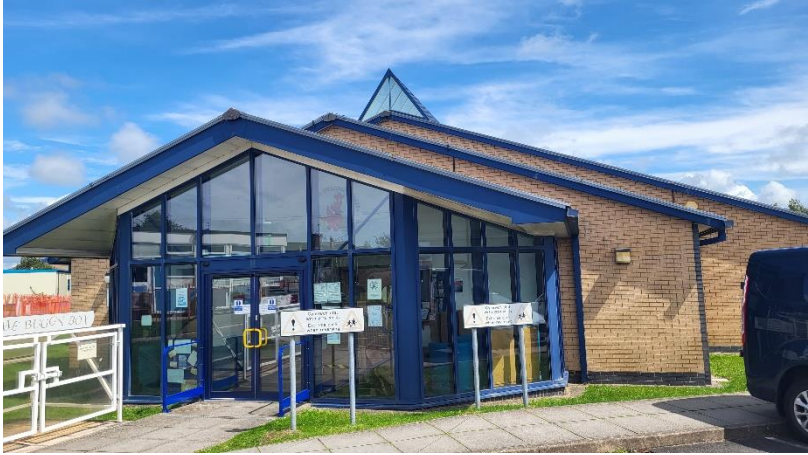
<p style="text-align: center;">Image 27</p>
<p>B2 (b)</p>	<p>Gaps behind lead flashing on N side.</p>

- 3.2.20 **Section B2(a)** is an entrance porch/atrium at the western end of the building (Image 27) with tiled roof and floor-to-ceiling windows. A minor gap was noted under the ridge however this was considered to have low roost potential.

Building	Description	Image
<p>B2 (a)</p>	<p>Glass and brick atrium at western end of Building B2</p>

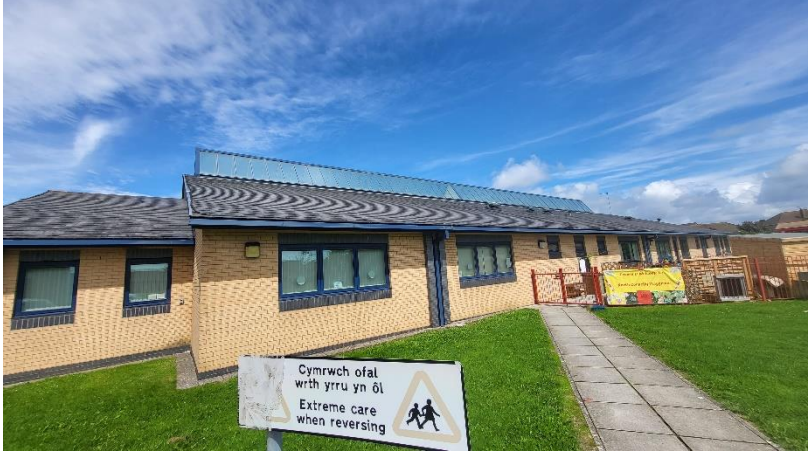
<p style="text-align: center;">Image 29</p>

- 3.2.22 **Section B2(c)** is the main section of the building (Image 29), and its tiled roof had a pyramidal-style roof window along part of the ridge. The roof appeared secure with no lifted tiles. No suitable gaps were noted under the soffits or elsewhere.

<p style="text-align: center;">Image 28</p>
<p>B2 (c)</p>	<p>Main section of Building B2 with pyramidal roof window.</p>

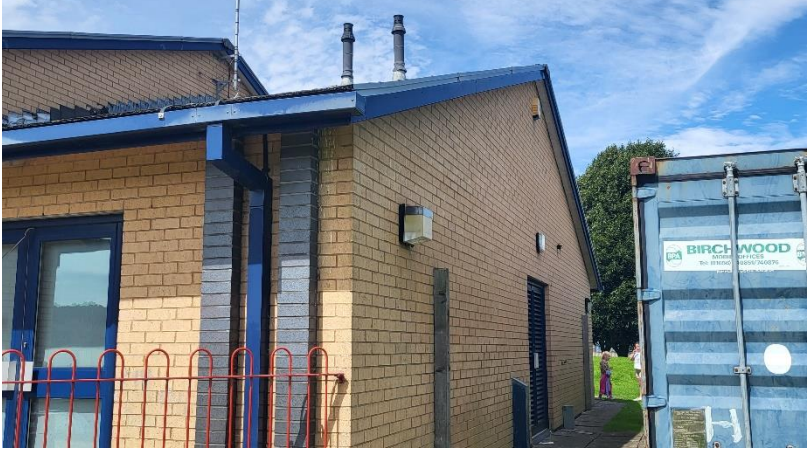
<p data-bbox="1023 725 1145 757">Image 30</p>
B2 (d)	Missing brick at top of wall under soffit with evidence of bird use.

- 3.2.23 **Section B2(d)** is a small section at the eastern end of the building (Image 30). Double doors were present in the south-facing wall and a single door present in the eastern gable. A brick was noted to be missing under the roof edge in the south-east corner and staining by bird droppings underneath indicated nesting had likely been occurring (Image 31). It is considered to have moderate bat roost potential in the absence of habitat considerations, dependent on the extent of bird use. A narrow gap was also present between the soffit and wall across the eastern gable end (low roost potential) and a further small hole was present due to a broken brick in the north wall underneath the soffit (Images 32-33).

Building	Description	Image
B2 (d)	Section at eastern end of Building B2

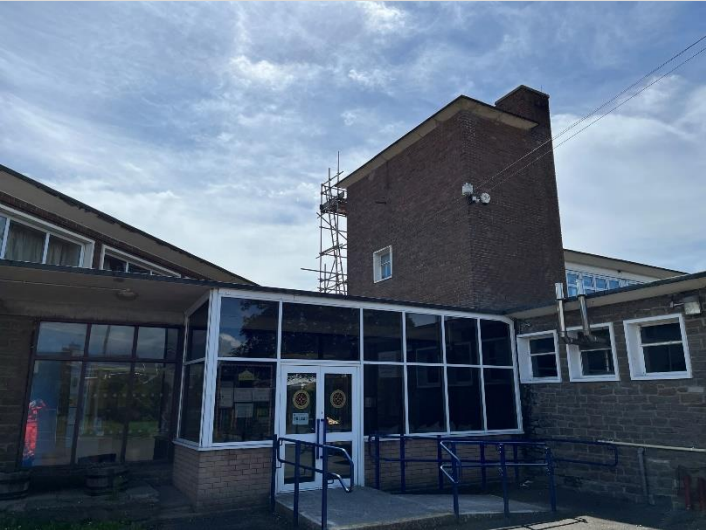
<p>Image 38</p>

- 3.2.26 **Section B3(b)** is a brick-built section at the north-east corner with multiple levels and flat roofs (Images 38-42). It was noted that the roof material was peeling in the south-western corner and a gap was present above the windows on the south eastern aspect. A broken section plastic soffit above a drainpipe on was also present on the south aspect, and the gap appeared to go into a void. Roof lining/felt was visible and its appearance suggested it may have been eaten/chewed (e.g. by rodents)

<p>Image 37</p>
<p>B3 (b)</p>	<p>NE corner section of Building B3 – variable levels</p>

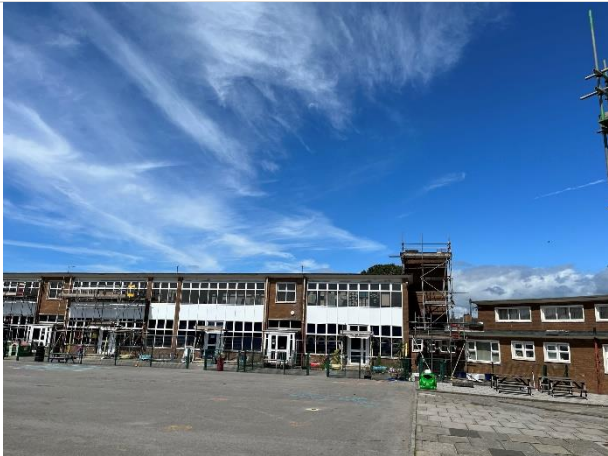
<p style="text-align: center;">Image 43</p>

- 3.2.27 **Section B3(c)** is a two-storey brick-built structure with a flat roof (Images 43-44). Scaffolding was in place during the survey. Along the south side minor gaps were noted along the roof edge and cracks in the soffit were noted where aerials were attached. However, the brickwork was secure (no gaps, cracks or crevices associated with missing mortar) and there were no gaps around window frames. Along the north side no obvious potential roost features were noted. The brickwork and plastic cladding appeared to be in good repair.

<p style="text-align: center;">Image 42</p>
<p>B3 (c)</p>	<p>South side of section B3 (c)</p>

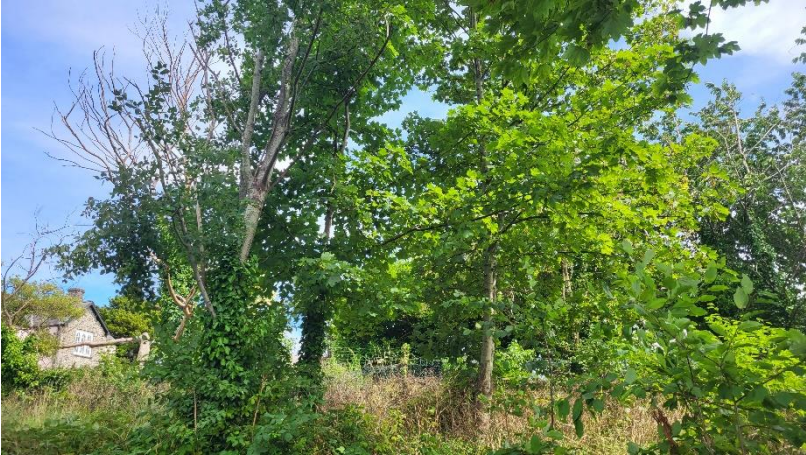
<p style="text-align: center;">Image 47</p>
<p>South-east boundary beyond playing field.</p>

Notes	Photographs
<p>Woodland learning area at southern boundary</p>

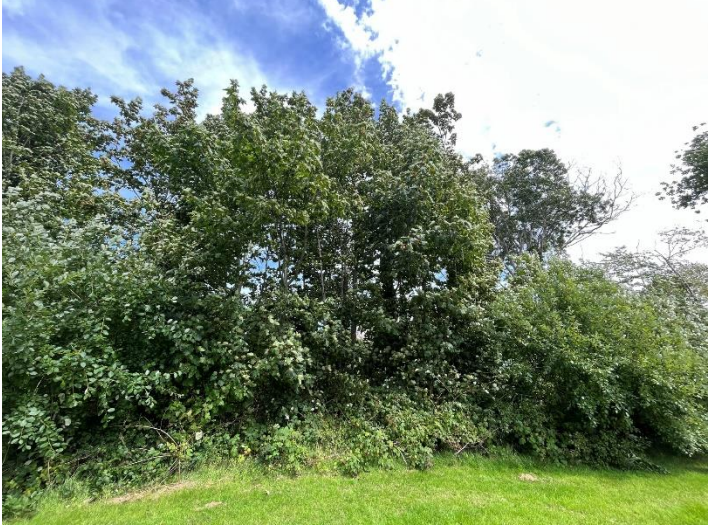
<p style="text-align: center;">Image 49</p>
<p>Example of ivy covering that commonly occurred across the trees present in the woodland learning area</p>

Notes	Photographs
<p>Example of scrubby trees along eastern edge of boundary</p>

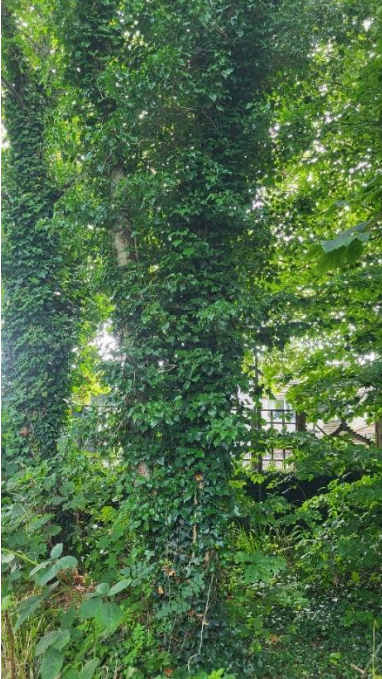
<p style="text-align: center;">Image 50</p>

trees was common. A minor split was noted in a single tree at the southern end of the eastern boundary (Image 50, approx. grid reference SS 81947 81583) which offered negligible to low roosting potential. No other potential roost features were record.
